## Determination 2019/013

# Regarding the refusal to issue a code compliance certificate for the relocation of and 18-year-old alterations to a house at 9 High Street, Waddington

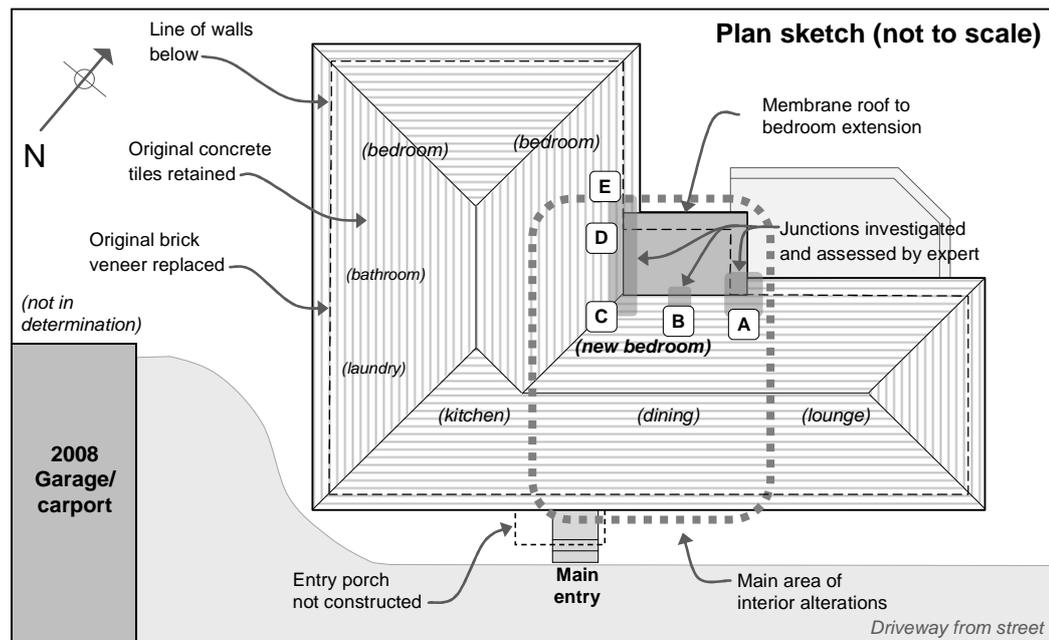
**Figure 2: Approximate plan**

4.3.1 The expert removed concrete tiles at the northeast end of the membrane/tile junction (Area A) to investigate the underlying construction and observed:

- an underlying metal back flashing intended to channel any water that spills over the membrane edge down into the adjacent gutter
- plastic mesh over the above junction to prevent debris entering and blocking the underlying back flashing
- a build-up of wind-blown leaf debris within the soffit cavity, but no sign of any dampness or moisture penetration despite recent heavy rain
- at the internal corner, water stains to the original soffit framing but no evidence of current moisture, with all timber apparently sound and undamaged.

4.3.2 At the southeast membrane/tile junction (Area B), the expert noted:

- the upper edge of the membrane extends up under the adjacent concrete tile and past the underlying timber tile batten
- the bottom of concrete tiles rest on the butyl, which will eventually cut through the membrane. There appeared to have been a separating element between the tiles and the membrane in the past.

4.3.3 The expert also removed concrete tiles along the southwest butyl/tile junction to investigate the underlying construction and noted the following:

- The membrane turned up to form an upstand with varying height to suit the butyl slope up under the concrete tile, but lacked any support to the membrane behind the upstands at junctions with tiles.

- In regard to the southeast end of the junction (Area C):
  - the lap joint has opened, with a ruler able to be inserted
  - old water stains and a recent damp patch on the underlying timber

- very low invasive moisture readings in the timber with the old stain.
- In regard to the northwest end of the junction (Area D):
  - the lap joint has also opened, with a ruler able to be inserted

- a damp patch from recent rain on underlying timber
  - very low invasive moisture readings in the adjacent top plate.
- In regard to the western end of the junction (Area E):

- ‘ample upstand’ to the membrane to prevent water flowing into the roof cavity
  - no support provided to the membrane at the upstand
  - no evidence of past or current moisture penetration into the soffit cavity.

The [membrane] roof is leaking at the lap joints where they turn up the flat roof-to-pitched roof junction on the SW side of the flat roof.

Attention is required to all four sides of the [membrane] roof.
