Determination 2019/022

Regarding the decision to issue a code compliance certificate in respect of surface water drains to a house at 17 Flavell Street, Heathcote Valley, Christchurch

Summary

This determination considers the compliance of an as-built surface water drainage system to a new house. The system as consented did not provide a compliant solution and the work as installed is not considered to be compliant by the building owner.

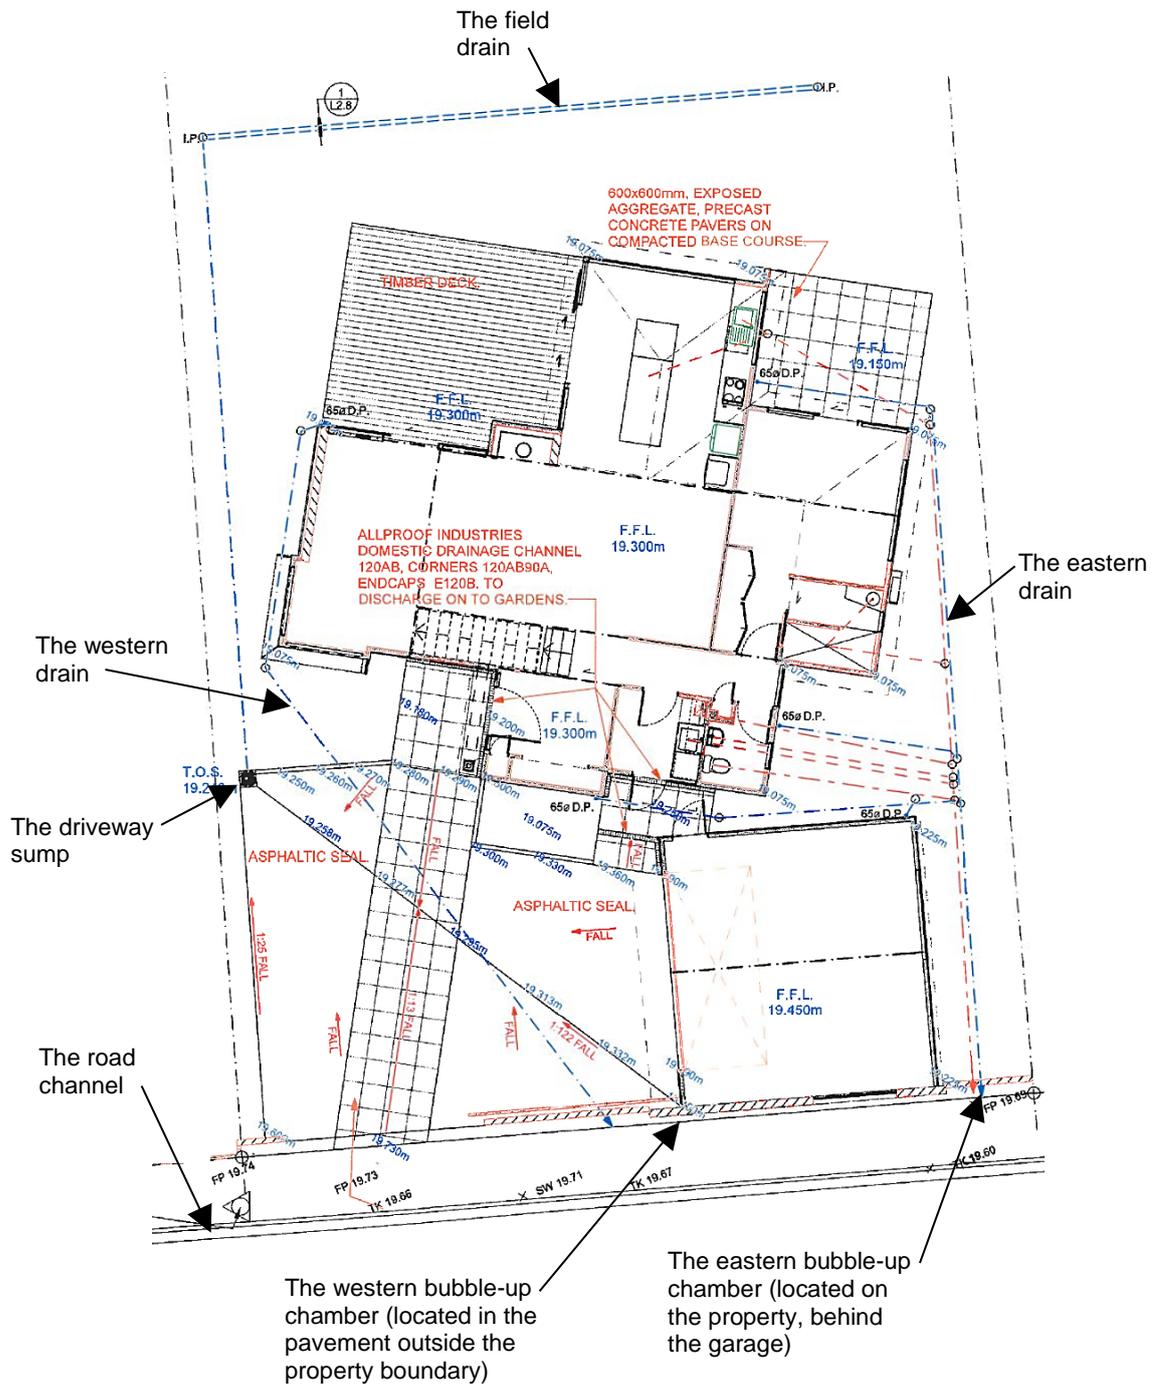
Figure 1: The surface water drainage system taken from the amended drainage plan⁵ dated 1 October 2015 (not to scale)

2.1.3 The as-built surface water system consists of:

- downpipes from the building that connect to a surface water drain on the west side of the property (“the western drain”). The western drain connects to a bubble-up chamber located in the pavement outside the property (“the western bubble-up chamber”), which connects to an existing drain leading to the a channel⁴ running between footpath and the roadway (“the road channel”)
- downpipes from the building that connect to a surface water drain on the east side of the property (“the eastern drain”). The eastern drain connects to a bubble-up chamber located on the south-east corner of the property, behind the garage (“the eastern bubble-up chamber”), which connects to an existing drain discharging to the road channel
- a sump to the western side of the driveway (“the driveway sump”) connected to a drain, which runs to a field drain on the north of the property.
