## Determination 2019/027

# Regarding building work compliance at 302 Kennedys Bush Road, Christchurch with Building Code Clause E1 Surface water, and grant of a building consent and code compliance certificate for this work

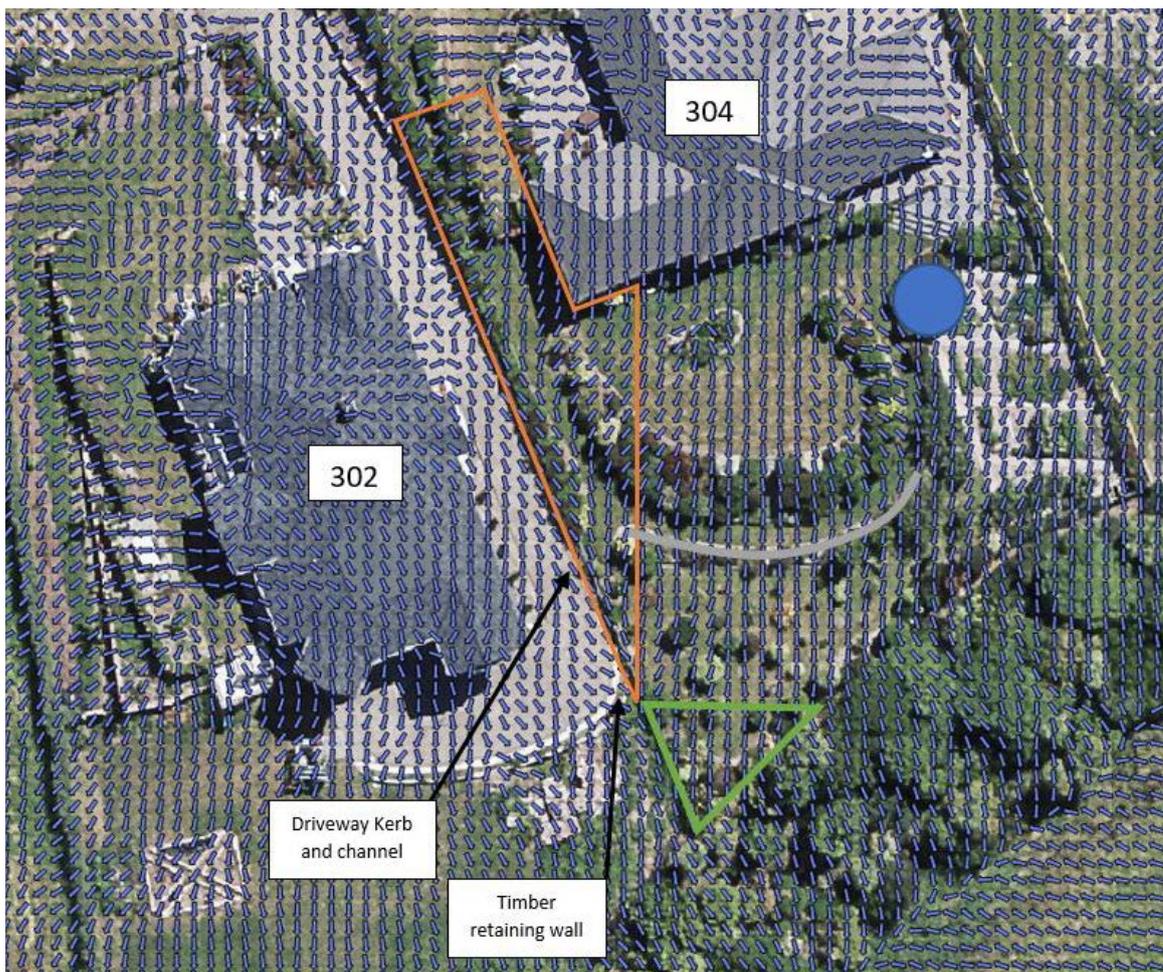
**Figure 1: Site layout and flow direction of surface water (from the experts' report)**

5.2 In their report the experts said their review of the material and onsite observations indicated that the overland flow concentrated along the boundary between No. 304 and No. 302 by No. 302 was likely to cause a nuisance and damage to No. 304.

5.3 The experts said the flow rates predicted for a 1:10 year storm event, concentrated along the steep flow path at the shared boundary between Nos 302 and 304, were likely to cause scour and erosion damage in the southwestern corner of the applicant's property. Accordingly, in their view the neighbour's driveway development works did not comply with Clause E1.3.1.

This is because the driveway prevents the natural overland flow of water from [No.] 304 crossing the boundary in the manner it did prior to development of the subdivision and leads to a concentration of these flows at the southwest corner of [No.] 304, where scour and erosion of the land is likely to occur.

5.4 The experts said the owner's construction of a driveway kerb and the subsequent backfilling of the area between this kerb and the shared boundary had collected and concentrated the overland flow, which was then disposed of back onto the neighbour's property.

For this drain to be effective it would need to be reinstalled underground with a layer of open graded drainage stone placed above to a level below that of the neighbouring property.
