Determination 2019/049

The refusal to issue a code compliance certificate for a 20-year-old house with monolithic cladding at 30 Firth View Road, Thames

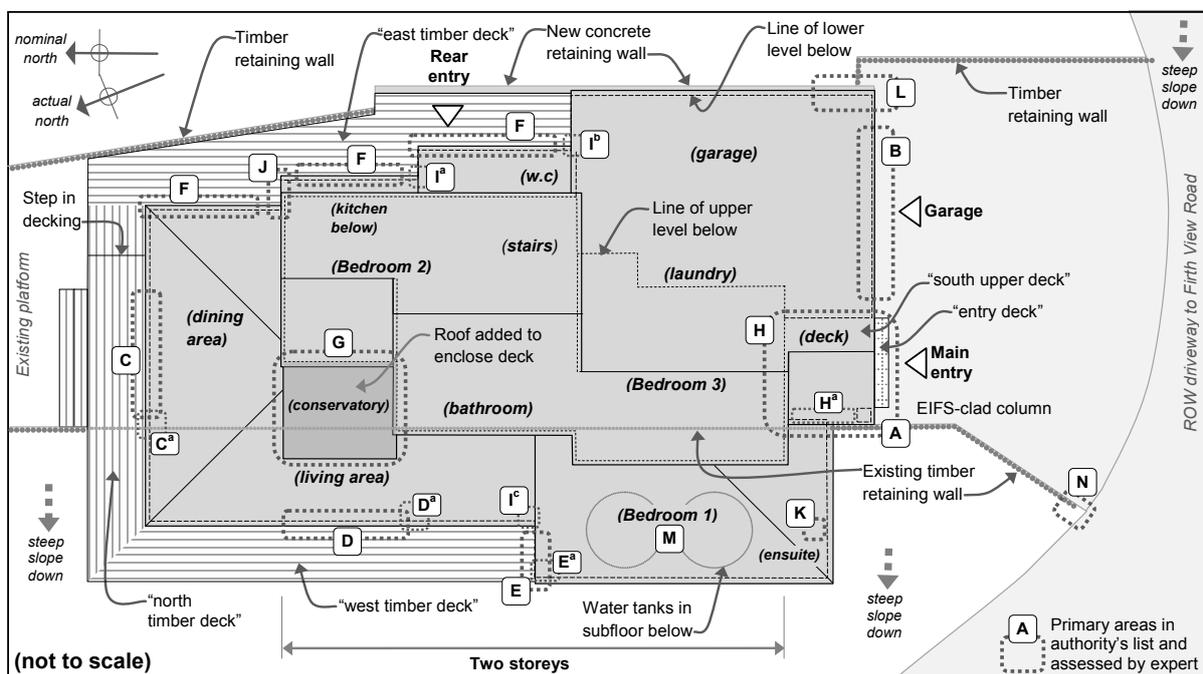
Figure 1: Approximate site plan

- 96% and heavily decayed flooring at the north deck doors (Area C^a)
- 20% in water stained floor joist below the above (Area C^a)
- 91% and decayed flooring and bottom plate at the west deck doors (Area D^a)
- 18% in water stained flooring beside Bedroom 1 deck door (Area E^a)
- 19% in soffit framing below the south upper deck (Area H^a)
- 27% in framing below the end of the east apron flashing (Area J)
- 18% in skirting beside the ensuite shower cubicle (Area K).

- inadequate clearances between the cladding and the ground at the garage and front entry (Areas A and B)
- inadequate clearances between the cladding and timber deck (Areas C to E)
- in regard to the EIFS-clad balustrade to the south upper deck (Area H^a):
 - the height of the balustrade is insufficient
 - the balustrade cap flashing lacks a slope
 - there is a leak into the soffit framing below the balustrade
- leaking apron flashing/gutter junction north-east kitchen corner (Area J).

- cladding clearances at the garage and front entry (Areas A and B)
- cladding to timber deck clearances (Areas C to F)
- the inadequate height of the EIFS-clad balustrade (Area H^a)
- investigation and repair in regard to moisture penetration at:
 - soffit framing below the clad west balustrade (Area H^a)
 - framing below the east apron flashing/gutter junction (Area J)
 - framing and flooring adjacent to timber decking (Areas C to E).
