Determination 2019/060

Regarding compliance with Building Code Clause B1 Structure of a multi-storey steel framed building at 230 High St, Christchurch

This determination considers the compliance of a recently-completed eight-storey steel framed building. Specific aspects of the completed frame had been brought to the notice of the authority, and the authority also questioned work carried out that varied from the approved consent. The determination considers the compliance of these matters in respect of Building Code Clause B1 Structure.

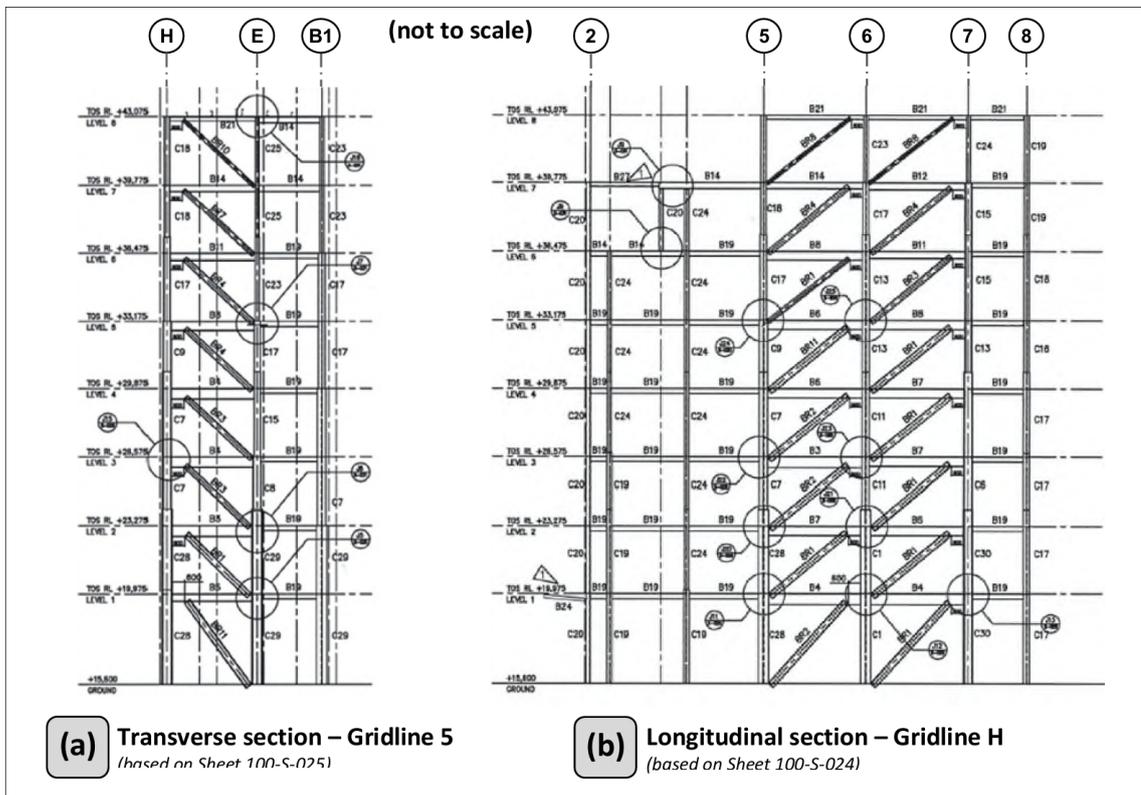
Figure 3: Frame elevations along Gridlines 5 and H – taken from building consent Drawings 100-S-024 and 100-S-025

Column on Grid 5-H	The independent engineers' comments and the expert's conclusions were based on nominally ductile loads, but the building was designed for limited ductile loads and had clearly defined seismic resisting elements in two different directions, so NZS 1170.5 clause 5.3.1.1 applied.
Foundation uplift by overturning	The building was designed for a ductility of $\mu = 3$ (not $\mu = 1.25$) so the overturning needed to be checked for this and with an appropriate overstrength factor. It was not clear which ductility the expert had assumed.

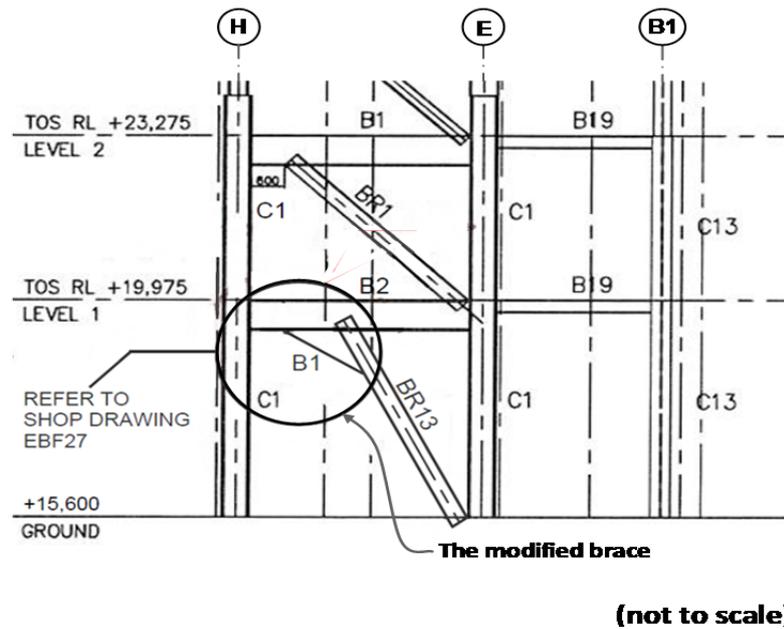
Figure 4: The modified brace on Grid 6 (circled) – taken from building consent Drawing 100-S-025 Rev 2

2.4.1 During construction, the bracing of the EBF at ground level on Grid 6 next to the stairwell was modified to enable access to the stairwell (refer to Figure 4). This modification involved moving the upper section of the brace member further along the beam and adding a gusset section taken from a hot rolled section of steel, which I assume was to maintain the geometry of the active link adjacent to the column at Grid 6-H.

2. Modified brace (ground level, Grid 6)	<ul style="list-style-type: none"> brace is highly eccentric and required to support 50% of the building's base shear demand – it would buckle well before the active link (a potentially dangerous failure mechanism) 	<ul style="list-style-type: none"> load transferred through the stiffened brace at the top, where a bending moment is applied as additional force and combined with the axial force brace designed to support this combined action; additional stiffener is provided at the base 	<p>NOT in accordance with B1/VM1</p> <ul style="list-style-type: none"> said beam and brace have sufficient capacity for the revised layout, but load path changed so moment in the active link zone is considerably higher this results in higher moments in the column and beam/column connection, which do not appear to have been checked in the frame redesign based on the expert's calculations the supporting column on Grid 6-H and the beam/column connection

2. Modified brace	Considered this detail was in accordance with B1/VM1; said analysis showed stress change (from original design) was mainly in the collector beam and brace; and the original section of the column was still satisfactory with the beam induced load.	Said the beam was 700 mm deep with a 450 mm clear yielding region, which did not conform with the HERA publication's requirements (i.e. that the yielding region must be as long as the beam depth). The revised beam size had insufficient capacity to support the original design loads and, as noted in the expert's final report, the amended bracing layout resulted in significantly higher actions in the beam, column and connection that had not been accounted for in the design.
