Determination 2020/002

Regarding the consented alterations to the walls and roof of a house and its compliance with Building Code Clause B1 at 25 Sturrocks Road, Redwood, Christchurch

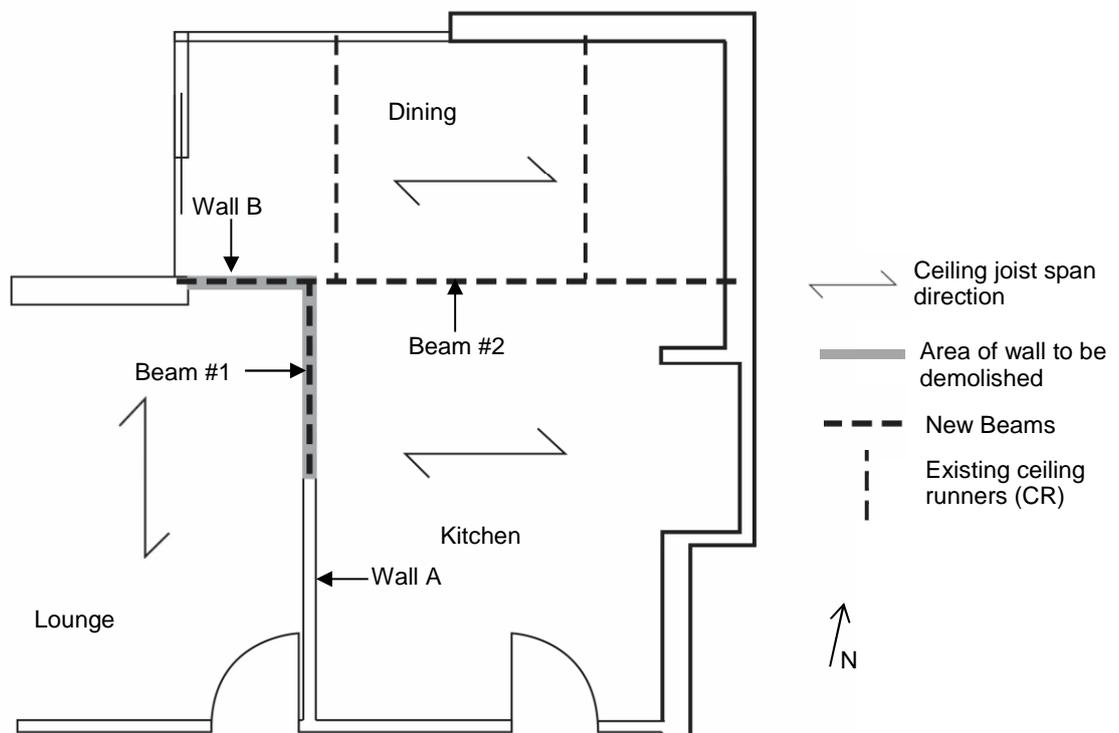
Figure 1: Drawing showing proposed demolition and new beams (not to scale)

- 2.3 In 2013 the previous owners decided to alter the house by removing sections of two walls (1.1m and 1.9m long) between the lounge and kitchen/dining areas (refer Figure 1). They engaged the engineer to provide structural engineering advice and drawings for this to allow the builder to carry out the alterations.

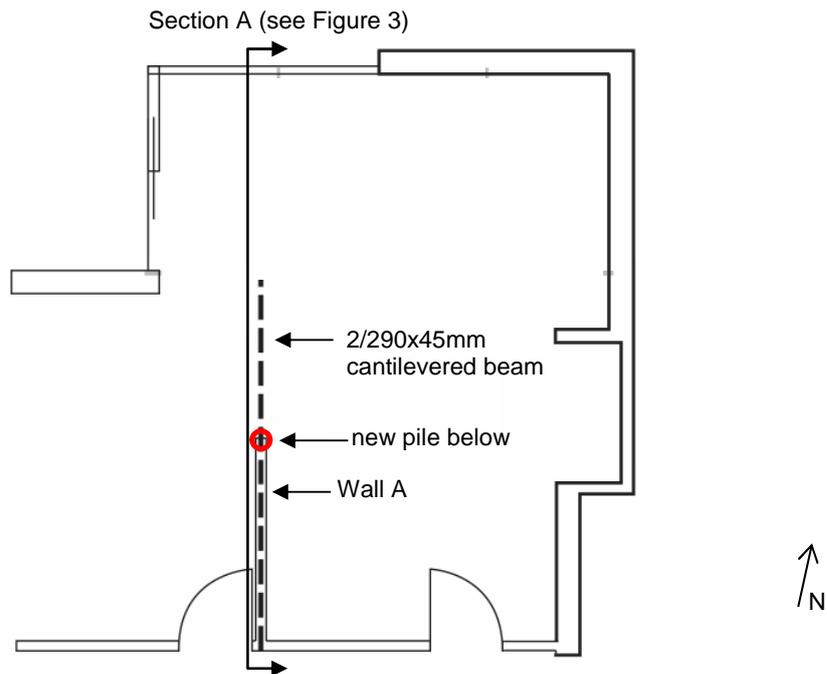
Figure 2: Sketch of the revised design based on the amendments to engineer's design sheet SK-2 (not to scale)

- 2.11 The engineer issued a site report dated 26 March 2014 to the builder to this effect along with a marked up-sketch showing the changes (refer Figure 2). The site report also stated that once the new work is completed another engineering inspection would be completed so the PS4¹¹ could be issued. I note that the authority can find no record of receiving the site report and associated details in 2014. I have received conflicting and changing accounts of whether the authority was informed and approved of the change in design as a minor variation.

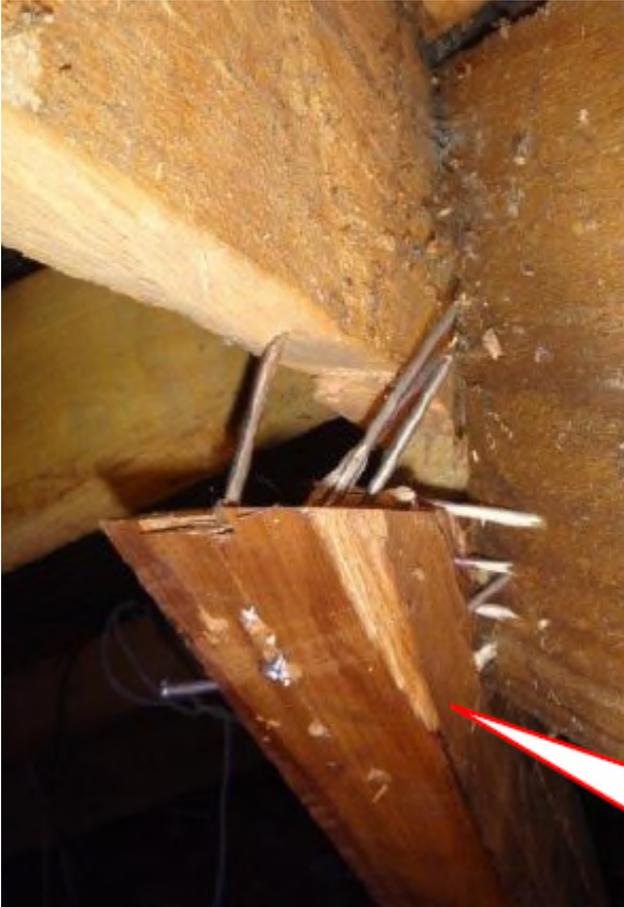
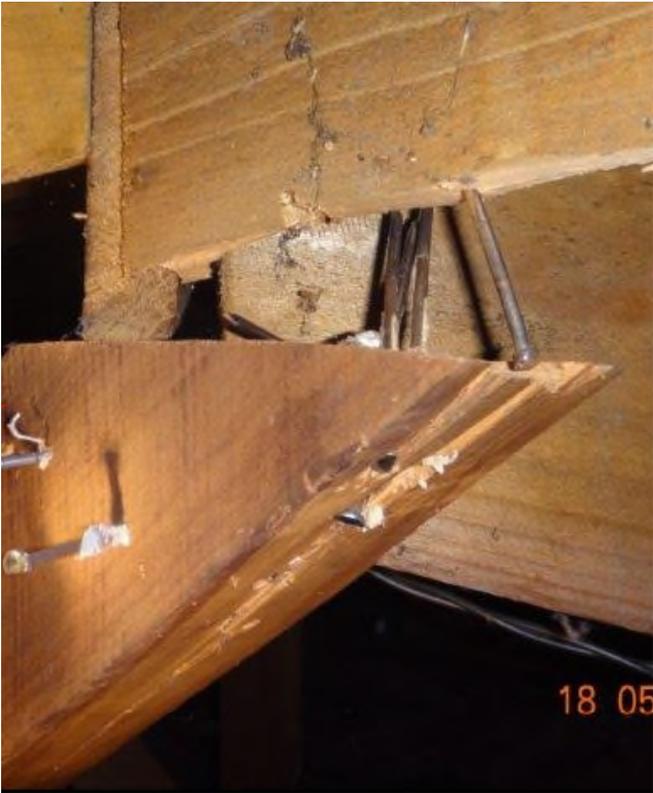
C.1 Photographs of the roof strut dated 18 May 2018 taken from the first expert’s report.

4.4 The first expert concluded that the "cantilevered beam and all work associated with it (including the roofing) is meeting the...Building Code". The first expert also noted while the roof strut was poorly fitted there was no indication the roof had moved as a result of the strut.

- The nailed connection at the top of one of the roof struts is inadequate (refer photographs in Appendix C.1).

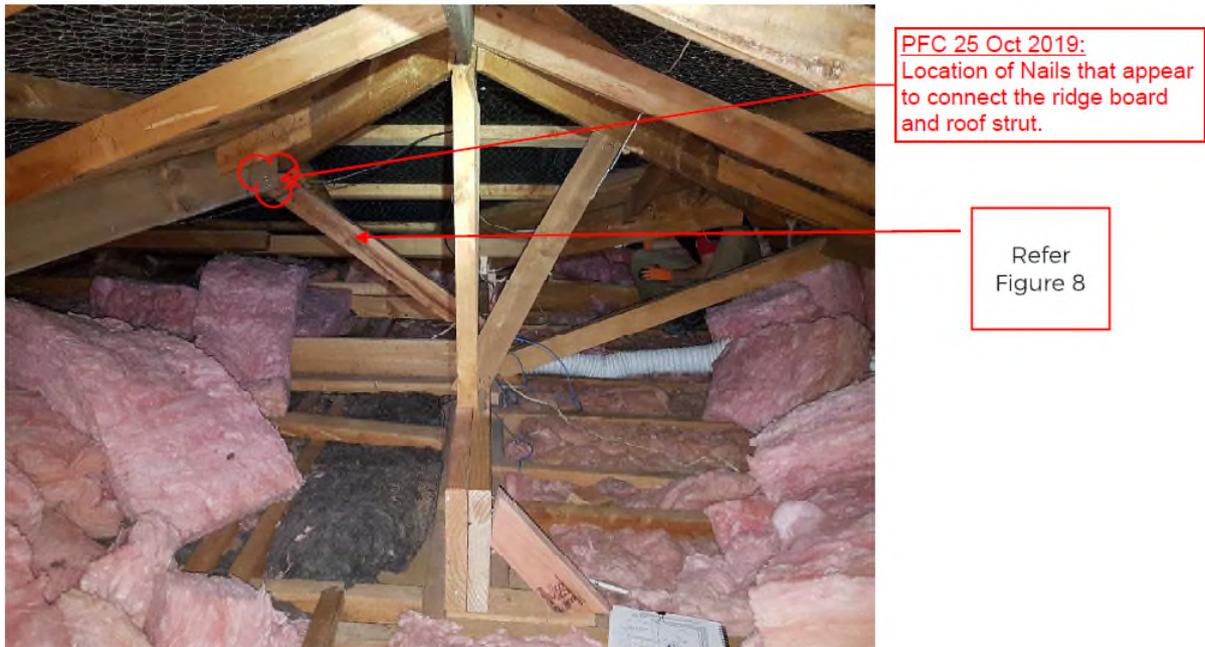
C.2 Photograph of the roof strut by the engineer, which was taken from the second expert's report, with the engineer's comment provided 25 October 2019.

- The second experts agreed with the engineer that there was a sufficient connection between the roof strut and the ridge beam. It is not clear whether there is significant splitting, and if there is it has occurred in the years after the installation. Photographs included with the submission show there was no significant or discernible damage to the roof strut in March 2016. This indicates the roof strut would not have been compromised when the code compliance certificate was issued.

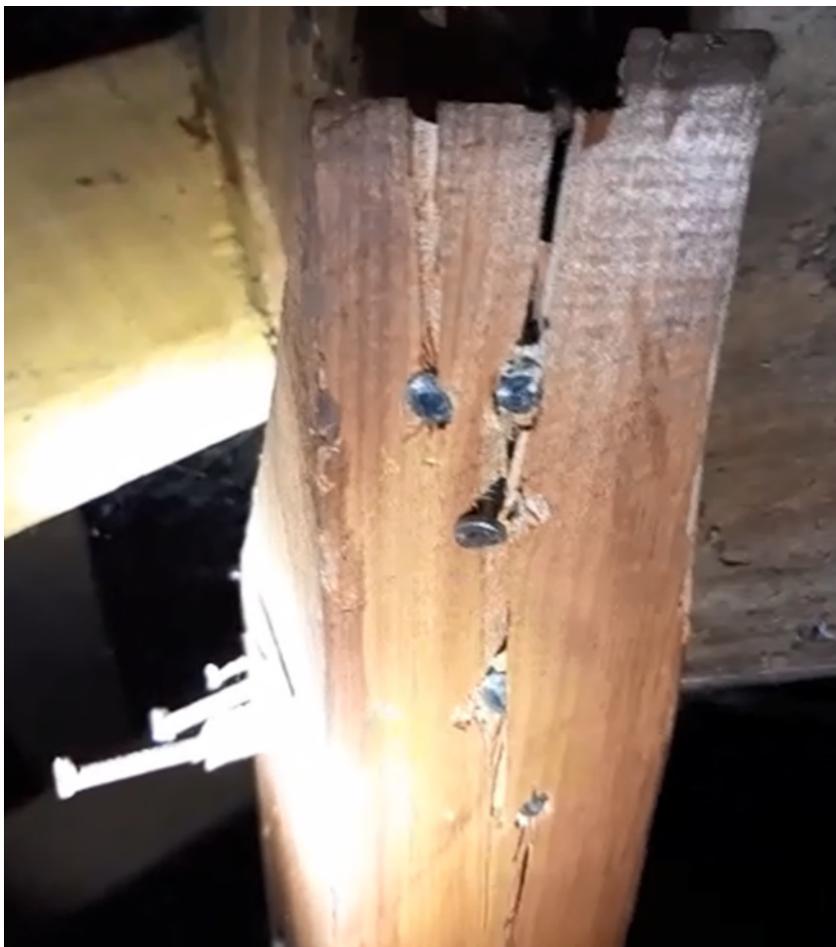
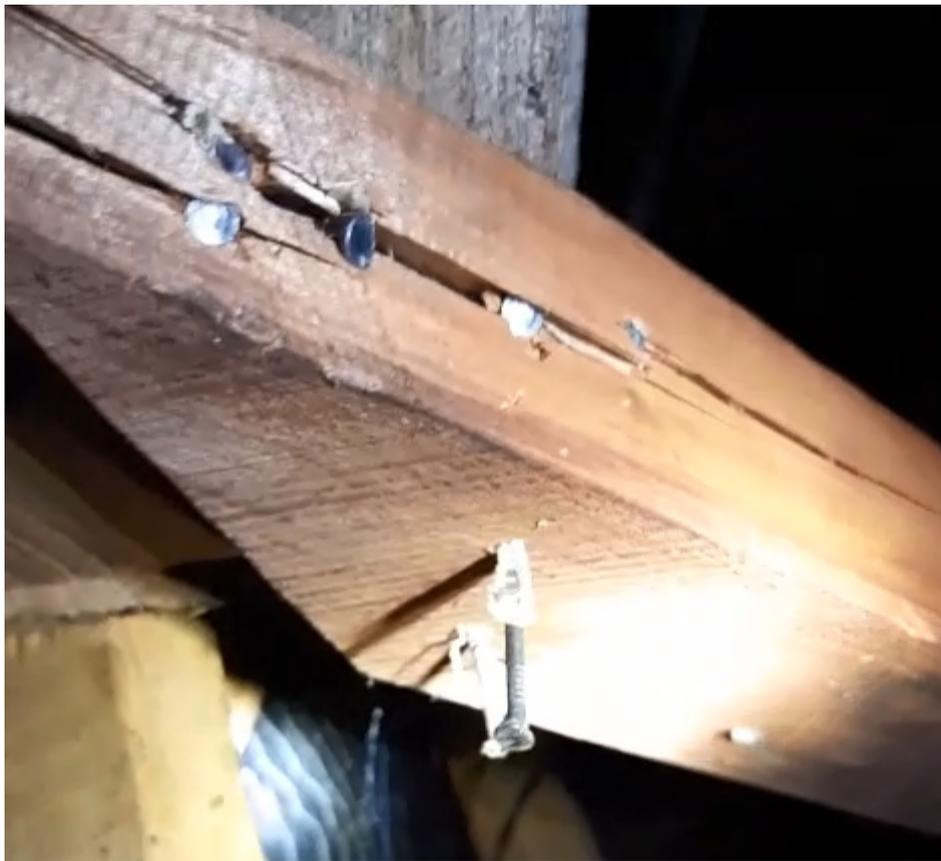
C.3 Screenshots of the roof strut taken from the owner's videos provided 5 February 2020.

Splitting shown below the bottom nail

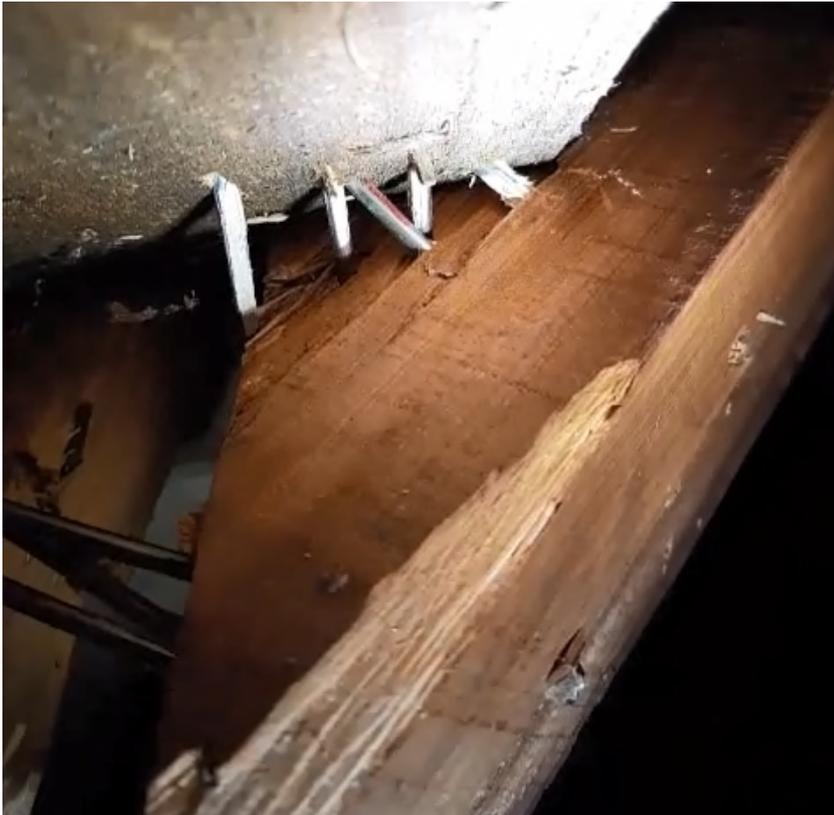
Connection from the strut to the ridge beam

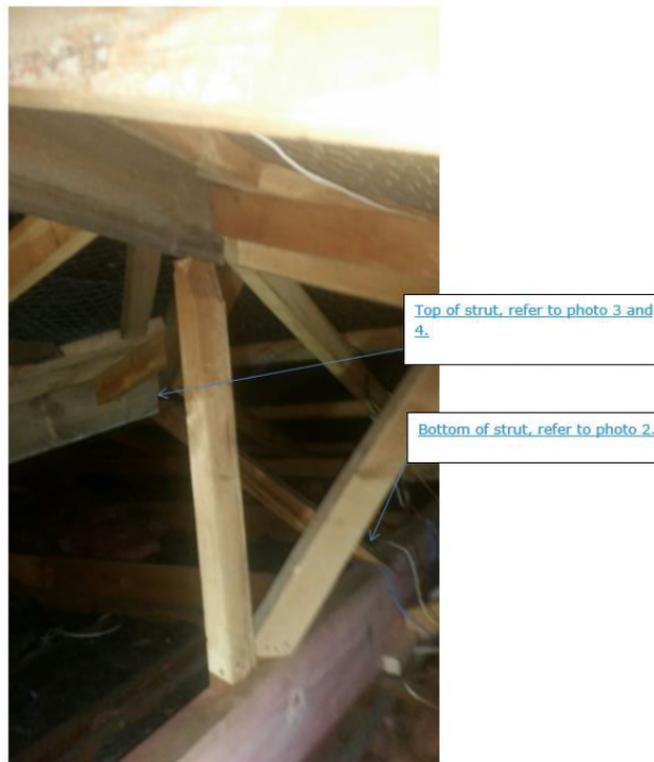
Photo 1, showing the strut which has been noted as being poorly installed.

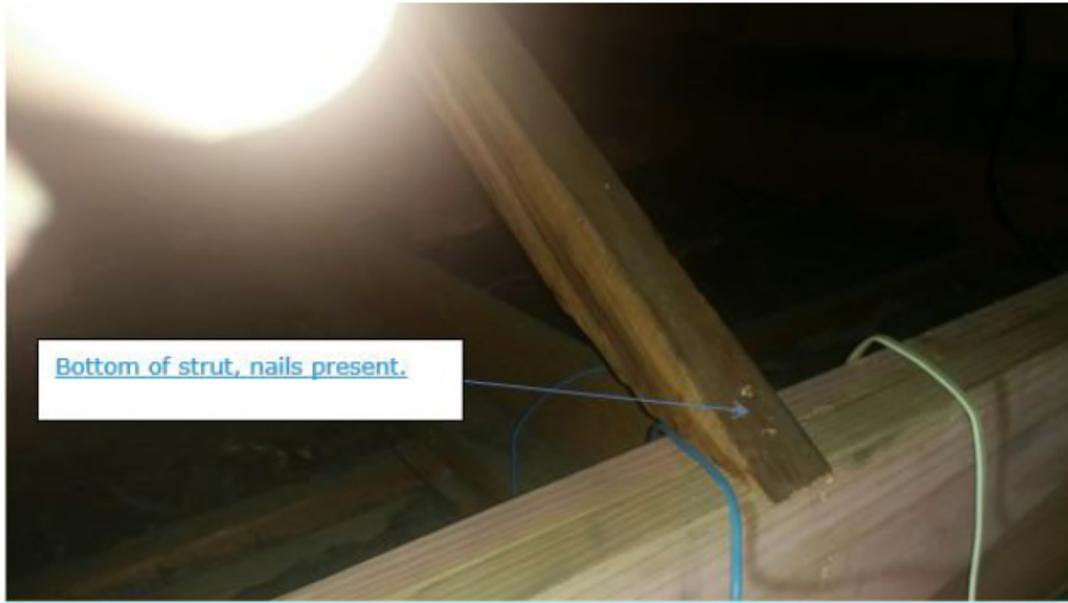
[Photo 2. Bottom of strut with very little splitting of the timber.](#)

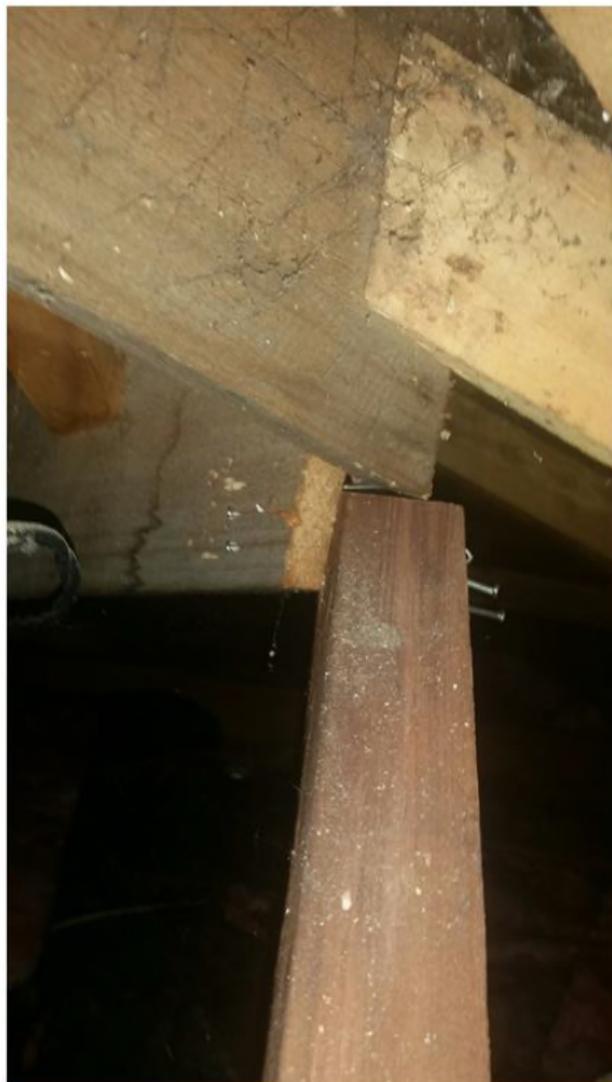
[Photo 3. Top of strut with nails present and no observable splitting in the timber.](#)

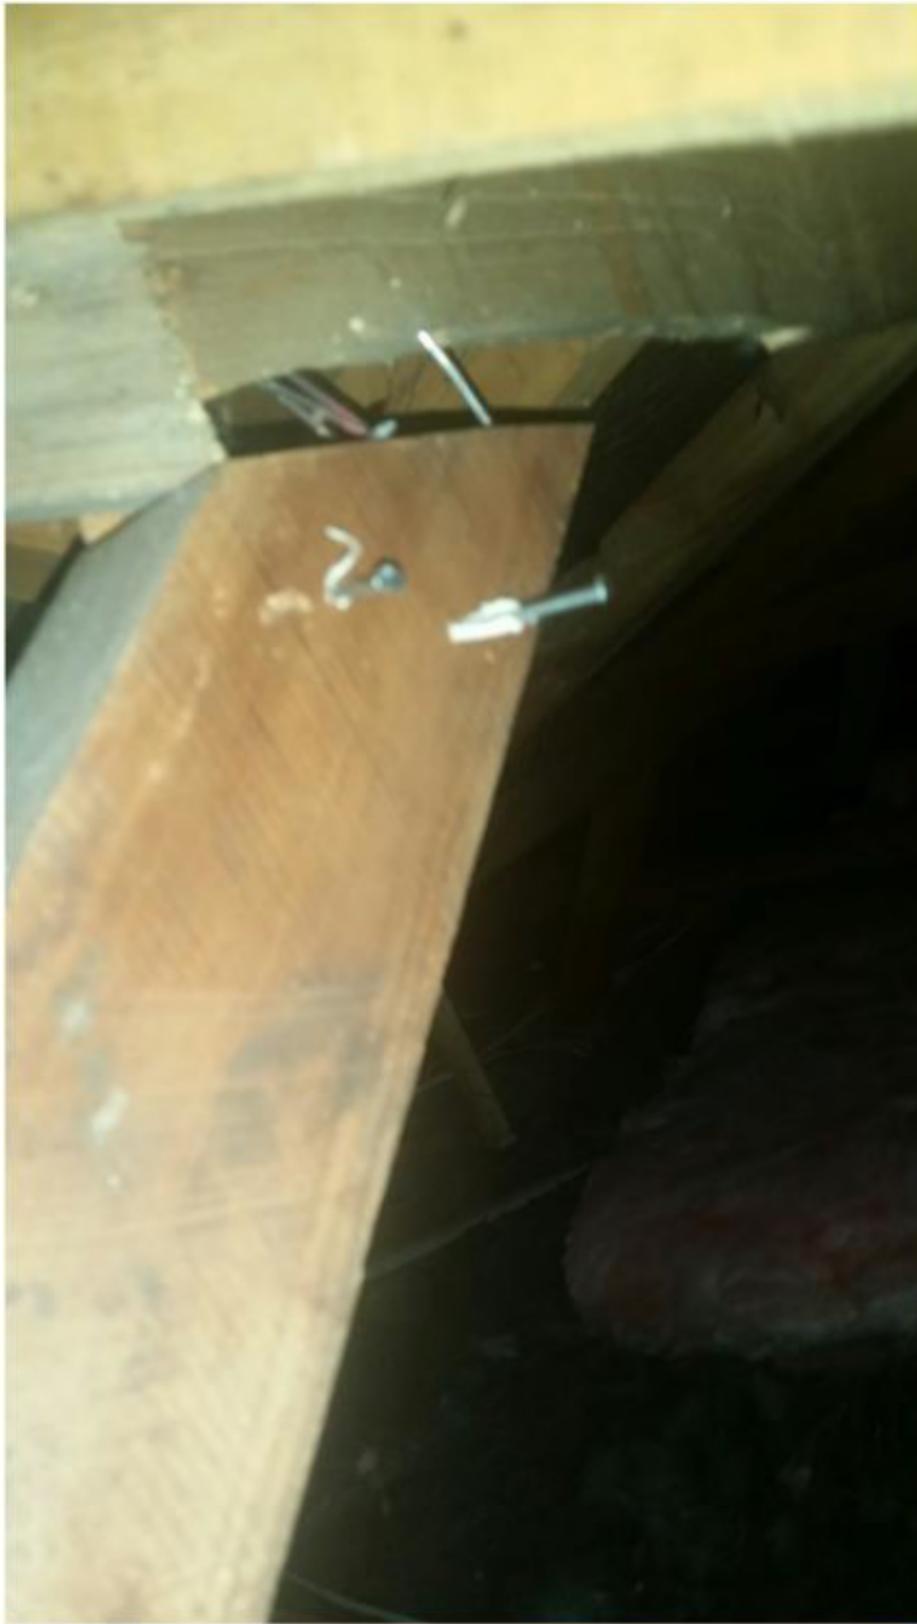
Photo 4, Top of strut with no observable splitting of the timber as installed.

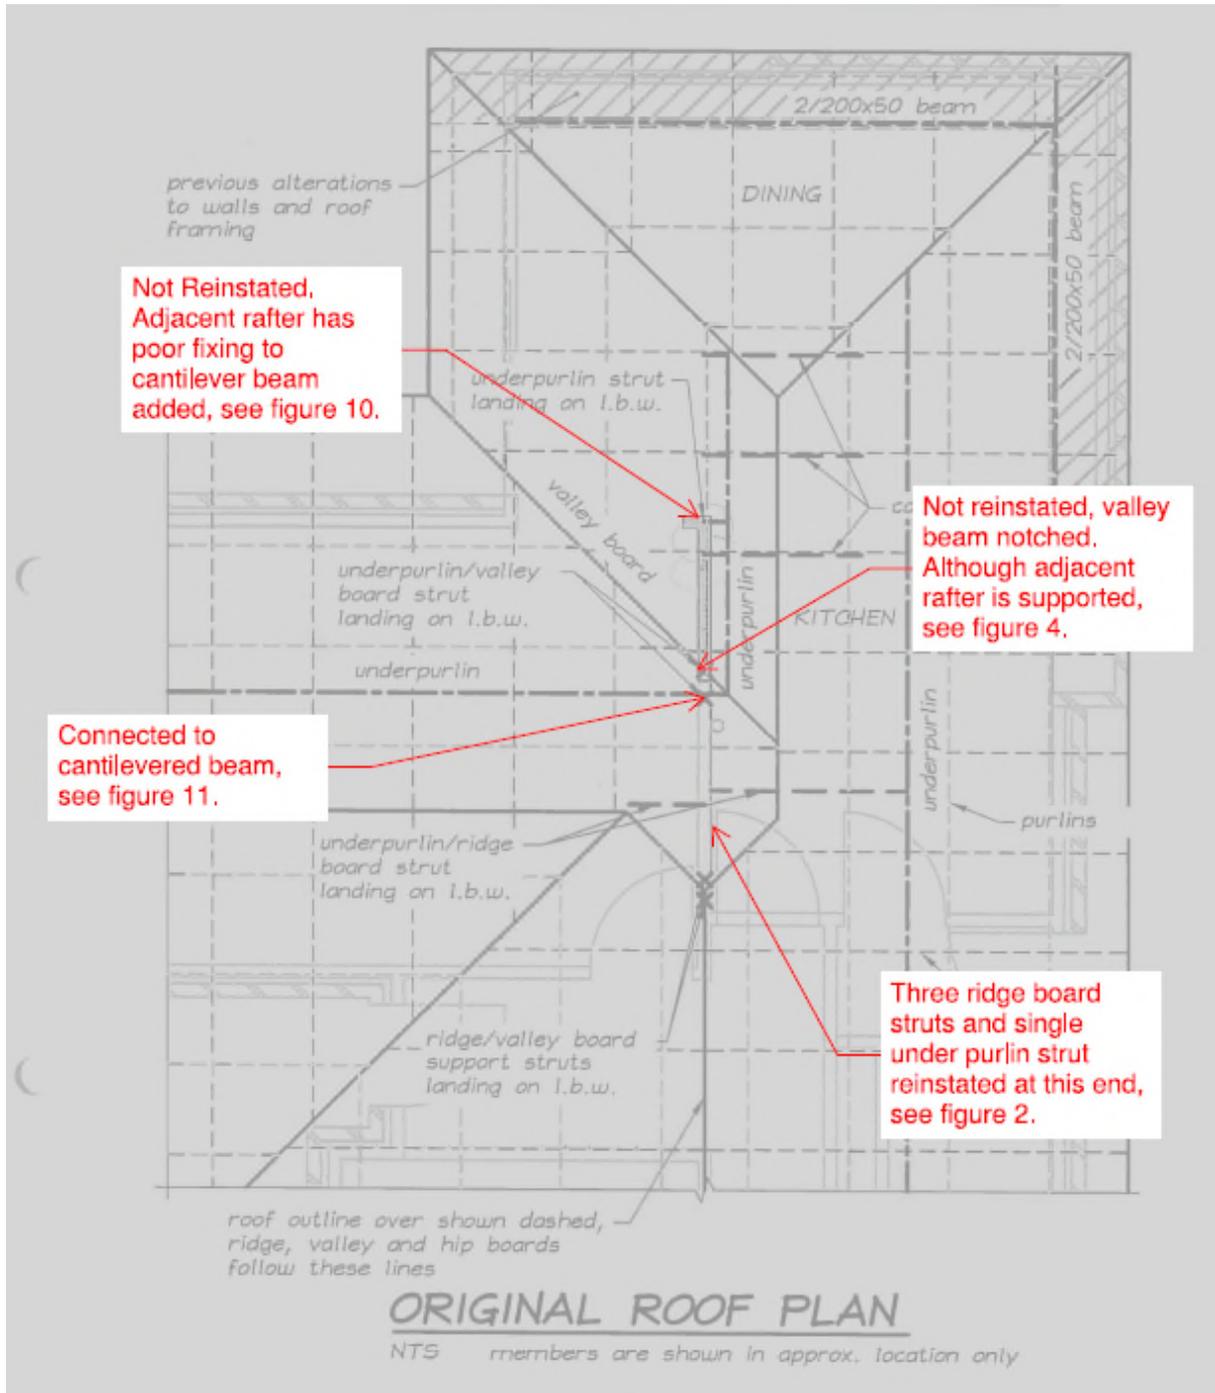
- Some roof struts have been reinstated and re-fixed to the top of the cantilever beam, although an under-purlin strut and a valley beam strut are missing. In both cases there is a timber block that appears to be intended to connect to the adjacent rafter to reinstate the support, but the block is ineffective in replacing the missing under-purlin strut.

- As previously stated the engineer agrees that it appears an under-purlin strut is missing. The builder has since stated the under-purlin strut was removed and not reinstalled because it was believed to be adversely loading the ceiling of the kitchen. The second experts stated an attempt was made to the load the rafters, which were previously supported by the under-purlin strut, onto the cantilevered beam using timber blocks. However, these timber blocks appear to have shrunk and are not in contact with the rafters they were installed to support. The work to remedy this is "extremely minor".

C.5 The second experts' comments on the original roof plan provided by the engineer, included in the report dated 3 July 2019 (note the comment in the first text box that states "Not Reinstated" is in reference to the under-purlin strut).
