## Determination 2020/007

### Regarding the compliance of sub-floor fixings to the foundations of a house at 43B Armagh Terrace, Marton

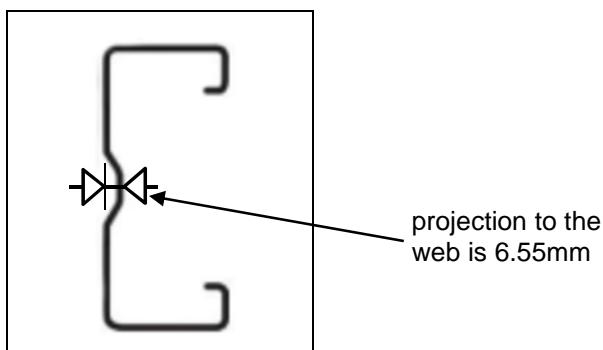
**Figure 2: Profile of the installed bearers**

- 2.5 The installed bearers are 152mm high, 65mm wide and also have a BMT of 1.45mm. The profile of the installed bearers is shown in Figure 2.
- 2.6 Adjacent bearers are joined using a splice plate that transfers the load from one bearer to the next and to secure the joined bearers to the anchor piles providing vertical and lateral support to the structure above.

- 2.8 The inwards projection of the installed section is 6.55mm, compared to 3.05mm for the section described in the building consent.

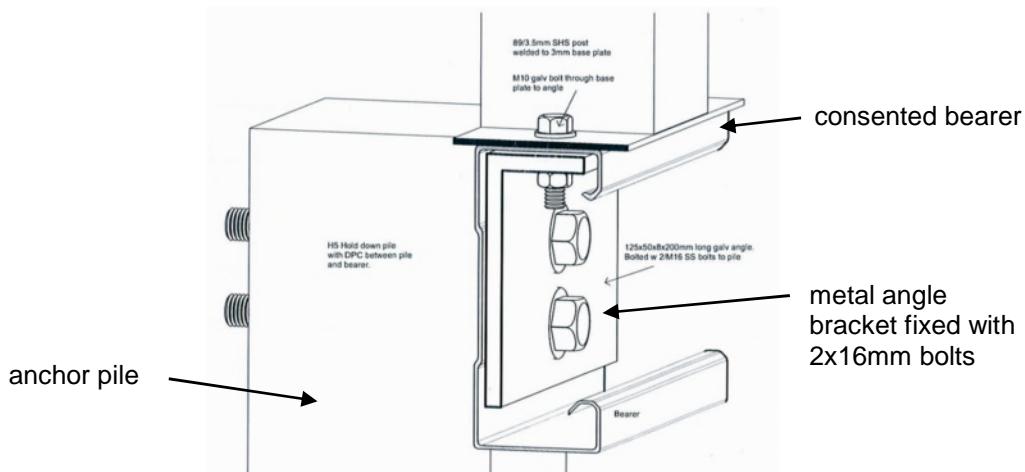
**Figure 3: Detail from the consent drawing (Dwg 406) showing the 125x50x8mm metal angle bracket supporting the SHS steel post above**

- Figure 3 – the fixing of the angle bracket used to support the SHS<sup>8</sup> post (paragraph 4.4, 2<sup>nd</sup> bullet point refers), and
  - Figure 4 – the splice plates used to join the two ends of adjoining bearers to the timber anchor piles (paragraph 4.4, 1<sup>st</sup> bullet point refers).

- the consented plan shows the SHS post is fixed directly onto the bearer via an 8mm thick bracket (refer Figure 3). As installed, the fixing plate is on an angle due to the profile of the bearer, and the bolt fixings are located between two piles.

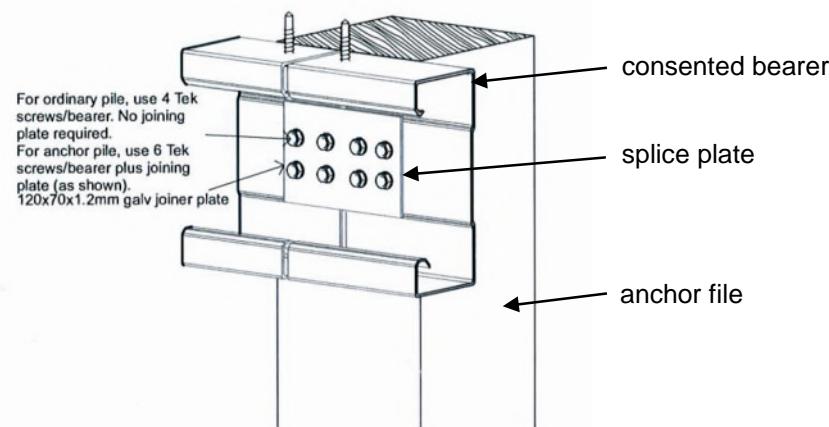
**Figure 4: Detail from the consent drawing (Dwg 401) showing the splice plate fixing adjoining bearers to an anchor pile**

- the consented details show bearers join and connect to anchor piles via a fixing plate that bears against the flat mid-section of the bearer. This enables all components to be hard up against each other to provide the calculated connection strength to resist both horizontal and vertical forces

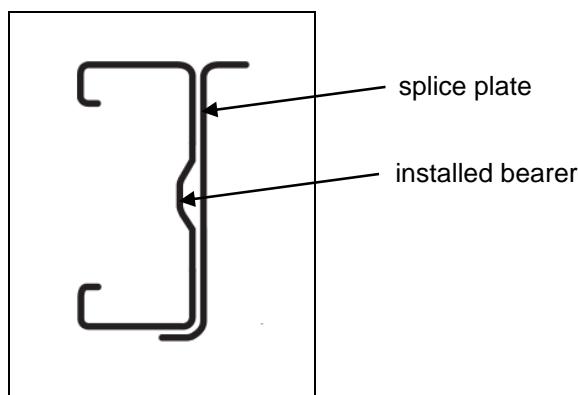
**Figure 5: Profile of proprietary splice plate for use with the installed bearers**

- In fixing the splice plate to the installed bearer it has in effect been folded over the central rib to the web as shown in photograph 1 (refer paragraph 4.4, 1<sup>st</sup> bullet).
- The proprietary splice plate made for the installed bearer is designed to be fixed at the rear of the bearer as shown in Figure 5 (in this case between the bearer and the pile) so the fixings hold the bearer and splice plate in close contact. The proprietary splice plate for the installed bearer has not been used.

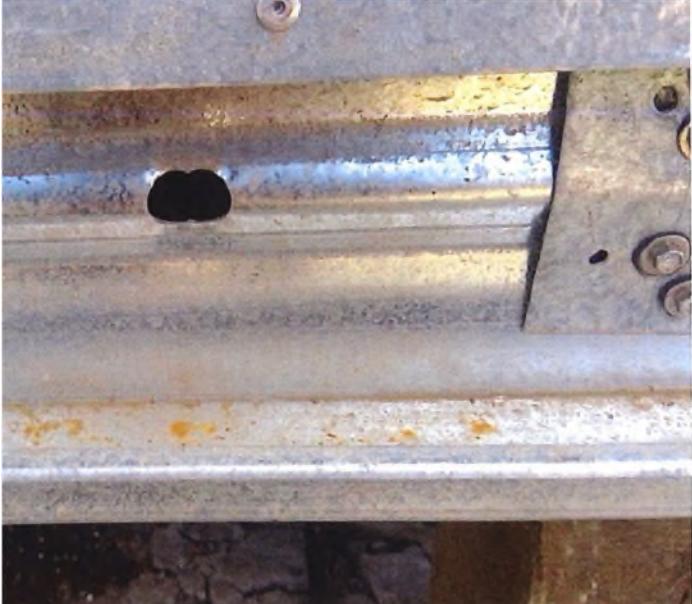
- The metal screw fixings are angled through the splice plate above and below the central rib leaving a gap between the splice plate and the web. The fixings do not hold the splice plate and the bearer in close contact with the timber piles. This gap will allow the joint to move before the fixings take up the intended load, leading to the joint's design capacity not being achieved.

- Excessive movement at these joints may result in a loss of amenity to the structure.
- 5.2.3 The splice plate as installed means the designed lateral capacity of these joints (between adjoining bearers and between the bearers and the anchor pile) is unlikely to be achieved. The foundation may have more anchor piles than might be necessary to achieve compliance and consequently these joints may not need to achieve full capacity for the structure to perform as intended, but I not been provided with any information from the applicant to verify this or to put forward such an argument.

- 5.2.4 Information about the basis of the design of the joints and the capacity that the joints are required to achieve has been requested but not provided. I consider insufficient information has been provided to demonstrate that the as-built splice plate detail is adequate, and that sufficient capacity can be achieved by these joints.

<p><b>Photograph 1</b> showing a bearer splice plate (refer Figure 4 for the consented detail). The splice plate is shown to the far right of the photograph</p>

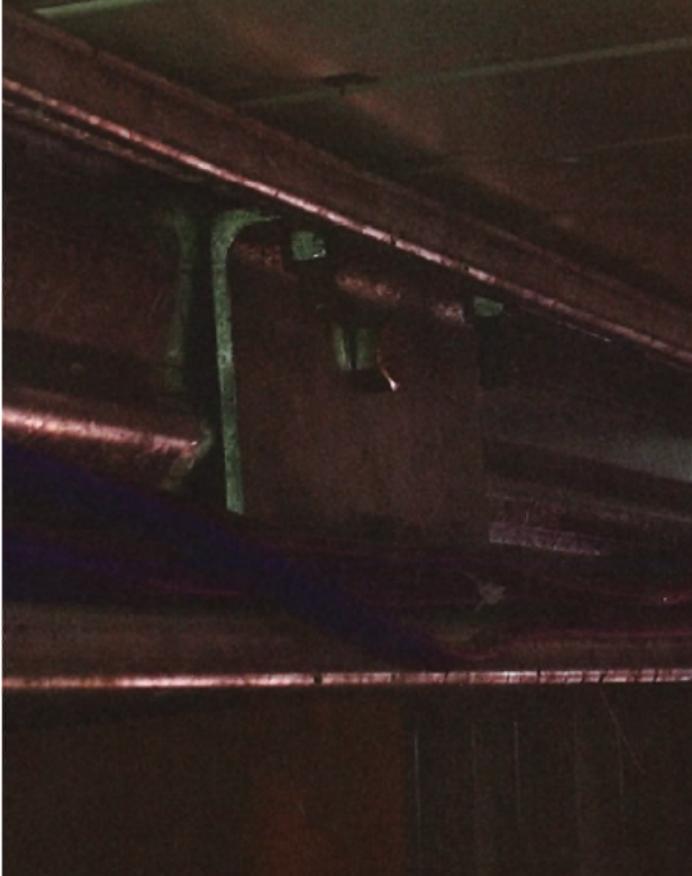
- 5.2.6 The following is noted regarding the angle bracket's alignment and fixing:
- the bracket is not fixed flat or in close contact with the web of the bearer and the anchor pile, lacking proper alignment to either the bearer or the pile

- as a result of this misalignment the top of the bracket has rotated towards the anchor pile (around the central rib to the web) as shown in photograph 3 (refer paragraph 4.4, 2<sup>nd</sup> bullet) so the point load from the SHS post above is concentrated on the outside edge of the 50mm angle leg.

- 5.2.7 I have not been provided with evidence that sufficiently addresses the concerns raised by the authority regarding the misaligned bracket and whether the bracket can achieve the required design capacity with respect to uplift. Therefore, I am not satisfied the bracket is providing a compliant load path for the SHS post above.

<p><b>Photograph 3</b> showing the metal angle bracket supporting the SHS steel post above; the bottom fixing bolt is obscured by electrical cabling.</p>

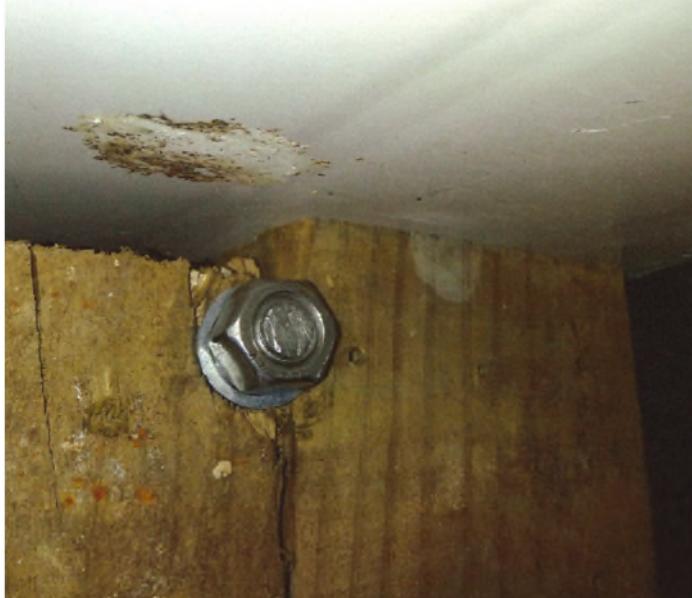
- photograph 4, with description ‘bolt at top of pile and pile hard up to flooring’
  - photograph 5, with description ‘bolts in join [between two] piles’.

- The end distance from the top M16 bolt to the top of the pile is in the order of 10 to 15mm (judging from the location of the top bolt to end of one pile in photographs 5 and 6)

- 5.2.11 I note:
- the location of both M16 bolts on the joint between the two piles means any fixing at this point will be ineffectual as it is unable to transfer the load from the bracket to the pile

- Applying NZS 3603, the top bolt also has insufficient end distance.
- 5.2.12 Information about the design of these joints and the capacity they are required to achieve has been requested but not provided. However, given the location of both M16 bolts on the junction between the two piles and the lack of any other information that shows how the piles may have been secured together, I consider there is sufficient evidence to show that the fastening of the angle bracket to the piles as built is not compliant.

<p><b>Photograph 4</b> showing the top bolt fixing to the metal angle bracket supporting the SHS above (the photograph is taken from the other side of the pile from Photograph 3).</p>

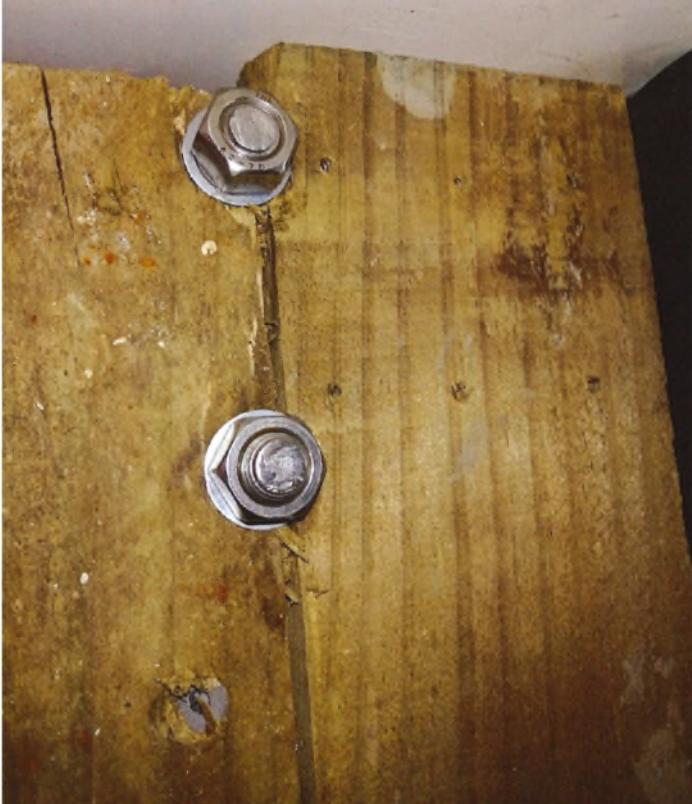
- 5.2.8 The photographs provided by the authority (refer paragraph 4.4, 3<sup>rd</sup> & 4<sup>th</sup> bullet points) show 2x M16<sup>9</sup> bolts at one location securing the angle bracket to the hold-down pile. The following is noted:
- both bolts are installed though the vertical junction between two piles located side by side, i.e., along the adjoining faces of two piles (photograph 5 supplied by the authority appears to show one skew nail joining the piles)

<p><b>Photograph 5</b> showing both bolts fixing to the metal angle bracket supporting the SHS above.</p>
