Determination 2020/008

The refusal to issue a code compliance certificate for a 20-year-old house with monolithic cladding at 60 Godley Lane, Albany, Auckland

Summary

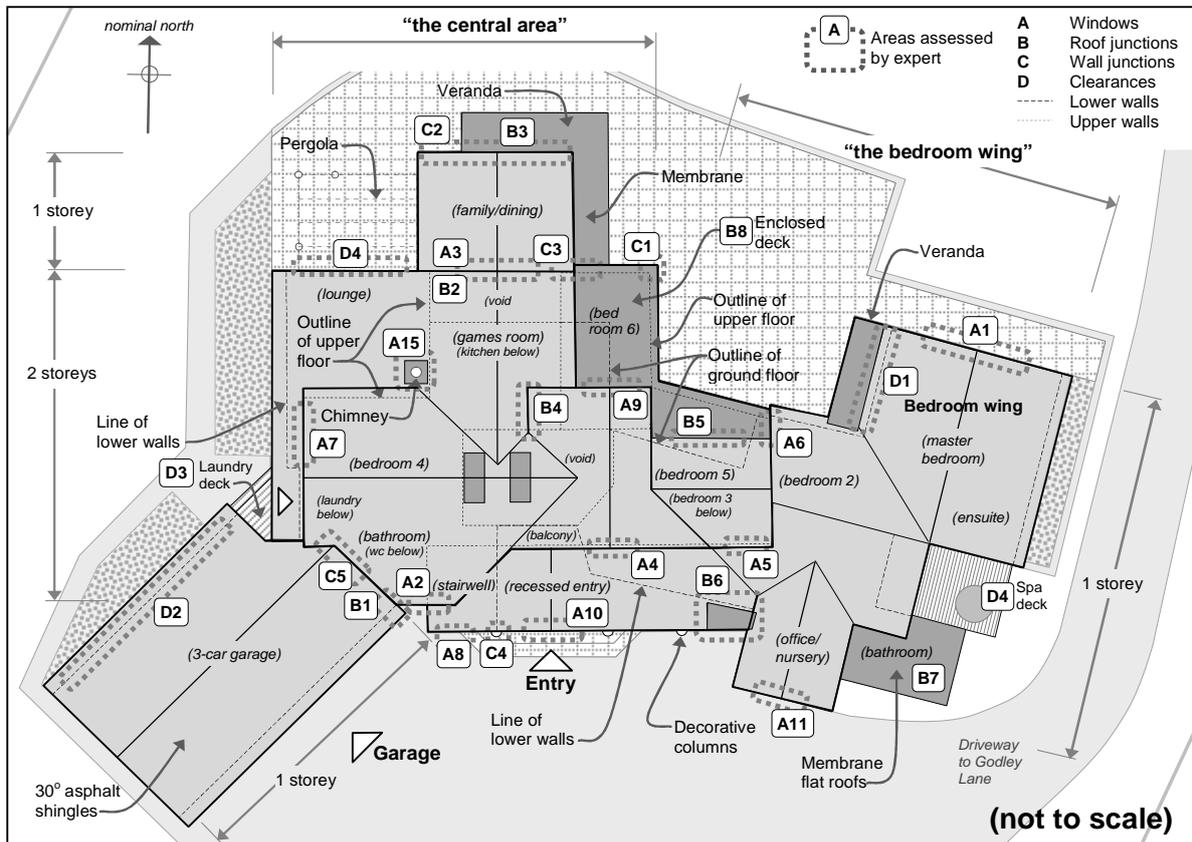
Figure 2: Approximate site plan

5.3.2 Most readings varied from 8% to 15%. However, elevated readings or signs of damage were recorded as follows (with locations as per Figure 2 shown in brackets):

- 13%, but decayed drillings below window jamb to Bedroom 1 (Area A1)
- 20% to 21% below window jamb to lower toilet (Area A8)
- 22% below the garage/toilet roof junction (Area B1).

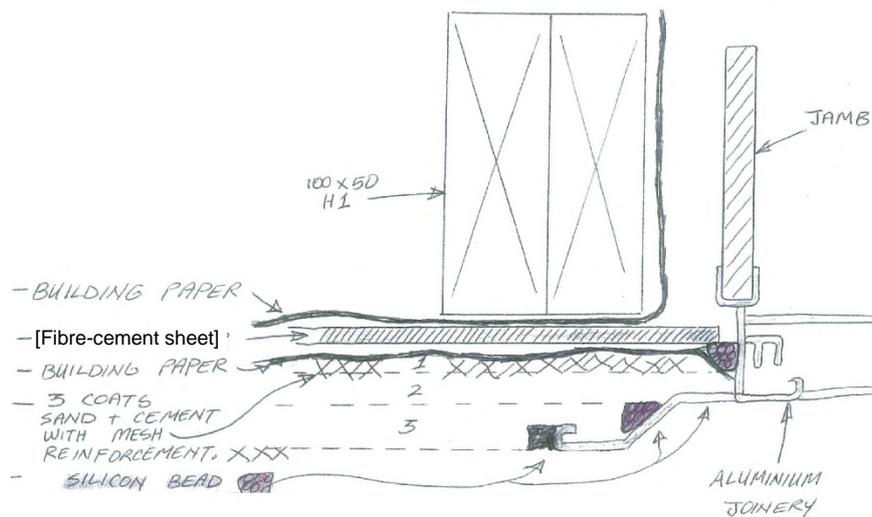
Figure 3: Typical window installation (as provided with the determination application)

- 4.2.5 On 16 August 2019 the authority accepted the first draft subject to the following comments (in summary):
- The typical window jamb detail (Figure 3) was a critical junction ‘which could potentially cause damage to every elevation of the building’ particularly as there are no sill flashings. Deconstruction of a sample of these junctions was required to determine performance.

- E2/AS1 at the time of construction did not include jamb flashing details, likewise the second edition published in February 1998
 - decay revealed at Area A1 indicates significant historic leaking at either the head or jamb, most likely the jamb.
