Determination 2020/011

Regarding the refusal to issue a code compliance certificate for a relocated house with 19-year-old alterations and additions at 215 Horndon Street, Darfield

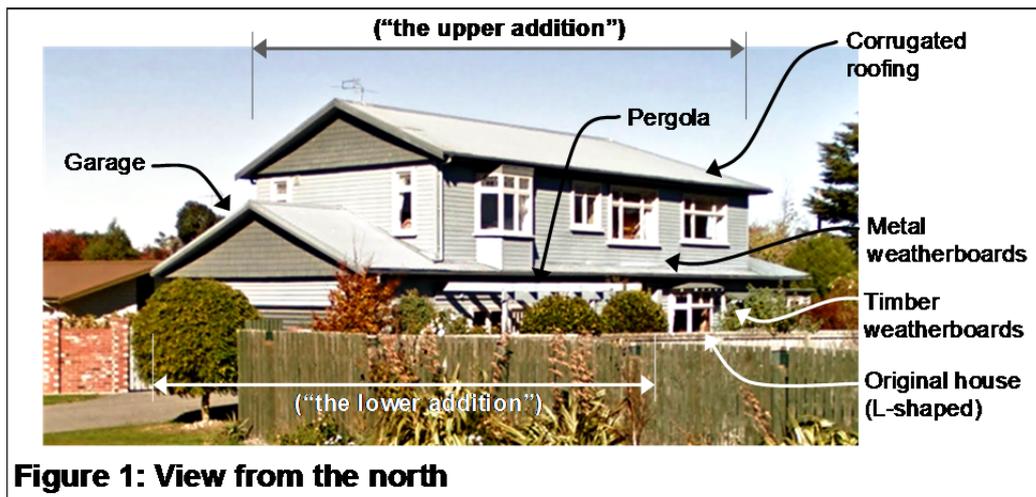
Figure 1: View from the north

2.2 As shown in Figure 1, the relocated house forms the lower rear half of the ground floor, with an addition to the front (“the lower addition”). The original eaves to the relocated house extend around the ground floor, with an upper floor addition covering about 75% of the ground floor area (“the upper addition”).

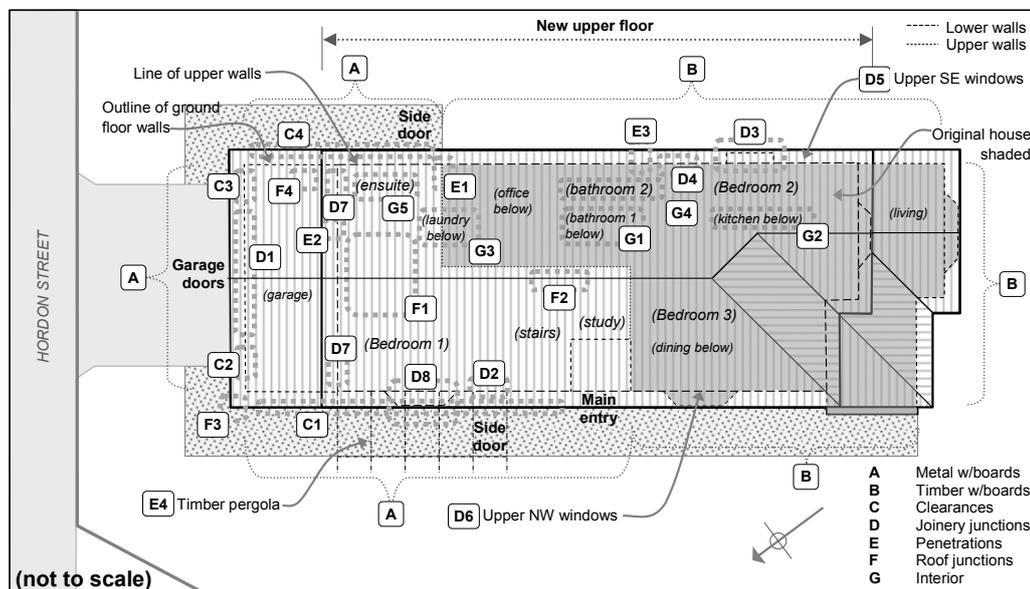
Figure 2: The house as completed

2.4.1 As shown in Figure 2⁸, the relocated house is shown shaded, with the ground floor addition to the northeast and the new upper level addition above.

Inspection notice 13 April 2017		CI.	The expert's comments (in summary)	Area reference
1. Exterior				
1.1 1.2	Metal weatherboards used in lieu of timber	E2	<ul style="list-style-type: none"> No evidence of past or present moisture ingress Invasive readings all below 12% Cladding meeting performance requirements 	Area C1

1.3	Clearance to paving	E2	<ul style="list-style-type: none"> Concrete paving had been cut away from walls, a liquid applied membrane applied to edge of foundations and drainage stones laid in trench Invasive readings in adjacent framing all below 14% Timber garage door reveals are in contact with drainage stones which were to be lowered to provide clearance to the reveals 	Areas C1 to C4

1.5	Head flashings: <ul style="list-style-type: none"> Garage door Side door/window to garage Kitchen bay window Pantry window 	E2	<ul style="list-style-type: none"> Invasive moisture testing and visual inspection All door and window openings meeting minimum performance requirements, but maintenance recommended to some areas No head flashing to garage door Reliant on flexible sealant No evidence of moisture ingress around door Invasive readings in framing all below 12% Head flashing upstand overlaps cladding Slopes towards cladding – reliant on sealant Invasive readings at lintel below 11%, with firm and clean drill shavings Some protection from eaves about pergola No head flashing to bay window Reliant on flexible sealant to flat top of frame 200mm overhang above provides little protection No evidence of moisture ingress around window Invasive readings in framing all below 12% Head flashing upstands overlap cladding Well protected by 580mm lower eave 200mm above the top of flashing Little risk of moisture penetration 	Area D1 Area D2 (plus below Area D8) Area D3 Area D4

<ul style="list-style-type: none"> Upper south east and north west windows Small upper north east windows Upper north west bay window 		<ul style="list-style-type: none"> No head flashing Heads well protected by 430mm wide eave 90mm above window head Little risk of moisture penetration Head flashing upstands overlap cladding Sheltered by 200mm verge overhang 120mm above No evidence of moisture penetration Little risk of moisture penetration Head flashing installed Flashing upstand extends up behind gutter 	<p>Area D5, and D6</p> <p>Areas D7</p> <p>Area D8</p>

1.6	<p>Other penetrations</p> <ul style="list-style-type: none"> Vent from dryer Vent from ensuite Vent from Bathroom 1 	E2	<ul style="list-style-type: none"> Louvre grille now fitted to dryer outlet, duct well sealed to cladding No sign of moisture ingress Recommend replacing expanding foam at penetrations with flexible sealant Louvre missing Maintenance needed Has been attended to 	<p>Area E1</p> <p>Area E2</p> <p>Area E3</p>

1.7	<p>Roof cladding</p> <p>No access to inspect roof</p> <p>Roof spaces</p>	E2	<ul style="list-style-type: none"> Flashing junctions generally adequately fitted Recommend replacing poorly fitting sheets and replacing loose nails with roofing screws Able to gain adequate view of all roof surfaces Sheet laps poorly fitting above the north end of Bedroom 1 on both north west and south east sides Several loose nails around ridge capping centre Garage and upper storey roof spaces inspected No visual evidence of any moisture ingress to any accessible areas Area above Bathroom 2 where underlay not properly fitted – requires attention 	<p>Areas F1 and F2</p> <p>Area G4</p>
