Determination 2020/033

The refusal to issue a code compliance certificate for historical building work to construct an outbuilding at 2/820 West Coast Road, West Melton

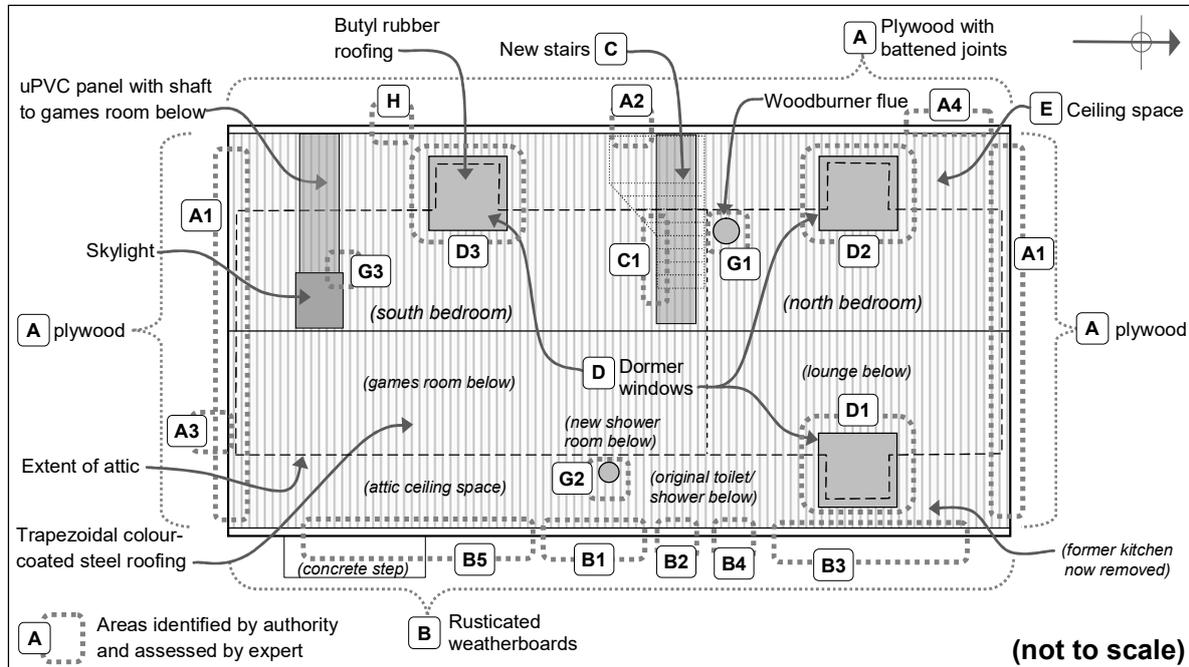
Figure 3: The current building

- plumbing, structural fixings and insulation incomplete at 1999 pre-line inspection, with outstanding work not re-inspected
- unsealed cladding penetrations (Areas A2, B1, B2, B4, G1, G2, G3)
- waste pipes not sealed to gully trap (Area B3, B4)
- no vent to toilet (Area B2)
- downpipes discharge onto ground
- unsealed internal wet areas
- changes from original building consent:
 - change of use from an “outbuilding” to “sleeping accommodation”⁶
 - location changes to windows and doors
 - gas califont with uninsulated pipework
 - addition of kitchen area
 - addition of showers
 - solid fuel heater added.

- various holes (Area A2) and unsealed penetrations through the cladding
- for the weatherboard cladding
 - unflashed butt joints in weatherboards (Area B1)

- waste pipes not sealed to gully traps (Areas B1, B4):
 - gaps at waste pipe/foundation junction (Area B4)
- for the dormer windows
 - lack of wall cladding/roofing clearances (Areas D1, D2, D3)

- unflushed shower vent (Area G2)
 - hole at the lower end of the skylight (Area G3).
- 3.6.4 In regard to the building interior, the surveyor noted (in summary, with relevant Figure 3 areas noted in brackets):
- for the original staircase (Area C):
 - balustrade wires are too flexible and widely spaced
 - balustrade too low at 800mm
 - gap between stair treads is too high
 - irregular height of the bottom step
 - the height of barrier to south bedroom is too low (Area C1)
 - the games room ceiling is unlined
 - thermal imaging showed evidence of insulation in walls and ceilings.
- 3.6.5 The building surveyor concluded once all the items identified in the report were rectified a certificate of acceptance could be sought.

- 11% and 12% in the bottom plate at games room ranchslider jambs (Area B5)
- 16% to the bottom of stud behind butt-jointed weatherboards (Area B2)
- 12% in the bottom plate below the toilet wastepipe (Area B4)
- 15% in the bottom plate beneath unsealed redundant water pipes (Area B3)
- 9% to 12% beneath other repaired areas or representative at risk areas.

6.4.5 The expert's investigations included removing linings below one dormer window (Area D2), which revealed current leaks and evidence of advanced decay in the dormer framing. This indicated the dormer had been leaking for an extended period of time. Signs of moisture entry and timber staining were also observed in areas associated with the other north dormer window (Area D1).

6.4.6 I am not satisfied the two northern dormer windows have been weathertight and durable for a considerable time, based on: the expert's investigations; the changes in wall cladding from the consent drawing; the defects identified by the previous owner's building surveyor in 2017; and the similar construction details assumed for the other two dormers. I therefore conclude the two original dormer windows do not comply with Clause E2.

Dormer windows: <ul style="list-style-type: none"> cladding/roofing clearances wall cladding corners. 	D1 D2 D3 D2	<ul style="list-style-type: none"> Inadequate clearances to dormers. Poorly flashed junctions to dormers. Claddings deteriorating. Current leaking and decay in northwest dormer. Moisture staining from past leaks. 	Further investigation required Does not comply	6.5.2 6.5.2

6.4.7 The two original dormer windows are now some 20 years old. Further investigation and remedial work will be required to ensure that the dormers are made weathertight so as to protect the underlying timber framing from the penetration of water which could cause dampness or damage to building elements, as is required to meet the minimum durability requirement of 50 years.

- Clauses B1 and B2:
 - some inadequately nailed joist hangers
 - damaged and potentially damaged framing associated with dormer windows (Areas D1 and D3)
- Clauses E2 and B2:
 - weathertightness and durability of dormer windows (Areas D1, D2 and D3)
- Clause E3
 - lack of sealant to the handbasin/splashback junction (toilet area)
- Clauses F4:
 - lack of compliant barrier to stair landing window
- Clause H1:
 - though insulation has been installed, there is insufficient information with regard to the performance of the insulation installed in the roof to establish compliance of the whole of the building envelope.
