Determination 2021/003

The refusal to issue a code compliance certificate for 20-year-old additions and alterations to a 50-year-old house at 103 Te Hono Street, Tauranga

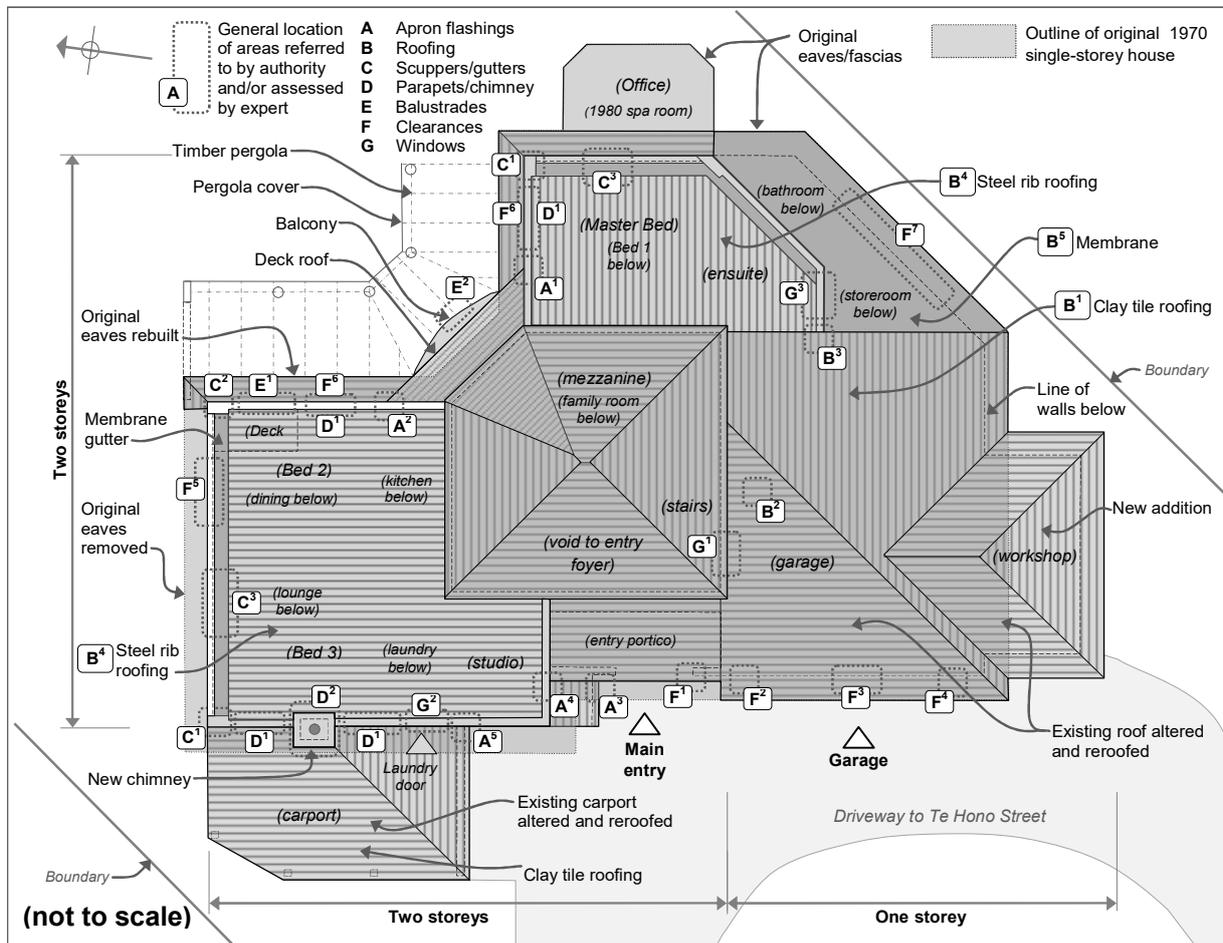
Figure 1: Site plan sketch

2.5 Except for a small workshop addition to the south and minor internal alterations, the general form of the ground floor layout was retained. The 1999 extensions added an upper floor and replaced the remaining original roofing as shown in Figure 1.

2.6 As shown in Figure 1, the house now accommodates the following:

3.13 The authority listed five items requiring attention (with typical areas shown in Figure 1 provided in brackets):

1. Investigation required of all roof areas and critical cladding junctions (Clause E2 [External moisture]) including but not limited to:
 - Ground heights to front entrance area (Areas F)
 - Barge/wall junctions (Areas A)
 - Parapets and roof – specifically outlets and overflows to roof area ... (Areas C and D)
 - Several areas of the bottom plate to brick veneer on the lower level are required to be testing (sic) to confirm supporting structure
2. Seal sanitary fixtures to wall (Clause E3)
3. Door off ensuite to remain locked with key removed or restricted to 100mm opening due to safety from fall issue off membrane roof. (Clause F4 [Safety from falling])
4. Window restrictors required where sill height is less than 760mm (Clause F4)
5. Extraction vent of internal ensuite [Bedroom 2] is not working, this is a requirement due to the lack of natural ventilation (Clause G4).

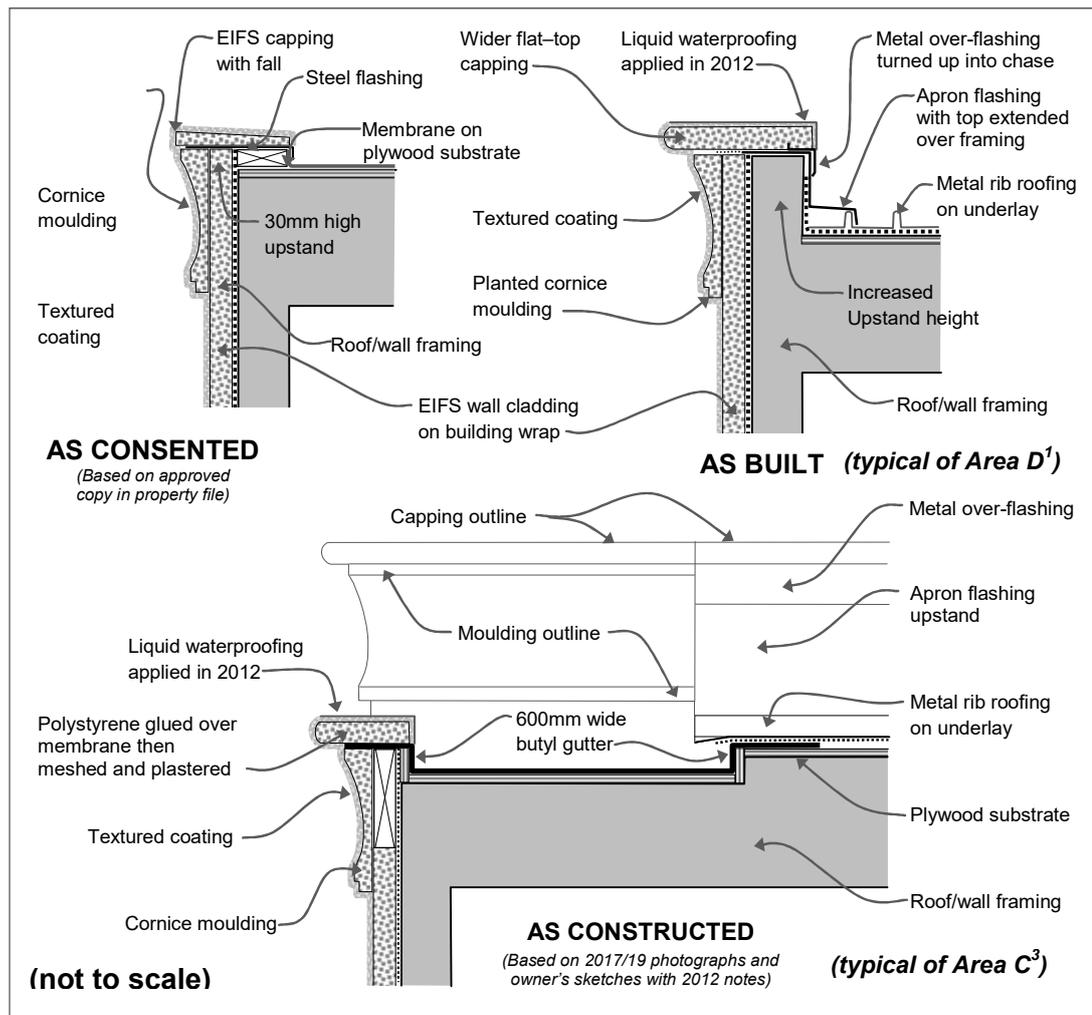
Figure 2: Roof parapets⁸

- 2.10 The consent drawings showed the upper bedroom roofs as butyl membrane on plywood substrate, with 30mm high parapet upstands as shown in Figure 2. The membrane was substituted with low-pitched galvanised steel trough roofing during construction. The roofing slopes to membrane-lined internal gutters and adjacent upstands of some 40mm high (Areas C³ in figures 1 and 2), with higher upstands bordering other sides (Areas D¹).

⁸ Refer to the expert’s comments in paragraph 5.9 regarding the compliance of the as-built detail.

5.9 The EIFS walls extend up to form parapets with flat EIFS ‘cappings’, which project past decorative polystyrene cornices on the exterior as shown in Figure 2. The expert noted regarding the parapets (in summary, with my additional notes added in brackets):

- (From the applicant’s note dated February 2012, it appears a liquid-applied proprietary weatherproofing coating was first used on the top of the polystyrene cappings in 2006)
- all parapets were apparently waterproofed with the same system in 2012, with the coating continued “to the front rounded edge and the inside square edge”
- elevations facing the harbour were repainted in December 2017.
- parapet tops are flat, which increases risks of water penetration at joints
- during an unsuccessful attempt to take a moisture reading in parapet framing, dry timber fragments in good condition were retrieved, which indicated the parapet waterproofing is performing.
