Determination 2021/025

Regarding compliance of timber shiplap weatherboards, coated with black paint, installed on a dwelling at 33A Hyde Road, Rothesay Bay, Auckland

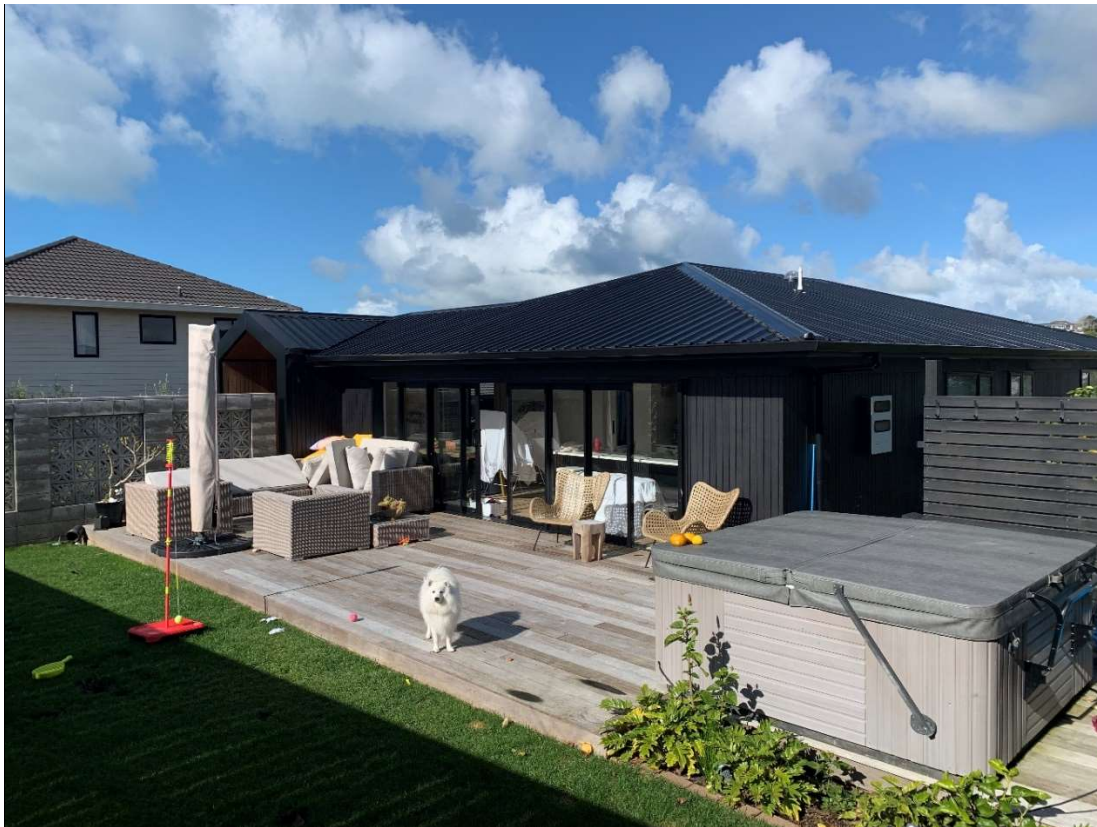
Figure 1 – northwest corner of building including deck

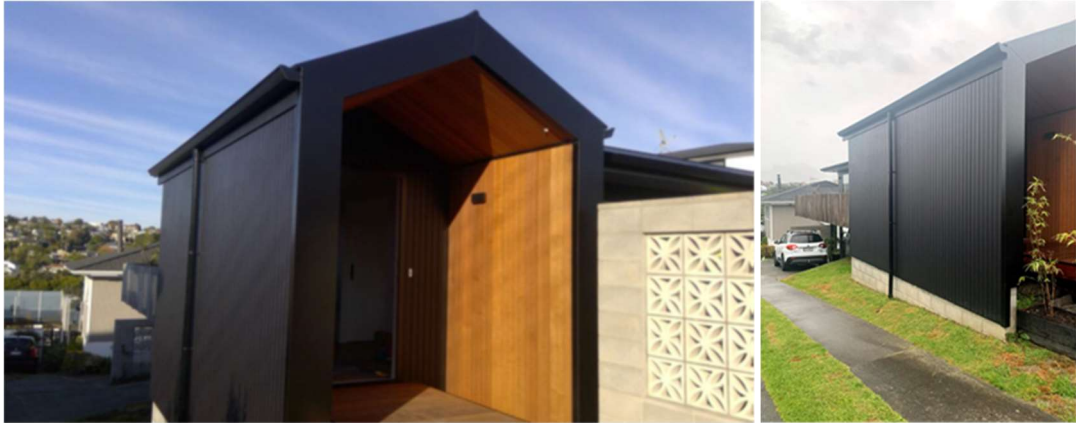
- 2.5. The northeast corner of the dwelling includes a new entranceway approximately 5.36m long x 2.49m wide. The entranceway has been constructed in the location where a former conservatory was removed as part of the building work (see figures 2 and 3).

Figure 2: entranceway (northeast view)

Figure 3: entranceway (east elevation)
