Determination 2022/019

Regarding the authority's refusal to issue a code compliance certificate for the stucco monolithic plaster cladding on an extension to an existing dwelling

468A Wright Road, Aongatete, Katikati, Bay of Plenty

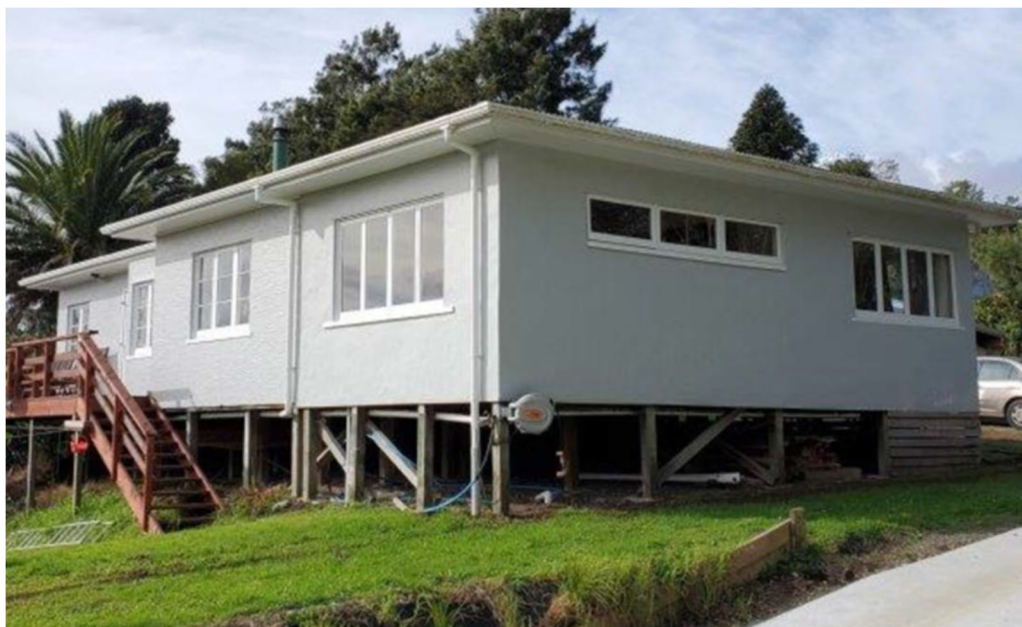
Figure 1: Southwest corner of dwelling.

- 2.1. The original dwelling is a single storey timber framed building with an external stucco monolithic plaster cladding (see figure 1).
- 2.2. The building work in this case relates to the construction of an 8.5m wide x 4m long extension to the south end of the existing dwelling (see figure 2). The building work consists of constructing timber piles, subfloor framing, and light timber wall framing, with particleboard flooring, and solid monolithic stucco cladding directly fixed over the external wall framing. Timber-framed windows have been installed, and the roof eaves are approximately 600mm wide.
- 2.3. The building consent plans stated the external cladding was to be “solid plaster on mesh on 10mm [thick proprietary cement boarding] to match existing stucco”.
