Determination 2024/058

An authority's decisions to grant a building consent and issue a code compliance certificate for a dwelling for the compliance of the foundations with *B1 Structure*

9 Highfields Way, Ahipara, Northland

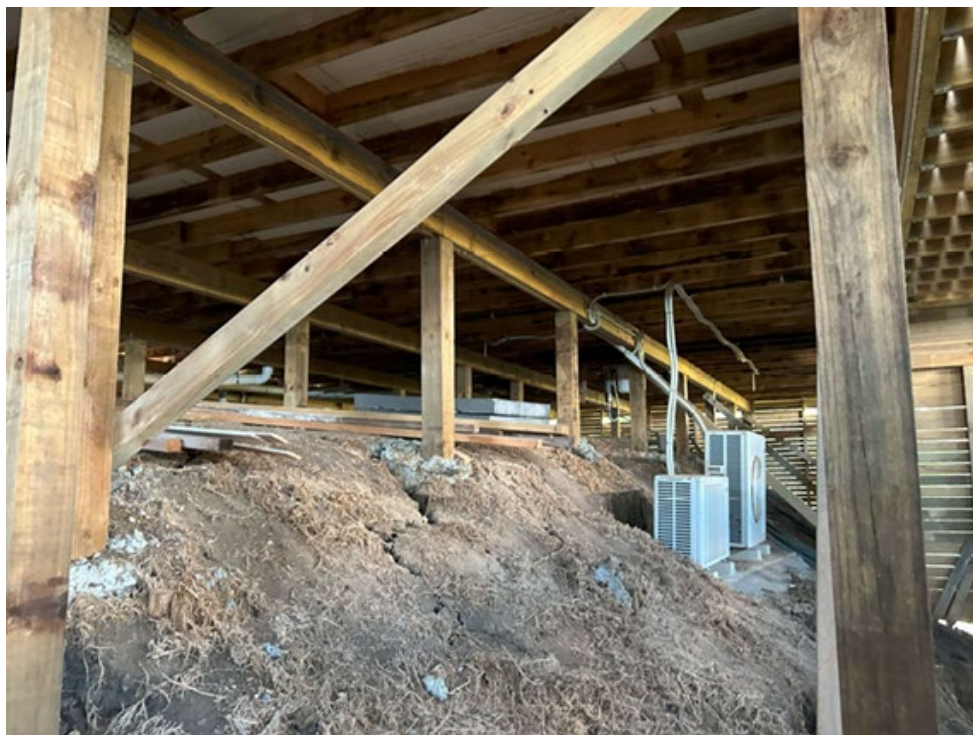
Cover Image: Dwelling sub-floor with piles, concrete encasement and cracking

- 3.26. The geotechnical engineer observed that the severe cracking, the presence of non-engineered fill and expansive soils “resulted in movement of foundations, observed by separation between bearer and top of piles and cracking on internal wall linings”.

- 5.29. As in the pre-purchase inspection report, this movement has been identified by bearers not sitting on piles and cracks to internal plasterboard linings, which has occurred within the first 5-10 years of the building's life.

- 3.28.3. Regarding the deck, the ground beneath “was wet and no cracks were observed”.
- 3.28.4. The geotechnical engineer recommended “that the existing dwelling be re-piled, with foundations specifically designed by a structural engineer”.

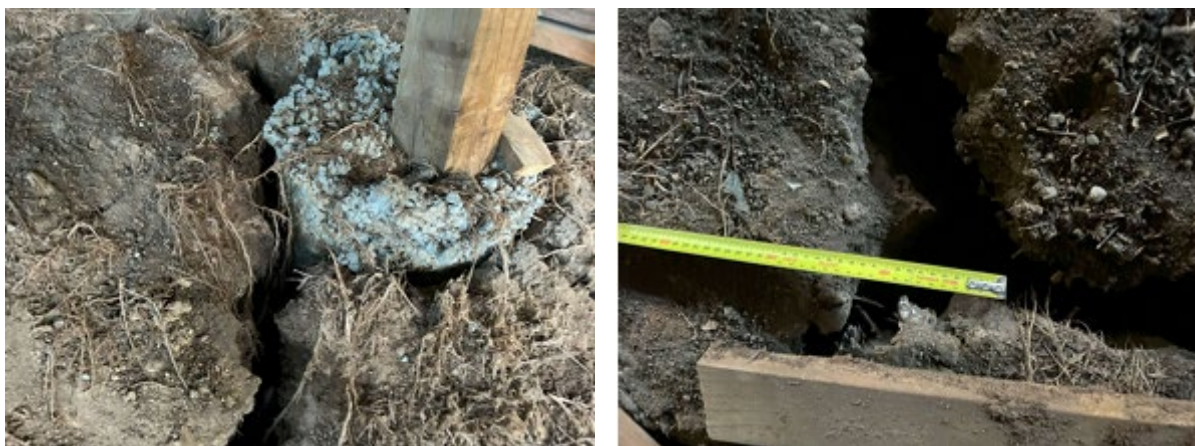
...the concrete piles to the house foundation appear to be solid [but t]he ground surrounding the piles show [sic] large cracks. This may indicate ground drying out (shrinkage) or ground (and pile) movement.

Figure 3: Ground cracking under the dwelling around piles

- 3.25. On-site investigations found “non-engineered fill material was encountered in all boreholes to between 0.2 and 1.0m [below ground level]. The fill beneath the dwelling was very dry and severely cracked”.
