Determination 2025/022

The decision to purportedly refuse to issue a code compliance certificate for a detached dwelling and garage

1A Pak Lims Road, Renwick, Blenheim

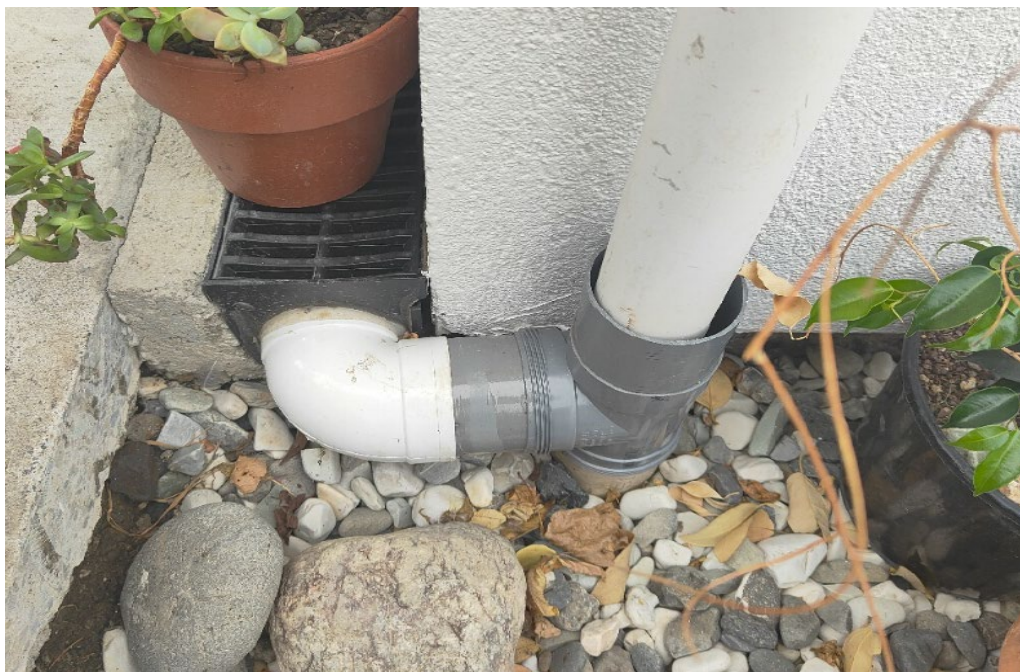
Figure 1: The channel drain

- 2.1. The building work comprises a single-level, 2-bedroom detached dwelling with a H1 treated timber framed structure, plaster-over-polystyrene cladding (‘the cladding system’), and includes a garage with an attached sleepout and bathroom clad in the same material.
- 2.2. At a later date, concrete paths were laid down which were poured up against the plaster cladding system.
- 2.3. A few years after that a PVC strip drain with a line of sealant and a form of metal flashing at the junction with the cladding (Figure 1) was installed abutting the base of the cladding.

- 3.9. At some point the owner installed a strip drain in an attempt to provide adequate clearance from the concrete paving to the bottom of the cladding and the level of the floor.

- 3.11.1. The strip drain installed at the main entrance, which did not meet the functional requirements of E2.
 - 3.11.2. The state of the framing (bottom plate in particular) due to lack of maintenance to the cladding and the concrete paths poured around the building.

- 4.2. The owner's agent acknowledges that the strip drain does not meet the requirements of E2/AS1 Fig 17B. However, the agent submits that the strip drain has been installed in a manner that maintains a level entry, with the drain butted up against the face of the cladding.

- 5.23. Given the base of the cladding is concealed behind the strip drain it is unclear whether it will manage moisture entering this concealed space, and little information on how drainage and drying would occur where moisture is drawn up behind the cladding.

- 5.24. There is insufficient information is available regarding the specific sealant used at the junction between the cladding and the drain, its maintenance requirements, and its ongoing durability.

- 5.25. There is some uncertainty around the ability of the strip drain to remain 'dry' in-service, e.g. not hold water that would provide an increased source of moisture transmission up into and behind the cladding system.
