# Determination 2025/035

**Compliance of horizontal rusticated weatherboard wall cladding as-built with double-nail fixings with Clauses B2 and E2**

**2 Ngake Street, Orakei, Auckland**

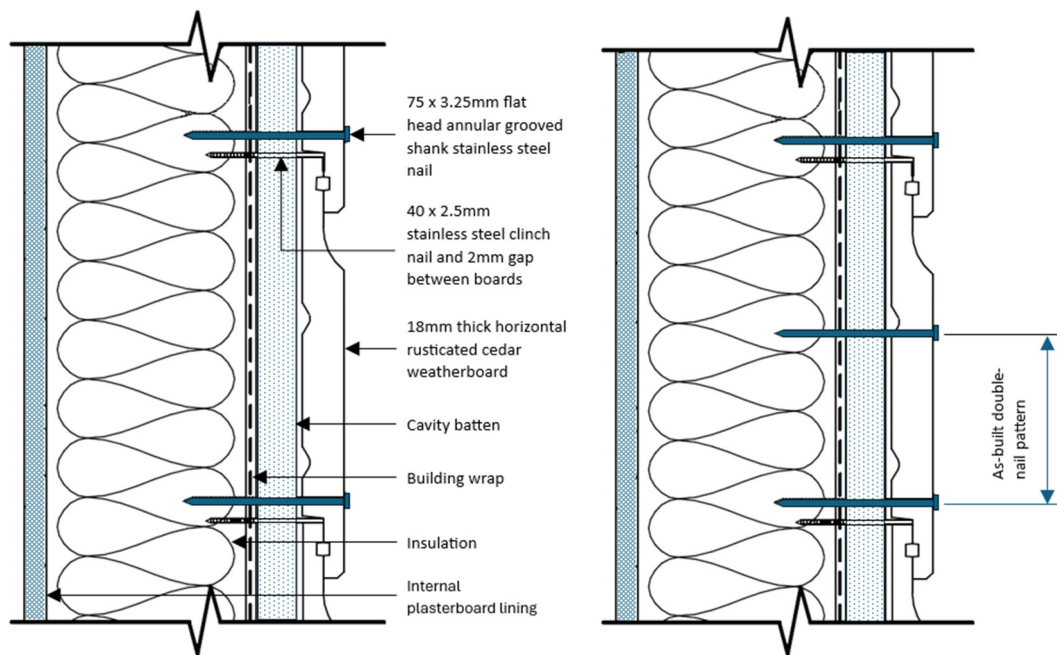
**Figure 2: as-built construction (Indicative and not to scale)**

- 1.4. The as-built weatherboards have been fixed using a pattern of double nails, ie one nail above an another (refer to Figure 2). The authority has not accepted the fixing arrangement because the cladding has not been installed in accordance with the manufacturer’s specifications, which relies on a single nail fixing arrangement.

- 2.7. The fixing of the weatherboards as-built, and subject of this determination, is described in Figure 2.

4.16.1. the weatherboards have been installed with a double-nail fixings arrangement,

4.16.2. the fixings are not uniform in some areas,

4.16.3. in some limited areas, the presence of a third fixing and/or over-driven fixings,
