# Determination 2025/049

## The compliance of a replacement cladding system on a dwelling with clauses B2 and E2 of the Building Code

16A Marellen Drive, Red Beach, Auckland<sup>1</sup>

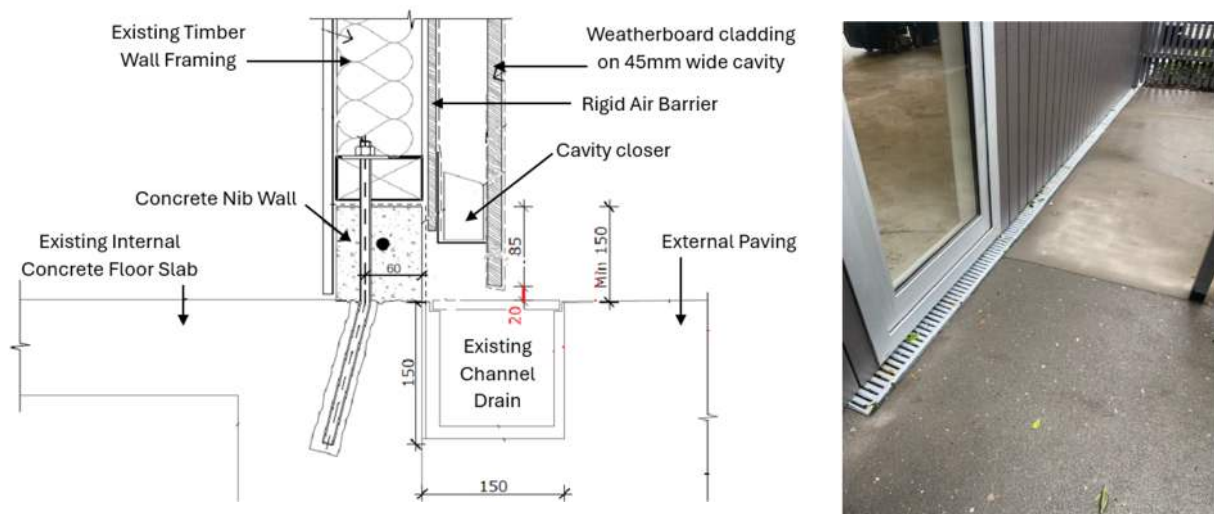
- 2.4. Figure 1 shows the as-built cladding detail for the northeast elevation of the rear garage (Detail 1). It comprises a concrete nib installed to raise the height of the timber bottom plate of the external wall to a minimum of 150mm above the finished ground level. Externally, there is an existing channel drain at the base of this nib and below the cladding system, covered with a grate. The weatherboards extend down past the top of the concrete nib, with a 20mm clearance between the

bottom of the cladding and the top of the channel drain grate. There are no eaves above the cladding in this location.

**Figure 1: Detail 1 – as-built cladding detail (not to scale) and photo along northeast elevation of rear garage**

- 4.40. In my opinion, these aspects of the construction of Detail 1 means there will be increased moisture levels within the channel and higher levels of humidity around the base of the cladding system. This is due to the channel collecting moisture from both the cladding and paved surface, as the channel drain is the primary surface water disposal system for the surrounding ground, coupled with the length and fall of the drain.

- 4.41. The increased moisture levels are also likely to be exacerbated by additional humidity from the adjacent concrete paved ground. Also, although the drainage channel grate can be removed for maintenance purposes, as is apparent in the evidence provided, the limited clearance between the grate and the cladding leads to a build-up of debris between the channel drain grate, which requires increased maintenance (ie monitoring and removal) to prevent further reduction in ventilation and increased humidity.

- 4.42. I acknowledge that the orientation, treatment levels, and the nib wall will all contribute to the performance of the cladding system and durability of the building elements. However, due to a combination of the features in this location, I consider that there is a higher likelihood of elevated moisture in the cladding system effecting its drying capacity along this elevation, with a resulting increase in the risk of condensation and accumulation of moisture. The owners have not provided any

- 4.43. I consider the lack of information about how the cladding system is to manage the levels of moisture within the cavity that would result in moisture being accumulated or transferred and causing condensation, fungal growth or the degradation of building elements means compliance with clauses E2.3.2 and E2.3.5 has not been demonstrated for the constructed section of the cladding system along the northeast elevation of the rear garage described in Detail 1.

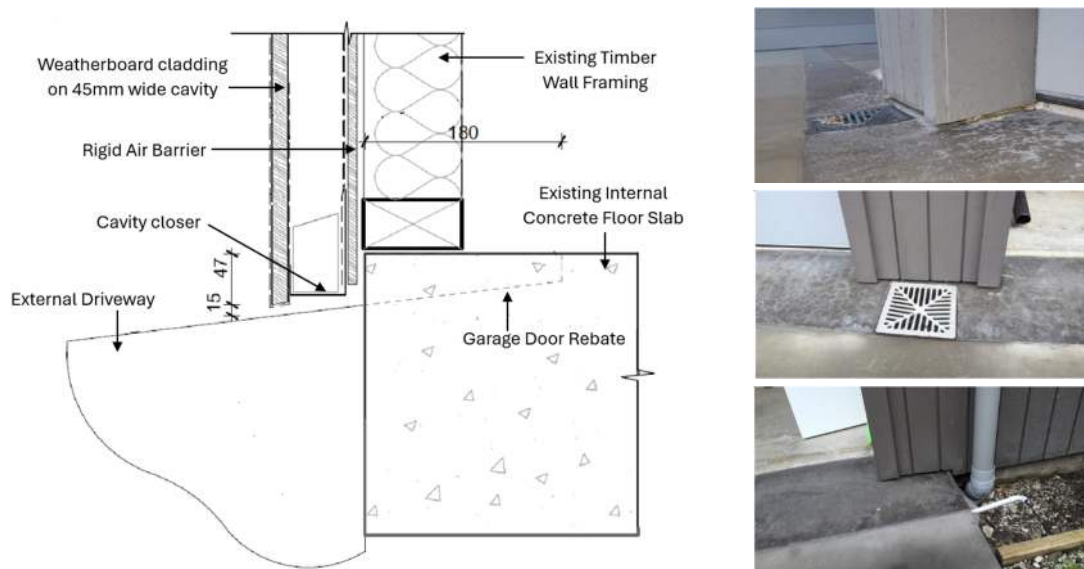
- 2.5. Figure 2 shows the as-built detail to the northwest elevation of the rear garage (Detail 2). The cladding system in this area is adjacent to the rear garage doors, covers a maximum of 700mm lengths in three locations, is installed over a cavity, and extends down to within 15mm of the concrete paved driveway below. In this location, the bottom of the existing external wall framing is within 60mm of paved ground and there are 600mm eaves overhanging the external walls.

**Figure 2: Detail 2 – as-built cladding detail (not to scale) and photos of northwest elevation of rear garage adjacent to doors**

- 4.48. I agree that the slope of the driveway in front of the cladding and garage doors will move surface water away from the base of the cladding. This will lessen humidity by reducing the ability of water to pond below the cladding. Drainage is also enhanced by the presence of the two stormwater sumps in front of (but not directly below)

- 4.50. Given the factors in this location, in particular those that support the cladding's deflection and drainage away from the cladding system, I consider that the risk of moisture transfer or accumulation in the cavity as condensation, and of this leading to undue dampness and fungal growth is low. I therefore consider that the construction of the cladding system on the northwest elevation of the rear garage described in Detail 2 will achieve compliance with clauses E2.3.2, E2.3.5.

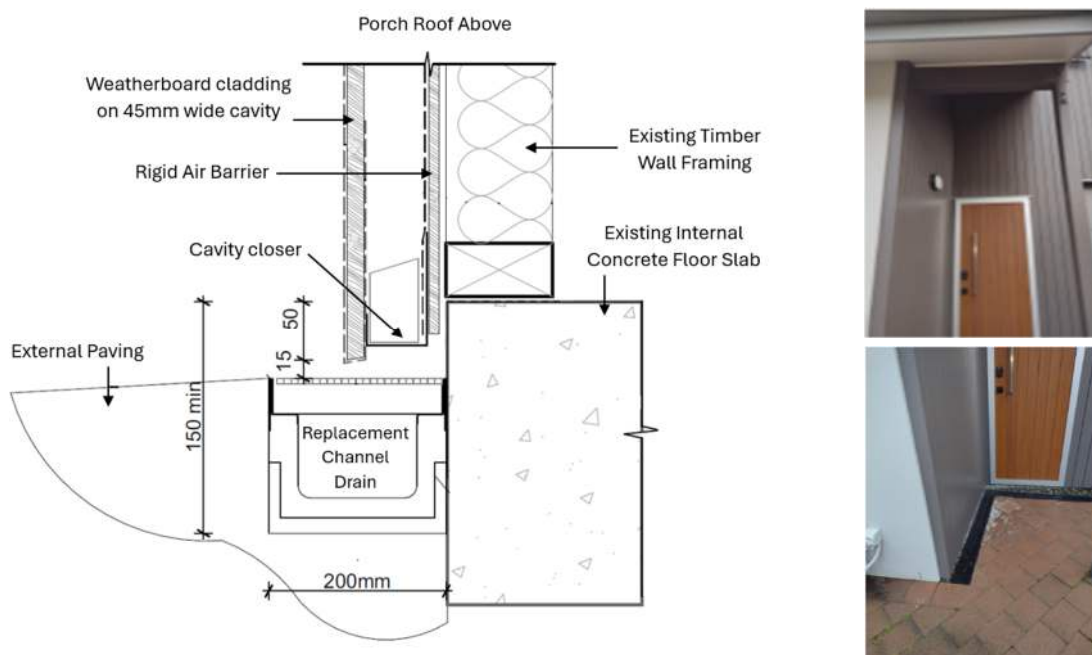
- 2.6. Figure 3 shows the proposed cladding detail for the southwest elevation of the dwelling adjacent to the front entrance (Detail 3). The cladding system is to be installed on two short wall elevations, with a new channel drain and grate (to replace an existing drain) connecting into an existing drain to dispose of any surface water collected. The cladding system is to extend down to within 15mm of the channel drain grate. In this area, a porch roof extends between 1.1m to 1.3m beyond the external walls and is open on two sides. Existing pavers fall away from the external walls.

**Figure 3: Detail 3 – proposed cladding and channel drain detail (not to scale) and photos of front entrance porch and existing drain**

4.56. I agree with the owner that the location and cover to the area in which Detail 3 is located are significant factors in considering compliance of the cladding system. The areas of cladding are largely sheltered by the entry porch overhang above, which means there is minimal risk of significant amounts of water contacting the cladding system. In turn, the risk of moisture entering the cladding cavity through gaps and cracks beyond what is able to be handled by drainage and drying is low.

4.57. The design of the channel drain is proposed to have a smaller capacity and to meet the fall of 1:100 set out in E2/AS1. The drain would not collect significant amounts of water in this location where the cladding and adjacent paving are sheltered, and I consider the risk of increased humidity that could affect the drying performance of the cavity is low.

4.58. While there is a limited area of cladding (approximately 500mm wide) to one side of the front door that is not covered by the porch roof, I consider the size and location of this area make it unlikely that the proposed construction will lead to condensation in the cavity and in turn, fungal growth or undue dampness or damage.

4.59. As with Detail 2, the existing timber bottom plate within the wall framing is in close proximity to the outside ground, being 75mm from the top of the channel grate in Detail 3. However, given the location of the external walls protected by the porch above and my conclusions that the channel drain is unlikely to collect or hold significant amounts of water, the risk of moisture being present in the cladding system cavity to a level which may cause fungal growth and undue dampness in this area is low and I consider the timber wall framing is protected from being exposed to moisture of a level that could cause undue dampness or damage.
