# Determination 2025/051

**Compliance of an altered timber retaining wall with Clause B1 *Structure* and an associated surface water management system with Clause E1 *Surface water* for protection of other property**

**50A, 52 and 52A Jackson Terrace, Ranui, Porirua**

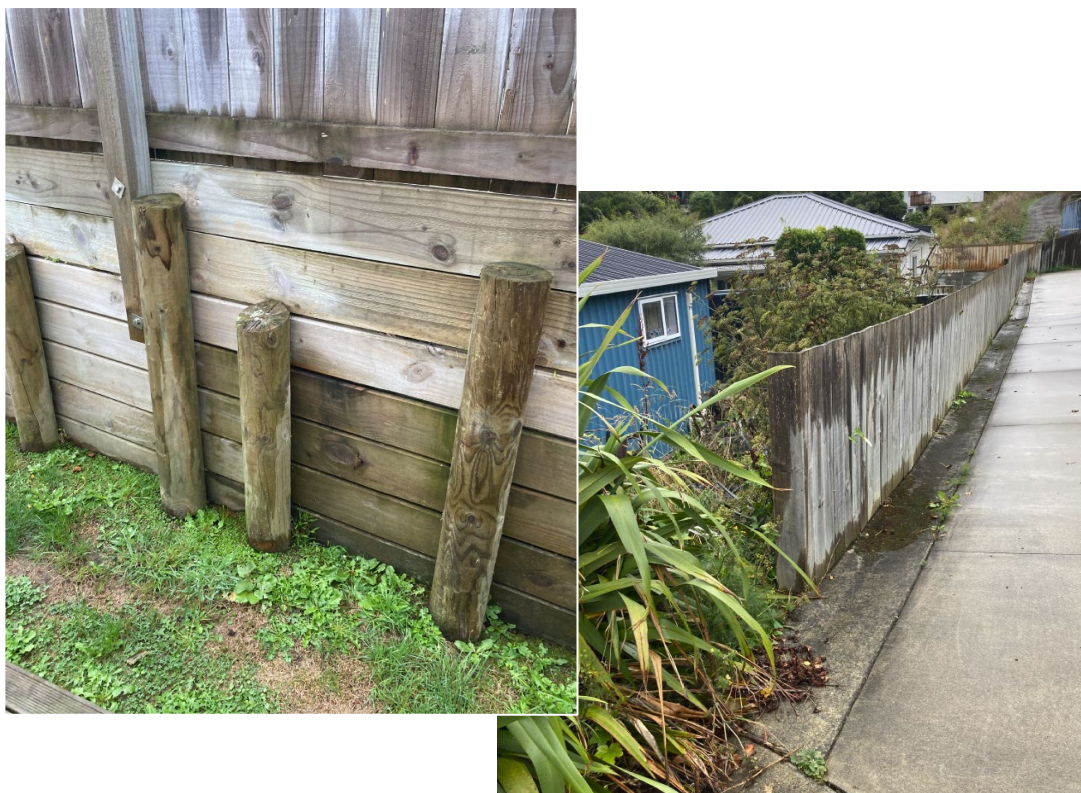
**Figure 1: The retaining wall (left) and surface water management system (right)**

- 4.12. The retaining wall is required to have a low probability of rupture, loss of equilibrium or collapse under B1.3.1. The 2025 report provides a comment about the soils behind the wall being “...likely to sink further...” and the evidence provided in other reports and seen during the site visit shows resultant cracking in the concrete driveway above the retaining wall, allowing surface water into the soils behind the wall. While retaining walls of this type have allowance for subsurface water placing lateral pressures on the structure, soils with an increased consistent saturation over significant periods of time create an increased lateral loading on the structure of the wall which will contribute to its eventual collapse.

- 4.13. The evidence in this case demonstrates that the retaining wall was constructed near vertical, and I consider the evidence of the posts now being up to 170mm from the vertical in various locations along its length demonstrates the wall is deforming and losing equilibrium.

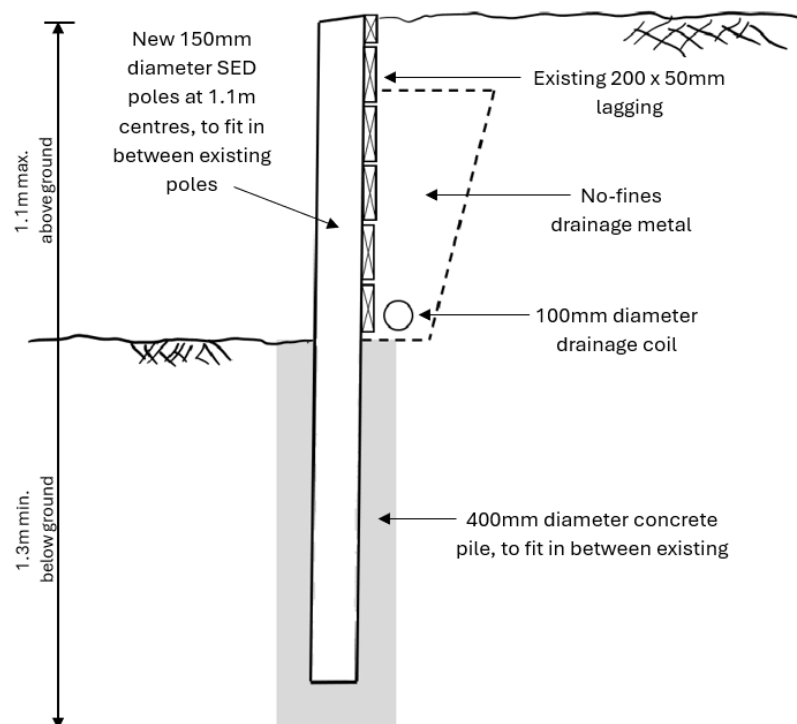
**Figure 3: Structural Engineer detail for the strengthening and addition to the original retaining wall (not to scale)**

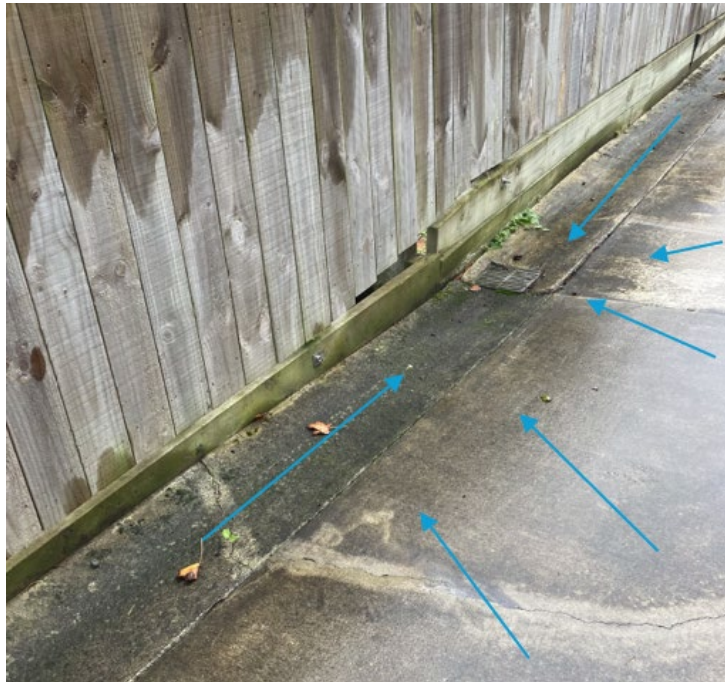
**Figure 4: Surface water management system dish channel falling from two directions to the disposal sump**

4.22. Considering the evidence as to how the system has been constructed, I am of the opinion the dish channel is inadequately sized and formed, and it is not sufficient to collect the surface water from an event having a 10% probability of occurring annually that is collected and concentrated by the building work on 52A Jackson Terrace. The dish channel is shallow and collects little water before overflowing, causing surface water to over-top of the retaining wall and flow down into the neighbour’s property. Therefore, I consider the surface water management system as constructed above the retaining wall does not perform to the level required by E1.3.1 with regard to avoiding likelihood of damage or nuisance to other property.

4.27. The failure of the retaining wall is contributing to the failure of the surface water management system by limiting the amount of surface water able to reach the dish channel to then be appropriately disposed of to the sump. The dish channel is no longer collecting the surface water from the building work associated with the construction of the dwelling at 52A Jackson Terrace, with that water instead saturating soils behind the retaining wall before seeping out along the length of the front of the retaining wall onto 52 Jackson Terrace.

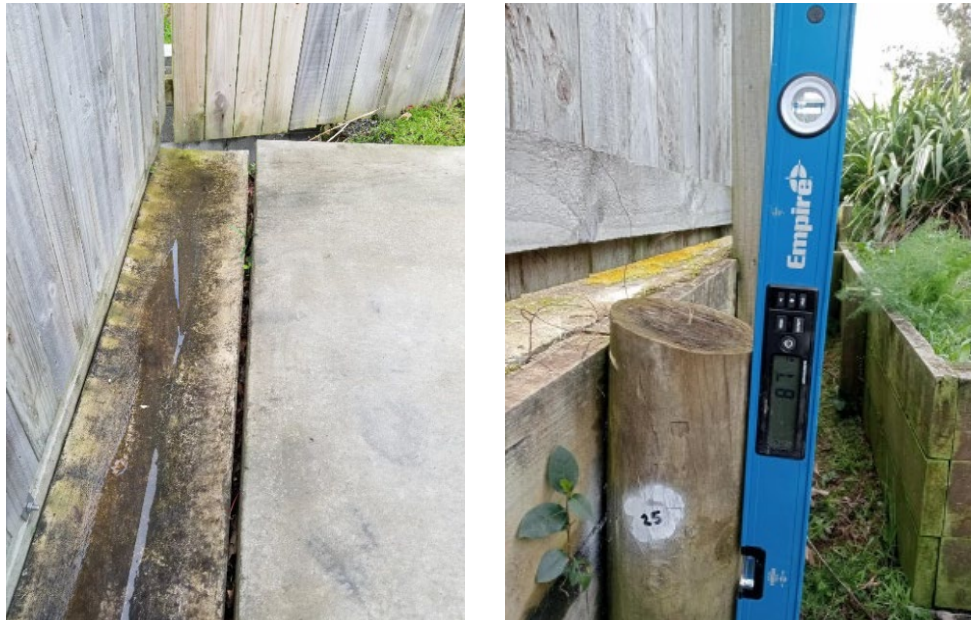
- 3.13.1. The full height/new posts are leaning away from the vertical (towards the lower property) by between 6.8 – 8.9 degrees along the length of the retaining wall, when the “standard requirement at time of construction was... 4 [degrees] leaning into [the] supported land”.

- 3.13.3. The dish channel was not cast as one piece and “was not tied to the driveway by reinforcing starter bars. The water runs [off] the driveway and runs into the gap created when the [retaining] wall has moved and separated from the [dish channel].”

- 3.13.4. Cracks in the concrete driveway and gaps/voids can be seen under and between the concrete driveway and dish channel in multiple locations, with a vertical displacement between the driveway and dish channel in the southeast corner of 52A Jackson Terrace.

**Figure 5: Separation of the dish channel of the surface water management system (left) and leaning posts (right)**
