Determination 2025/058

An authority's decision to issue a dangerous building notice, and whether the notice has been satisfied

26 Burnley Terrace, Mount Eden, Auckland

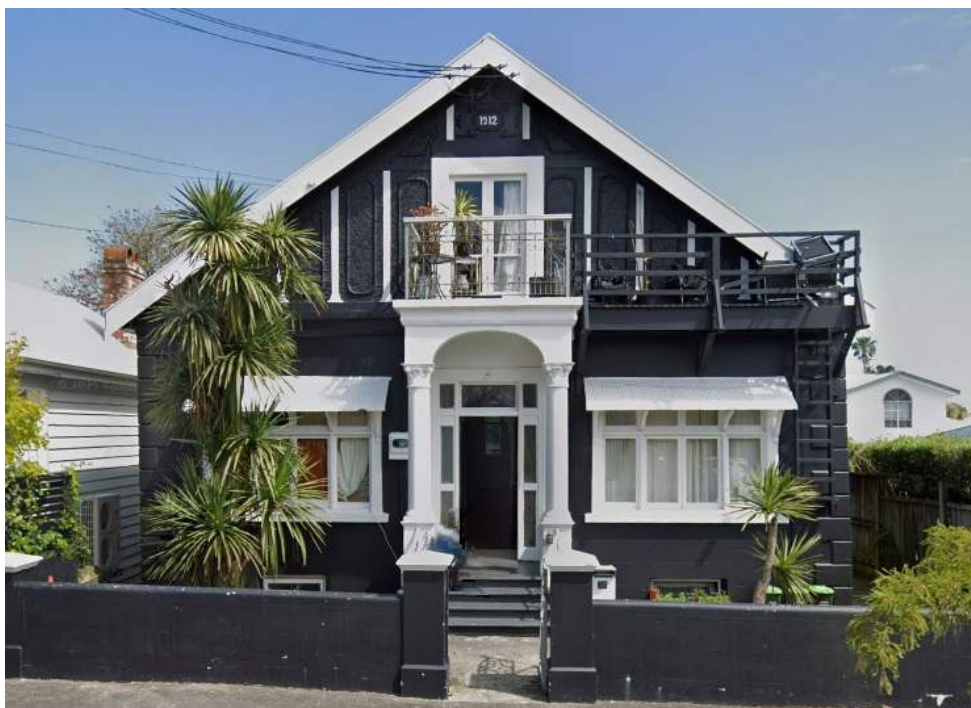
Figure 1: Photo of the building dated October 2024, taken from Google maps.

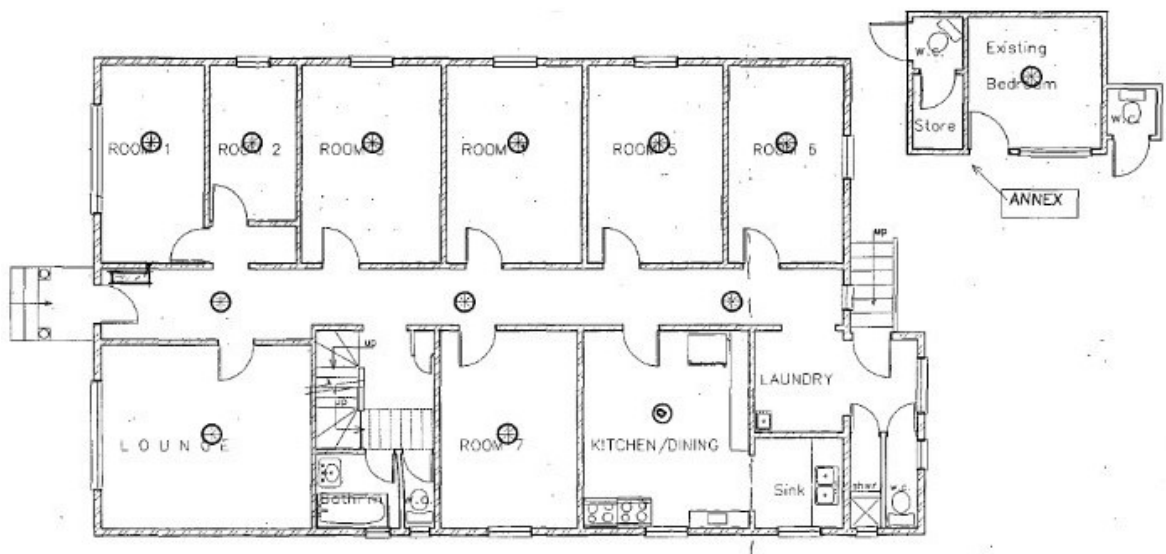
- 2.1. The building is a three-storey structure built around 1912 on a flat 516m² property in what is now an established residential neighbourhood. It is currently used as a boarding house and appears to have been used as a boarding house since at least the early 2000s. The owner purchased the property in 2009.
- 2.2. There are three levels in the building; a basement level, ground floor and first floor. The ground floor contains seven bedrooms, a bathroom, a lounge, a kitchen/dining room, a laundry and a hallway. There are two entry/exit points: a door at the end of the hall facing the street ("the front exit") and a door from the laundry onto the backyard ("the back exit") (see Figure 2).

Figure 2: Ground floor layout taken from fire report dated July 2000

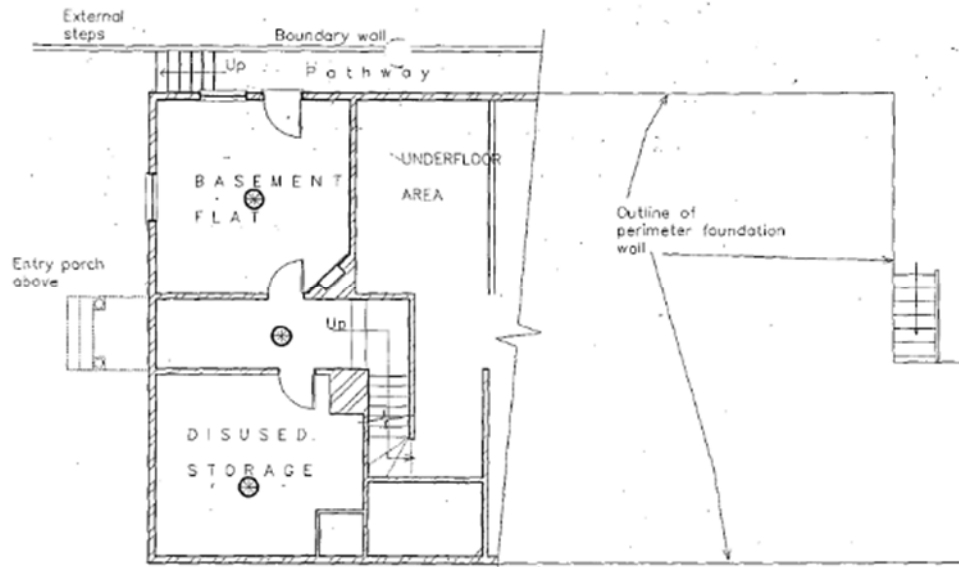
- 2.3. The basement level contains one bedroom and a storage area, and is accessible via internal stairs from the ground floor and external stairs to/from the basement bedroom (see Figure 3). The owner has advised the basement bedroom has been unoccupied since 2020.

Figure 3: Basement layout taken from fire report dated July 2000

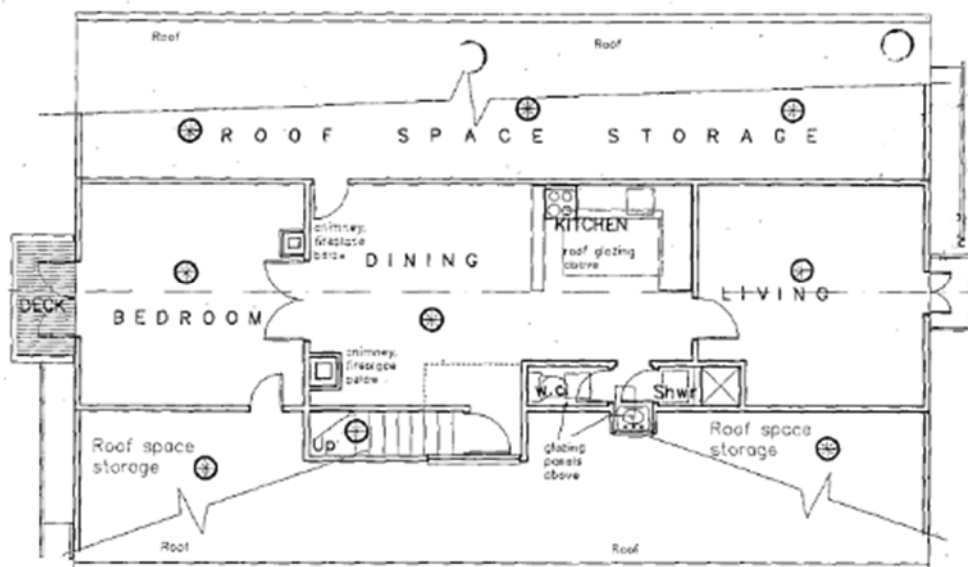
- 2.4. The first floor contains two bedrooms, a dining room, kitchen, bathroom and roof space storage ("the upstairs flat") (see Figure 4). Access to the first floor is via internal stairs from the ground floor. There is a fire escape ladder from the north bedroom's deck, and a fire escape landing and ladder from the south bedroom.

Figure 4: First floor layout taken from fire report dated July 2000⁵

⁵ The living area shown in the July 2000 architectural floor layout is now used as a bedroom.
