# Determination 2026/002

**An authority's decision to issue a code compliance certificate for alterations to a kura building and whether particular matters comply with the Building Code**

**114 Sunset Road, Mangakakahi, Rotorua**

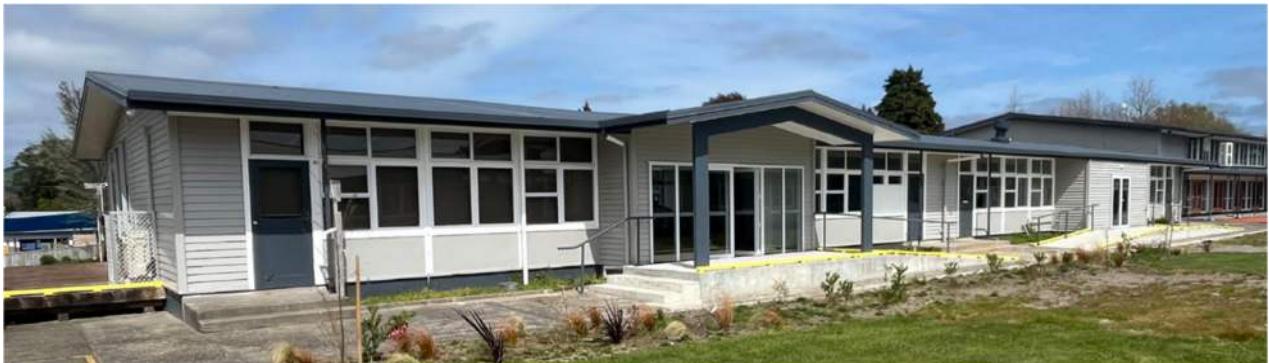
**Figure 1: The northern elevation of the building, following the building work**
