# Determination 2026/004<sup>1</sup>

**An authority's decision to issue two notices to fix for building work carried out without consent, a change of use and non-compliance with the Building Code**

**11 Laurence St, Manly, Auckland**

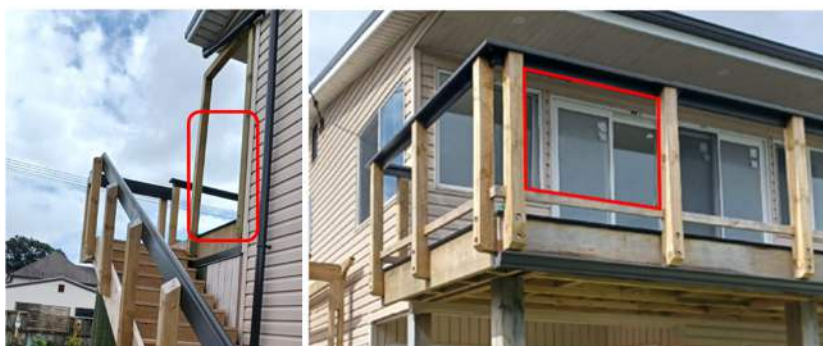
**Figure 3: Photos indicating the area without a barrier (left) and the open spaces between the posts and rails (right), taken 16 October 2023.**

- 3.31. The barrier as constructed consists of timber balustrades and top rail, and a timber rail near the bottom of the construction. There are open spaces between the posts and rails, which I estimate to be around 1m wide and 0.8m high (see Figure 3, right).<sup>13</sup>

- 3.32. At the time the notice was issued, the barrier would not safeguard people from injury caused by falling or reduce the likelihood of accidental fall (through the open spaces to the ground below). The barrier as constructed at that time would not prevent people falling through it (see clause F4.3.4(e)) and nor would it restrict the passage of children (see clause F4.3.4(g)).

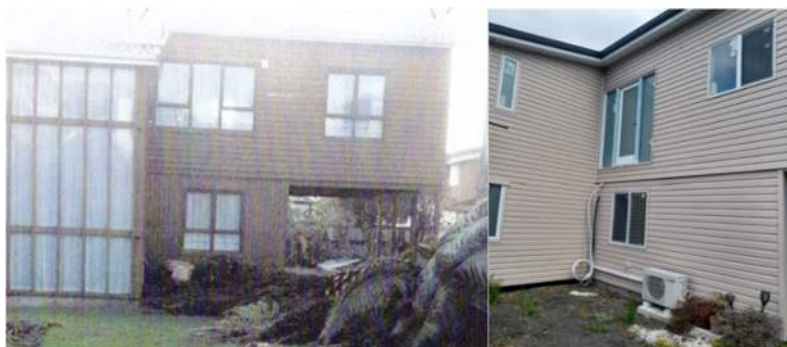
**Figure 5: Left - photo showing the former cladding on the south elevation, including the former carport and internal stairwell area (dated 24 July 2018). Right - photo of the south elevation, showing new cladding installed (dated 13 December 2024).**

- Both floors of the building have been reclad with a horizontal vinyl weatherboard cladding system over an insulated building wrap, direct fixed to a rigid air barrier which itself is fixed to the external wall timber framing.
- The owner considers the recladding work was exempt under clause 1 and referred to Determination 2017/004.<sup>21</sup> They also consider it is covered by the COA.

Due to differences in the finished assembly, I consider the replacement external wall cladding is not a comparable building product or assembly under clause 1.

In regard to clause 1, I consider the same rationale applies as discussed in paragraph 1C above. The replacement external wall cladding is not a comparable building product or assembly due to the differences in the finished assembly.

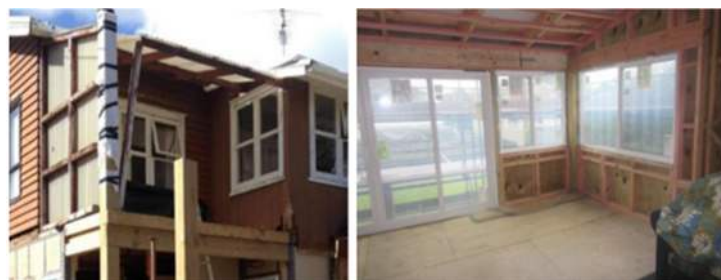
**Figure 6: Photos of the former first-floor deck area (left) and current extension of lounge (right).**

- The building work is the closing-in of the former first-floor deck area in the north-east corner of the main building. The owners consider the work was exempt under clause 15 of Schedule 1, and also that it was also covered by the COA.

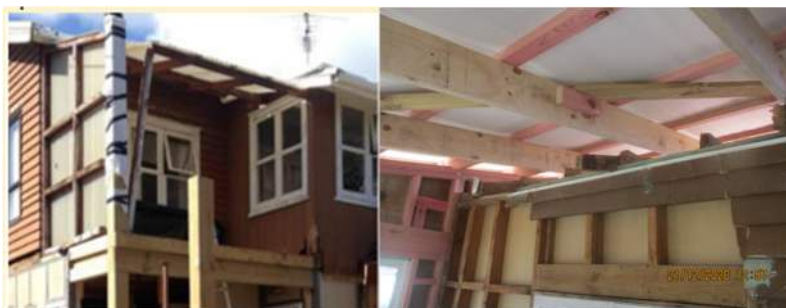
**Figure 7: The former first-floor deck (left) and the roof alteration (right).**

- The notice does not state which part of the roof it is referring to (eg whether it is the whole roof or a particular part).
- The building surveyor refers to "the roof height was slightly altered".
- The owners state the overall roof height was not altered and the roof is in the same place. They consider the work was exempt under clause 1 of Schedule 1, and that it was also covered by the COA.

- In regard to the owners' claims that the work was exempt under clause 1, I note the work to roof above the north-east corner of the dwelling was new building work, including new roof framing, roof underlay and an area of roof cladding. It was not 'repair' or 'maintenance' (under clause 1(1)) The new work altered the configuration, the form of construction, and profile of the roof. The roof has been raised to remove the change in pitch and flashing where the roofs intersected above the first-floor lounge. Therefore, the building work does not meet the criteria in clause 1.

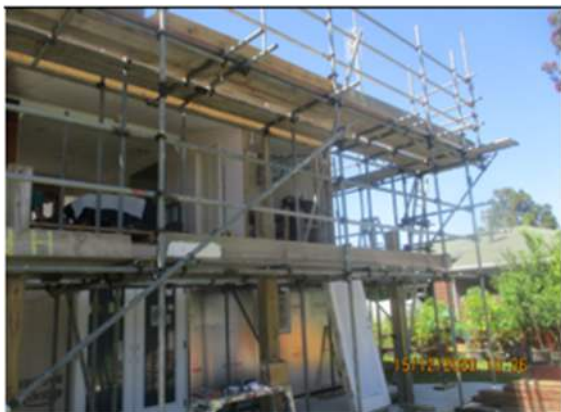
**Figure 8: Photo showing the first-floor wall removed and new timber beam/lintel in place (taken 15 December 2020).**

- It appears that it was only at the first floor level of the north elevation that the wall was deconstructed, though this is not clear from the wording in the notice to fix. The authority's photographs (dated 15 December 2020) show the entire first floor external wall construction, including any previous joinery, had been removed and a timber beam(s) / lintel(s) had been installed (see Figure 8). Subsequent photographs (from 21 December 2020) show the external wall reconstructed and some door and window joinery installed.
- The owners state that work was required to replace exterior windows and doors, under clause 8 of Schedule 1. They also consider it was "...not a substantial contribution to the building's structural behaviour or fire properties and therefore exemption 1 applies". The owner also states it was covered by the COA.

- It is not clear why the authority included this item in the notice to fix; the COA included the replacement of the first-floor external wall, which remedied any contravention of section 40.
- Nonetheless, I have also considered the owners' claim that the building work was exempt from requiring a building consent under clauses 1 and 8. Regarding clause 8, I note that

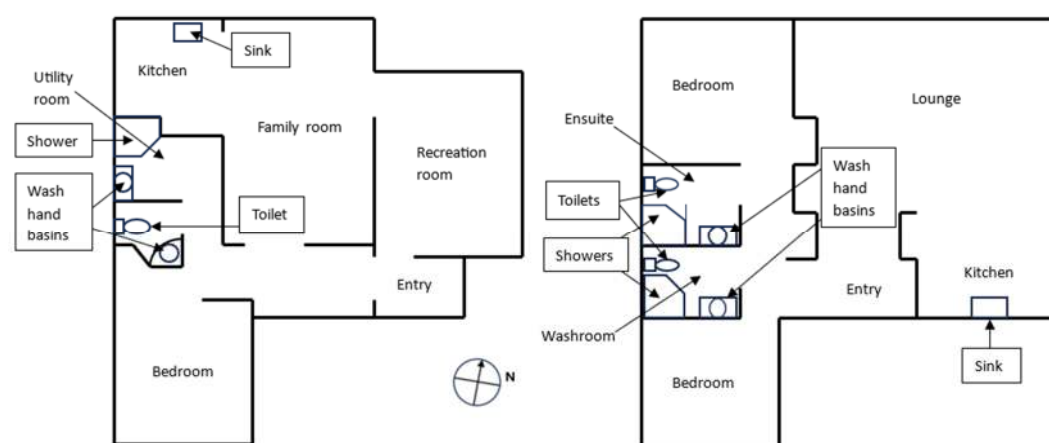
**Figure 9: Current layout of ground floor (left) and first floor (right) showing locations of sanitary fixtures.**

- The work was undertaken between September and December 2021. It appears the plumbing work has been completed although some sanitary fixtures have not yet been installed.
- The notice to fix refers to “The installation of new plumbing and drainage to support new sanitary fixtures...”. However, it does not specify which sanitary fixtures and associated plumbing work was ‘new’ or additional (rather than being replacement, repairs or relocation of previous fixtures and plumbing) nor the extent of any new drainage.
- The owners consider there are no additional sanitary fixtures or drainage connections, only replacement of existing, and the work is exempt under clauses 32 and 35.

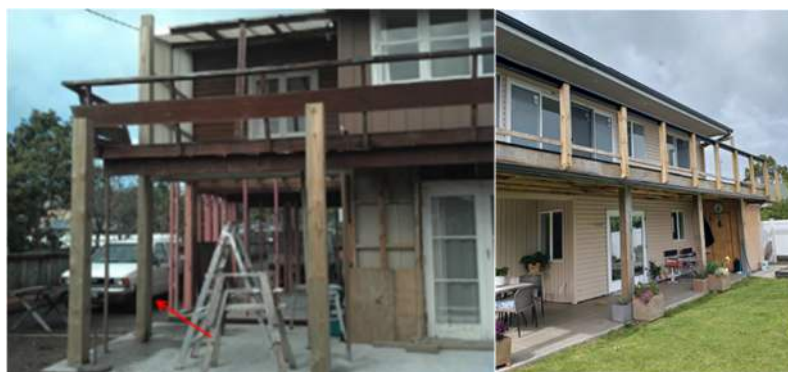
Figure 10: The former deck construction (left) and current deck construction (right).

- It appears the new deck was constructed sometime between 2 November 2021 and 16 October 2023, although the construction of the barrier is still incomplete. The new deck is 9.5m long x 2.5m wide.
- The owners consider that when finished, this will be the replacement that is exempt under clause 1(2) of an existing deck originally constructed in 1968, and that it is also the ground floor awning or veranda which is exempt under clause 16A. The owners also consider it was covered by the COA.
- The 1968 building permit plan shows a first-floor timber deck constructed across the north elevation of the main building, with a return at the north-east corner (see Figure 10, left). The deck was approximately 9.4m long and approximately 1.12m wide.<sup>28 29</sup>

- The COA included the new timber posts and supporting foundations, but not the remaining structure. Because the COA includes the new support posts and associated foundations, I have only considered whether the rest of the construction of the deck was exempt from requiring a building consent.
- I consider the building work does not meet the criteria in clause 1(2) because the new deck is larger than the former deck and so it is not in the same position.
- In regard to clause 16A, I note that awnings, unlike a deck, are not intended to support loads from persons or materials placed on them. I consider this building work is not exempt under clause 16A.

The building work to construct the timber deck was not exempt under Schedule 1 and required building consent. Only the timber posts and supporting foundations are covered by the COA. Therefore, there was a contravention of section 40 in regard to the rest of the deck construction.

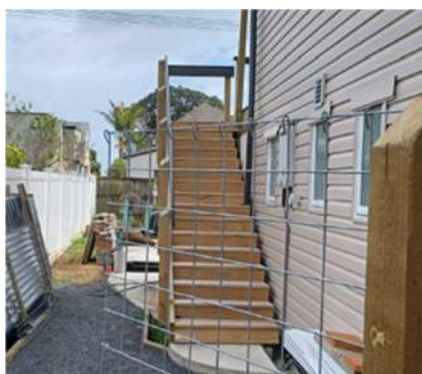
- The stair is located adjacent to the north-west corner of the main building and provides access to the first-floor deck. There is a landing at the top of the stair that is lower than the adjacent deck. It appears the stair was constructed sometime between November 2021 and October 2023.
- The owners state the stairs are 'a building site necessity for safe upper level access and escape, pending resolution of building consent refusal for the [proposed stairs to the main entrance of the first floor]'.

Figure 11: The stair to the first floor

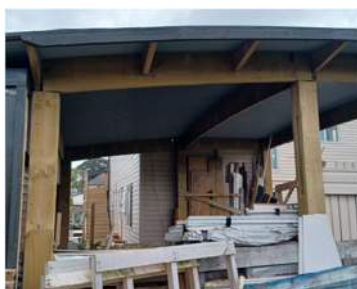
- The carport was built sometime between December 2020 and October 2023.
- The outside dimensions of the carport are approximately 24.8m<sup>2</sup> (4.96m x 5m).
- The owners consider the structure is exempt under clause 18A, and state it was constructed by an LBP, according to “LBP Design and Engineer certificates”.<sup>30</sup>

**Figure 12: The carport on the south-western side of the property.**

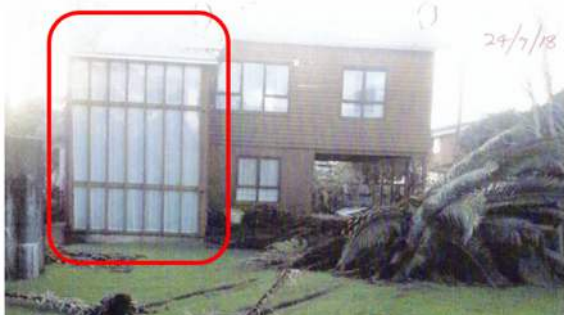
**Figure 12: Photo showing the previous stairwell area (dated 24 July 2018).**

- The building work to convert the enclosed stairwell into two bedrooms included constructing a new floor at first-floor level, as well alterations to the internal walls and some door openings. This work appears to have started prior to 15 December 2020, and by 18 March 2025 the stair had been removed and the new floor installed.
- The owners consider the work was internal alterations under clauses 11 and 12. They also consider that the stairwell conversion was covered by the COA.
- In regard to recladding, this has been assessed in Item 3.
