# Determination 2026/004

**An authority's decision to issue two notices to fix for building work carried out without consent, a change of use and non-compliance with the Building Code**

**11 Laurence St, Manly, Auckland**

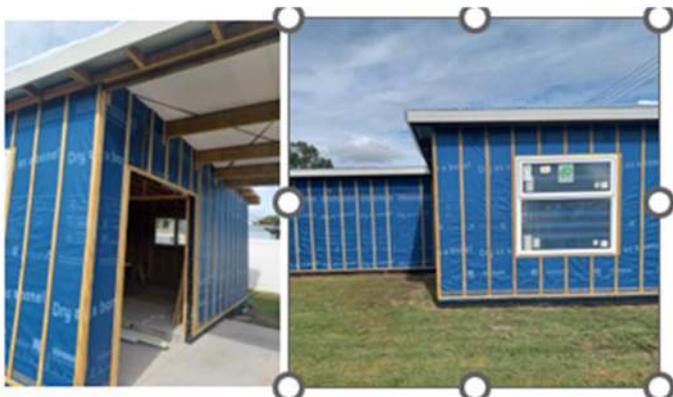
**Figure 2: The smaller building.**<sup>3</sup>

- 3.5.1. Item 1: The construction of the smaller building<sup>6</sup>, with the exception of the part of the concrete floor slab that was in scope of the COA.
- 3.5.2. Item 2: The installation of the drainage pipework in the smaller building.
- 3.5.3. Item 3: The majority of the new external wall cladding, with the exception of the cladding in the former carport area which was in scope of the COA.
- 3.5.4. Item 7: The installation of the below ground surface water drainage.
- 3.5.5. Item 8: The installation of new/additional sanitary fixtures, ie the kitchen sink and extra wash hand basin on the ground floor, and toilet, shower and wash hand basin in the first-floor ensuite.

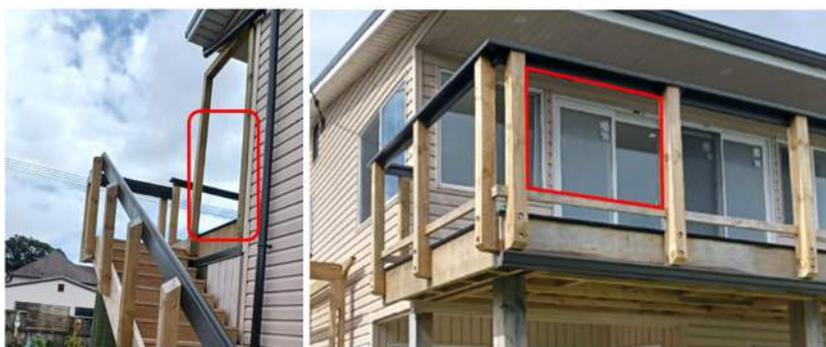
- 3.29. Clause F4.3.1 includes 'limits on application'. I do not consider any of the limits apply in this case. A barrier would not be incompatible with the intended use of the deck. Nor do I consider this is a temporary barrier on a construction site, as I have received no information indicating that the barrier is not intended to be a permanent feature, and its construction (while incomplete) broadly aligns with the information included in the COA plans.
- 3.30. A barrier as constructed runs around the outside of the deck. However, at the time the notice was issued, there was no barrier in the area adjacent to the external access stair (see Figure 3, left).

**Figure 3: Photos indicating the area without a barrier (left) and the open spaces between the posts and rails (right), taken 16 October 2023.**

- 3.31. The barrier as constructed consists of timber balustrades, a single metal top rail, and a timber rail near the bottom of the construction. There are open spaces between the posts and rails, which I estimate to be around 1m wide and 0.8m high (see Figure 3, right).<sup>11</sup>

- 3.32. At the time the notice was issued, the barrier would not safeguard people from injury caused by falling or reduce the likelihood of accidental fall (through the open spaces to the ground below). The barrier as constructed at that time would not prevent people falling through it (see clause F4.3.4(e)) and nor would it restrict the passage of children (see clause F4.3.4(g)).

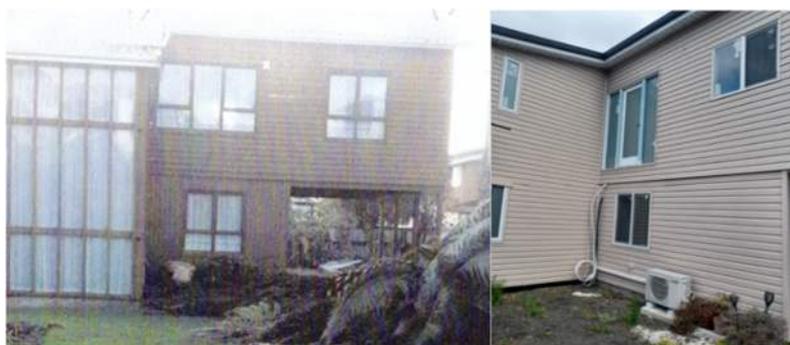
**Figure 5: Left - photo showing the former cladding on the south elevation, including the former carport and internal stairwell area (dated 24 July 2018). Right - photo of the south elevation, showing new cladding installed (dated 13 December 2024).**

- Both floors of the building have been reclad with a horizontal vinyl weatherboard cladding system over an insulated building wrap, direct fixed to a rigid air barrier which itself is fixed to the external wall timber framing.
- The owner considers the recladding work was exempt under clause 1 and referred to Determination 2017/004.<sup>17</sup> They also consider it is covered by the COA.

Due to differences in the finished assembly, I consider the replacement external wall cladding is not a comparable building product or assembly under clause 1.

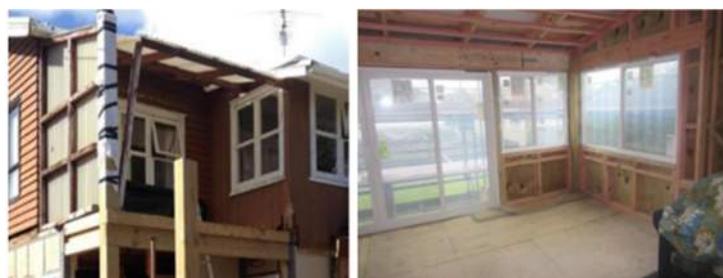
**Figure 6: Photos of the former first-floor deck area (left) and current extension of lounge (right).**

- The building work is the closing-in of the former first-floor deck area in the north-east corner of the main building. The owners consider the work was exempt under clause 15 of Schedule 1, and also that it was also covered by the COA.

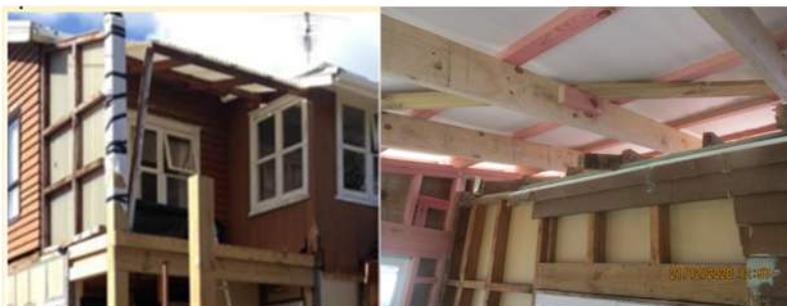
**Figure 7: The former first-floor deck (left) and the roof alteration (right).**

- The notice does not state which part of the roof it is referring to (eg whether it is the whole roof or a particular part).
- The building surveyor refers to “the roof height was slightly altered”.
- The owners state the overall roof height was not altered and the roof is in the same place. They consider the work was exempt under clause 1 of Schedule 1, and that it was also covered by the COA.

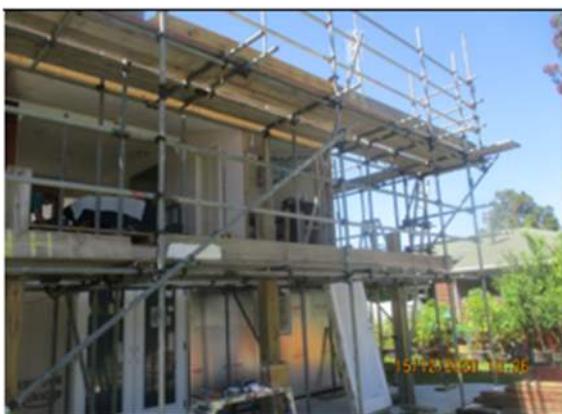
**Figure 8: Photo showing the first-floor wall removed and new timber beam/lintel in place (taken 15 December 2020).**

- It appears that it was only at the first floor level of the north elevation that the wall was deconstructed, though this is not clear from the wording in the notice to fix. The authority's photographs (dated 15 December 2020) show the entire first floor external wall construction, including any previous joinery, had been removed and a timber beam(s) / lintel(s) had been installed (see Figure 8). Subsequent photographs (from 21 December 2020) show the external wall reconstructed and some door and window joinery installed.
- The owners state that work was required to replace exterior windows and doors, under clause 8 of Schedule 1. They also consider it was "...not a substantial contribution to the building's structural behaviour or fire properties and therefore exemption 1 applies". The owner also states it was covered by the COA.

- It is not clear why the authority included this item in the notice to fix; the COA included the replacement of the first-floor external wall, which remedied any contravention of section 40.
- Nonetheless, I have also considered the owners' claim that the building work was exempt from requiring a building consent under clauses 1 and 8. Regarding clause 8, I note that the notice to fix concerned the removal of the external wall rather than replacement of joinery.
  - **Clause 1.** The north elevation external wall and new beam(s) / lintel(s) are integral to the structural performance of the building including supporting part of the roof

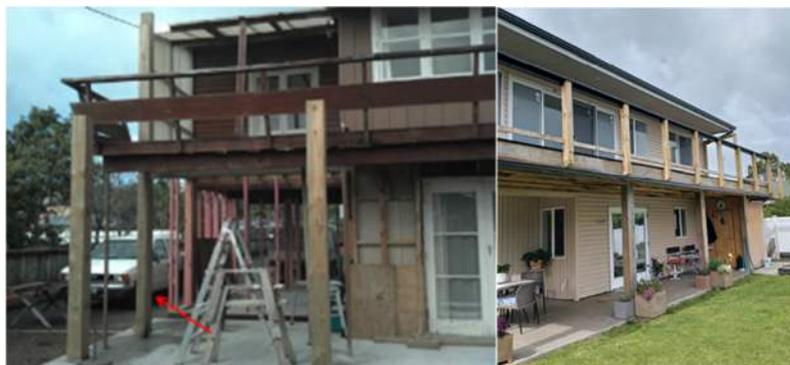
**Figure 10: The former deck construction (left) and current deck construction (right).**

- It appears the new deck was constructed sometime between 2 November 2021 and 16 October 2023, although the construction of the barrier is still incomplete. The new deck is 9.5m long x 2.5m wide.
- The owners consider that when finished, this will be the replacement that is exempt under clause 1(2) of an existing deck originally constructed in 1968, and that it is also the ground floor awning or veranda which is exempt under clause 16A. The owners also consider it was covered by the COA.
- The 1968 building permit plan shows a first-floor timber deck constructed across the north elevation of the main building, with a return at the north-east corner (see Figure 10, left). The deck was approximately 9.4m long and approximately 1.12m wide.<sup>24 25</sup>

- The COA included the new timber posts and supporting foundations, but not the remaining structure. Because the COA includes the new support posts and associated foundations, I have only considered whether the rest of the construction of the deck was exempt from requiring a building consent.
- I consider the building work does not meet the criteria in clause 1(2) because the new deck is larger than the former deck and so it is not in the same position.
- In regard to clause 16A, I note that awnings, unlike a deck, are not intended to support loads from persons or materials placed on them. I consider this building work is not exempt under clause 16A.
- As commented on in the notice to fix, it is possible to fall more than 1.5m from the deck if it collapsed. For that reason, the building work is not exempt under clause 24, and I am of the view no other clauses in Schedule 1 apply.

The building work to construct the timber deck was not exempt under Schedule 1 and required building consent. Only the timber posts and supporting foundations are covered by the COA. Therefore, there was a contravention of section 40 in regard to the rest of the deck construction.

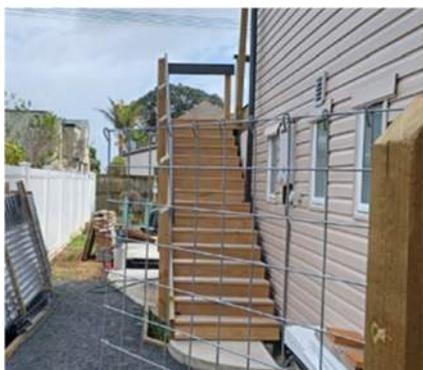
- The stair is located adjacent to the north-west corner of the main building and provides access to the first-floor deck. There is a landing at the top of the stair that is lower than the adjacent deck. It appears the stair was constructed sometime between November 2021 and October 2023.
- The owners state the stairs are ‘a building site necessity for safe upper level access and escape, pending resolution of building consent refusal for the [proposed stairs to the main entrance of the first floor]’.

**Figure 11: The stair to the first floor**

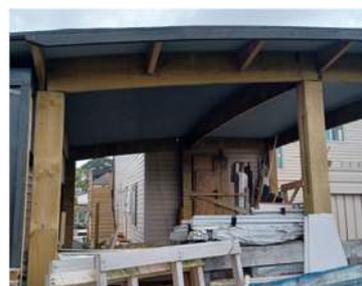
- The carport was built sometime between December 2020 and October 2023.
- The outside dimensions of the carport are approximately 24.8m<sup>2</sup> (4.96m x 5m).
- The owners consider the structure is exempt under clause 18A, and state it was constructed by an LBP, according to “LBP Design and Engineer certificates”.<sup>26</sup>

**Figure 12: The carport on the south-western side of the property.**

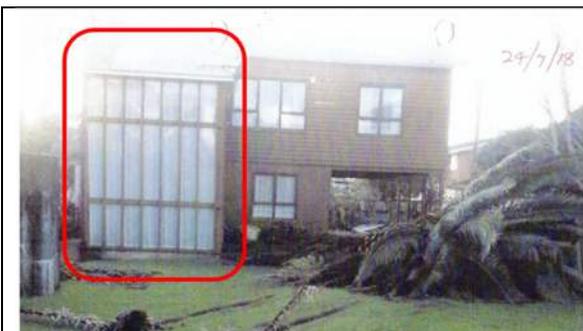
**Figure 12: Photo showing the previous stairwell area (dated 24 July 2018).**

- The building work to convert the enclosed stairwell into two bedrooms included constructing a new floor at first-floor level, as well alterations to the internal walls and some door openings. This work appears to have started prior to 15 December 2020, and by 18 March 2025 the stair had been removed and the new floor installed.
- The owners consider the work was internal alterations under clauses 11 and 12. They also consider that the stairwell conversion was covered by the COA.
- In regard to recladding, this has been assessed in Item 3.
