# Determination 2026/007

**The issue of a building consent, an alleged failure to issue a notice to fix, and compliance of proposed building work with Clause B1**

**1994 Arundel Rakaia Gorge Road, Mayfield, Ashburton**

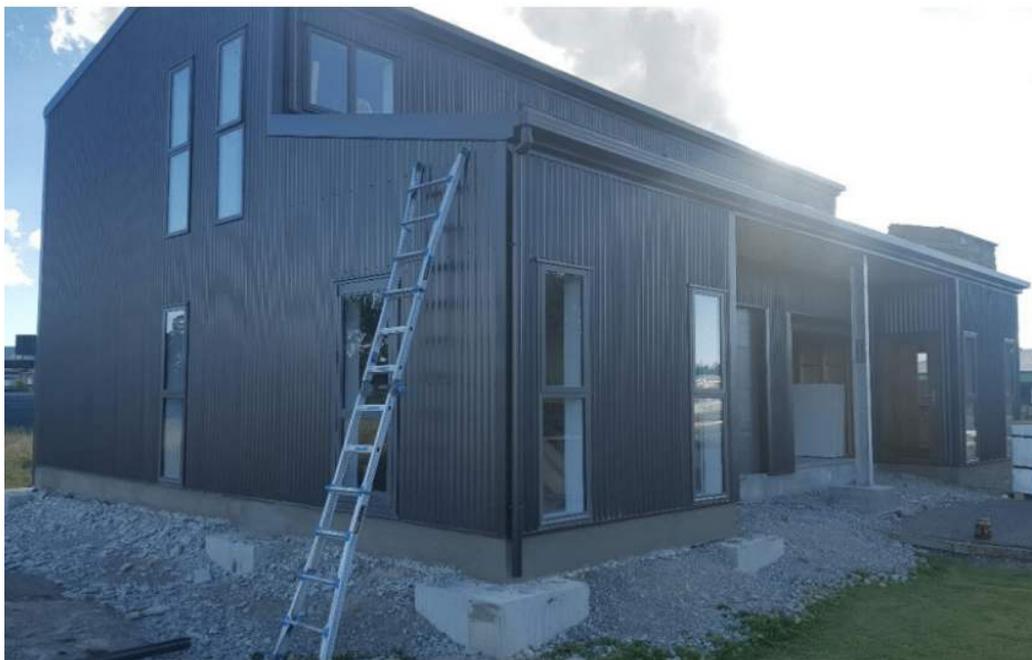
**Figure 1: View of east corner of the building**
