Determination 2026/015

Compliance of a tiled bathroom floor with Building Code clause E3

9 Stockport Grove, Churton Park, Wellington

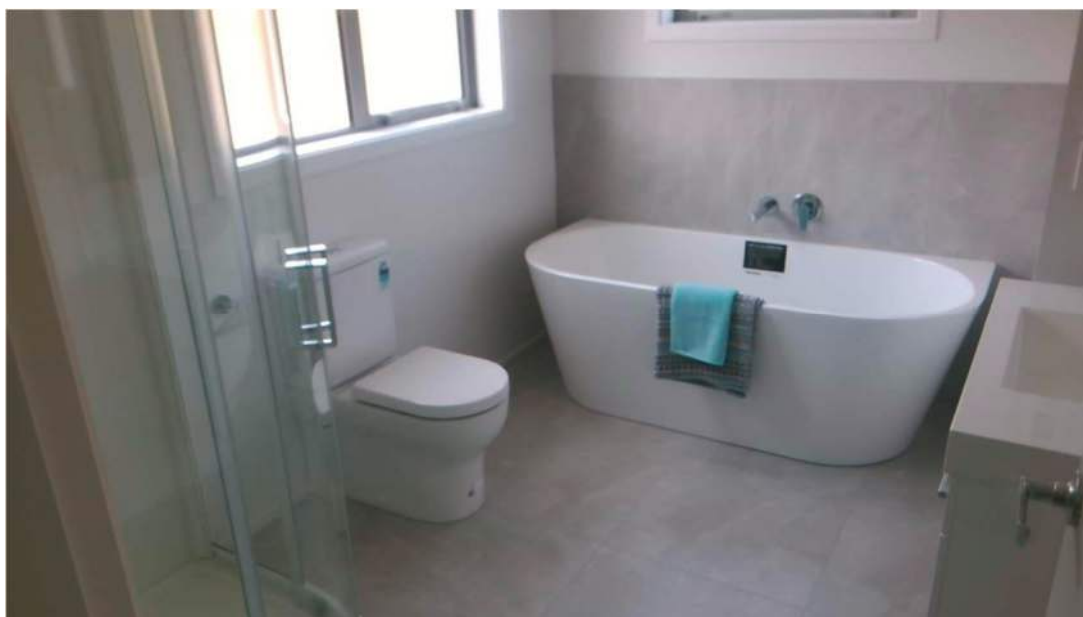
Figure 1: Upper-level bathroom including shower enclosure¹

¹ Photo taken at the time of final inspection 16 November 2023
