# Determination 2026/017

**The issuing of a certificate of acceptance for work completed on a new shower room, and whether the building work complied with the building code.**

**110a Lynwood Rd, New Lynn, Auckland**

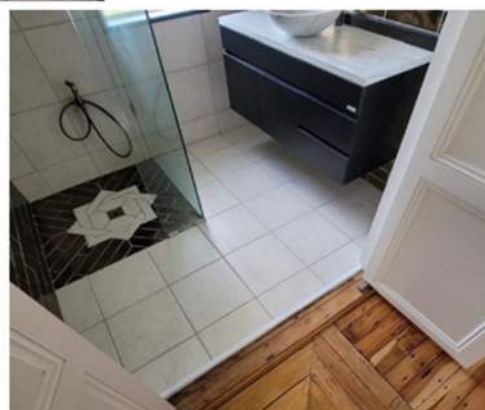
**Figure 1: The shower room**

- The gaps to one side and bottom edges of the glazed shower screen allows water splash to pass through into the adjoining space, meaning the junction between the screen and wall and floor surfaces are not impervious.

- 4.3. The concern raised by owners relating to gaps at the base and side of the glazed shower screen is that it allows water splash to pass into the adjacent shower room.
- 4.4. The as-built shower enclosure is an alternative solution because it does not fully comply with Acceptable Solution E3/AS1; for example, the floor to the shower area has insufficient fall and does not extend to the minimum radius.<sup>18</sup>

- 4.9. The location of the shower head is such that water splash is unlikely to be wholly contained within the shower enclosure due to the nearby 'open' entry point. A greater volume of water splash is more likely to extend beyond the open side of the shower enclosure where there is no glazed screen, door, curtain or the like.

- 4.11. While water splash beyond the enclosure is likely, the materials and construction used adequately manages this moisture and compliance with clauses E3.3.3 and E3.3.4 is satisfied.

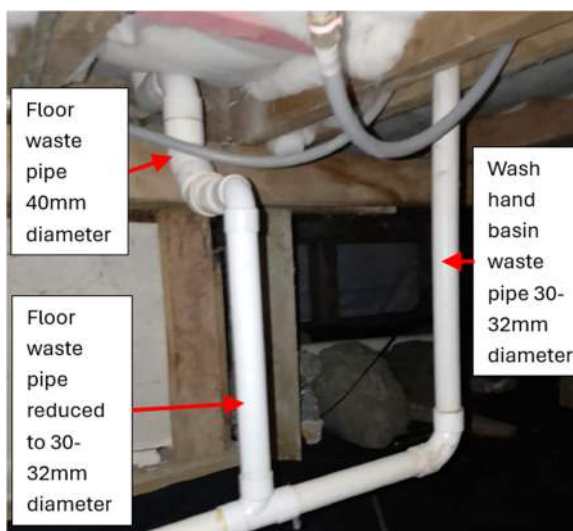
**Figure 2: View in subfloor space below the floor waste and wash hand basin**

- 2.2.16. As-built information confirms a 30 – 32mm diameter pipe was installed to the wash hand basin. A 40mm diameter waste pipe is installed to the floor waste (refer to figure 2) but it reduces in size to 30 - 32mm in diameter part way long its length (in the direction of flow of water). This pipe connects onto the discharge pipe from the wash hand basin (refer to figure 2).

- The reduction in size of the floor waste pipe in the direction of flow (up to and including where it connects with the smaller diameter wash hand basin discharge pipe) does not avoid the likelihood of blockage.

- 4.15. The reduction in pipe size from the floor waste to the discharge pipe does not comply with either the specified standard AS/NZS 3500.2 or with Acceptable Solution G13/AS1. Both provide for untrapped floor drains, but have minimum diameter requirements of 40mm, either for the floor waste (G13/AS1 paragraph 3.4.2) or the discharge pipe it connects to (AS/NZS 3500.2 paragraph 13.26.3). Neither provide for a reduction in pipe size along the direction of flow.

- 4.17. Reducing the diameter of a waste pipe in the direction of flow can have several effects, including (but not limited to) lowering flow capacity by restricting the cross-sectional area, increasing frictional resistance, turbulence, and pressure loss. Larger waste pipes connecting onto smaller waste pipes also increase susceptibility of debris accumulation in the pipe, progressively narrowing the flow path and increasing the risk of bottlenecks and blockages. In summary, the reduced diameter of waste pipe in the direction of flow does not avoid the likelihood of blockages over the intended life of the building, meaning compliance with clause G13.3.1(b) has not been satisfied.

- 4.20. Due to the as-built junction between the waterproof membrane, the existing floor sheeting, and the flange of the floor waste, the shower room floor is unlikely to be impervious at this location (contrary to clause E3.3.3). This creates a risk of moisture penetration and reduced durability of building elements such as the timber floor sheeting, and compliance with clause B2.3.1(b) as it relates to clause E3.3.6 has not been demonstrated.

- 4.21. In addition, the floor waste (which does not discharge to open air) lacks a water trap, which does not avoid the likelihood of foul air and gases entering the building from the plumbing system (contrary to the requirements of clause G13.3.1(c)).

- Separate floor overflow from vanity waste...Fit vermin cap and run to edge of deck or cladding
  - Install air admittance [valve] to vanity
- 2.5. Subsequently, in support of the COA application, the previous owners obtained (amongst other documentation) a report dated 29 November 2025 from a building inspection company<sup>10</sup>, some plans of the as-built work<sup>11</sup>, and a Producer Statement – Construction (PS3)<sup>12</sup> for the plumbing from the LBP. The PS3 described the work as “Visual inspection of existing bathroom plumbing only. Plumbing done by others...”.

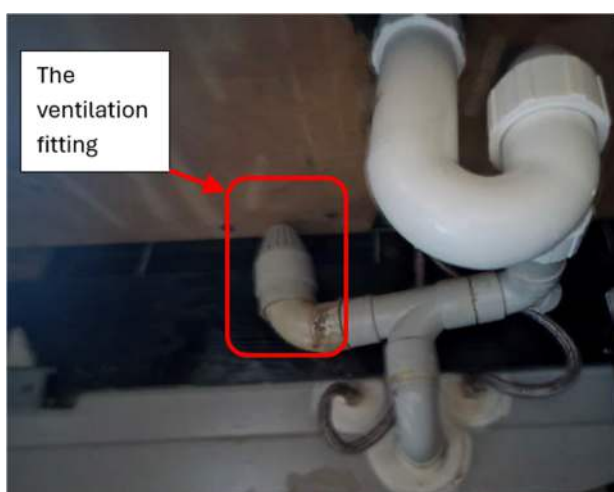
**Figure 3: View of ventilation fitting installed to wash hand basin waste pipe**

- 4.23. The issue relates to a ventilation fitting installed to the wash hand basin discharge pipe. The ventilation fitting, with open slots around its circumference, appears to be a vent cowl (usually installed to a vent pipe external to a building). Based on the photographs provided by the parties, it has no features that suggest it has a valve of any description to avoid foul air and gases from entering the building (like an air admittance valve).
- 4.24. As it presents, the ventilation fitting below the wash hand basin does not avoid the likelihood of foul air and gases from the plumbing system from entering the building (ie in the shower room), meaning the as-built work does not comply clause G13.3.1(c).
