Determination 2026/021

An authority's decision to refuse to issue a dangerous building notice for a private bridge

590 Makara Road, Karori, Wellington

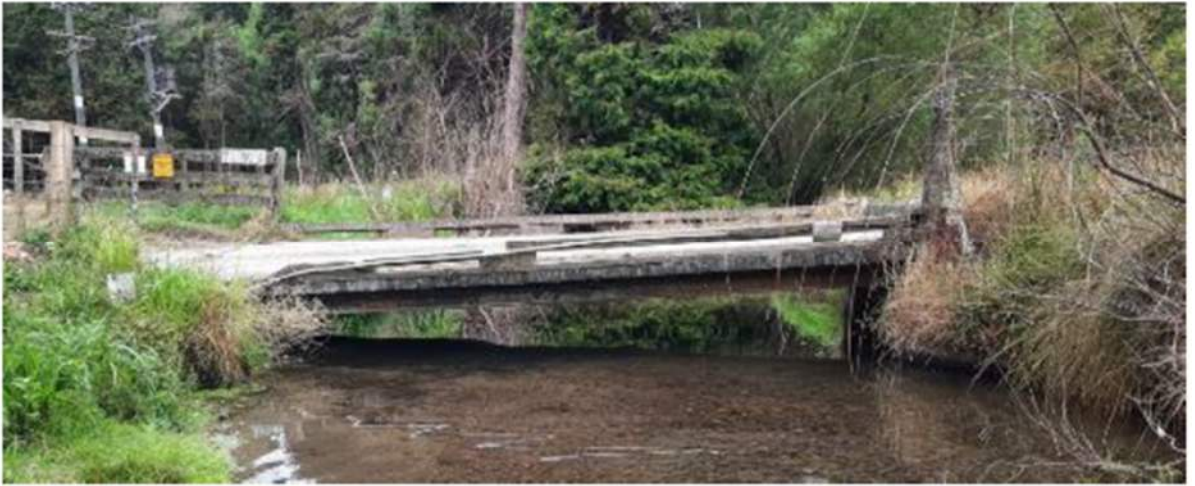
- 2.6. Prior to the repair, the deck and supporting beams had a slope of approximately 3.5 degrees between the banks and a 6-degree slope along the flow direction, due to long-term settlement of the true left abutment (see Figure 1). The owners' engineer states the steel rail beams had very significant corrosion with the presence of

sizeable quantities of pack rust. The metal pins securing the deck had corroded, leading to the deck becoming displaced in the flood.

Figure 1: Photo of the bridge prior to the flooding and subsequent repair.

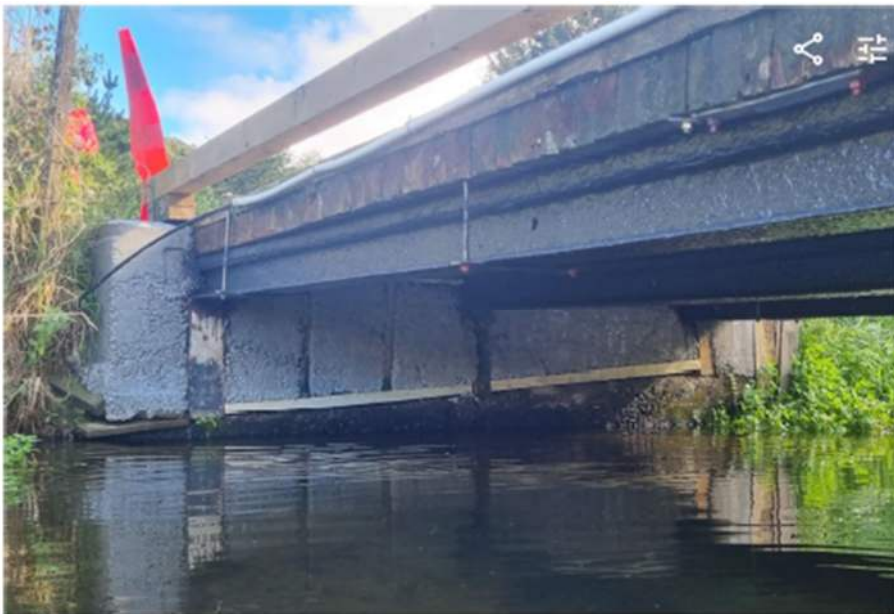
- 2.7. The repair work on the true left abutment involved the removal of a significant portion of the original abutment. According to the owners, approximately two thirds of the of the true left abutment was replaced. Piles were installed,⁴ rebar reinforcing and rods were wired to the piles and beams, and 7.5 cubic metres of concrete was poured to form the new abutment (see Figure 2).

Figure 2: Photo of the bridge and true left abutment following repair.

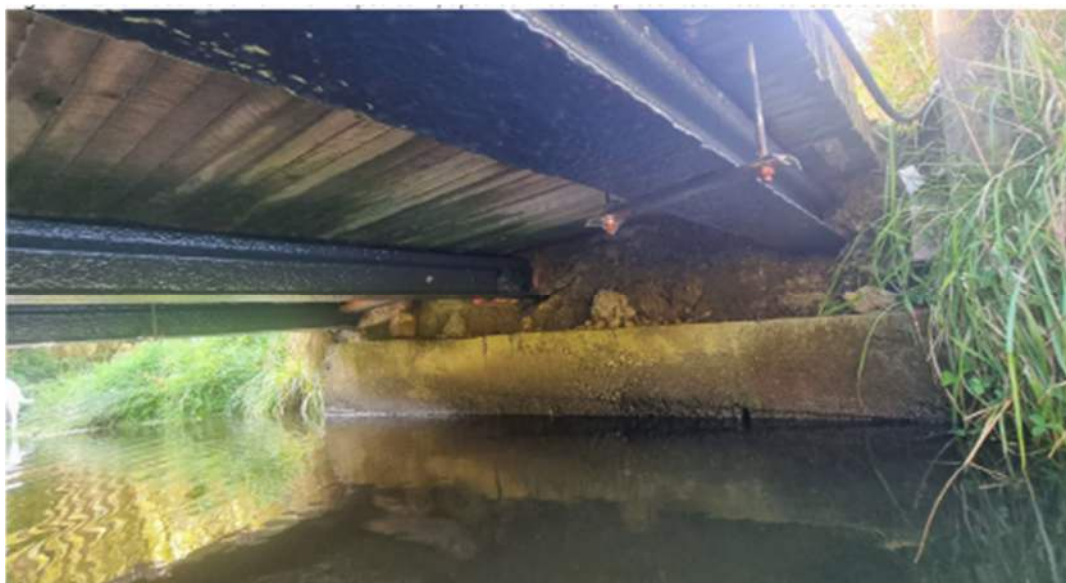
- 2.8. On the true right abutment, a fissure between the abutment and the deck was repaired. There is a crack in the abutment (see Figure 3), and the owners' engineer

states this removes support for the central rail beam.⁵ The neighbours consider it is superficial, and that the central beam remains fully supported along the majority of the 600mm which they believe the beam projects into the abutment.⁶

Figure 3: Photo of the bridge and true right abutment. The treated rail beams, and stainless-steel rods and plates tying down the deck, are also shown.

- 2.12. At a later point (prior to 11 April 2025), the neighbours treated the rail beams with a corrosion protection system (see Figure 3).⁸ However, the owners state the steel

has continued to corrode, noting that on 6 April 2026, a piece of pack rust peeled off the middle beam which measured approximately 150 x 100 x 6-7mm thick.⁹
