# Determination 2026/038

## An authority's decision to issue a notice to fix for building work to an apartment deck

### Unit 506, 28 College Hill, Freemans Bay, Auckland

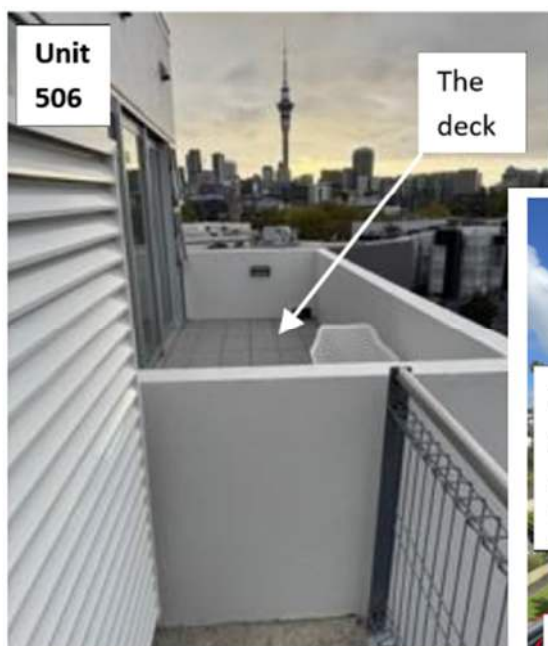
**Figure 1: view of deck looking east  
(prior to the building work)**

- 2.1. The property is a Unit (number 506) on level five of a multi-storey apartment complex, with a deck on the southern side (refer to figure 1). This deck also serves as the roof to part of the Unit below (number 409). The common property is owned and managed by the Body Corporate.

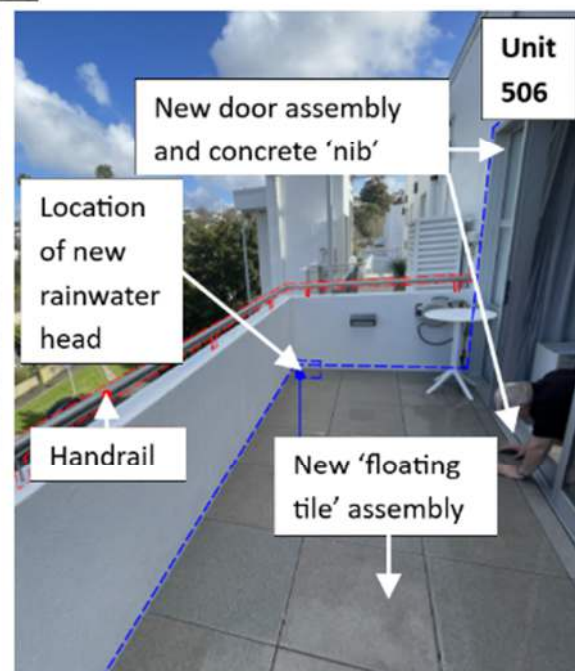
**Figure 2: view of deck looking west  
(after the building work)**

- 2.3. In April / May 2025 building work was carried to the owners’ deck, door threshold, rainwater head and downpipe (refer to figure 2).
- 2.4. On 11 June 2025 the authority conducted a site inspection.
