## Practice Advisory 13: Egress stairs — earthquake checks needed for some

This Practice Advisory was issued in response to concerns about stair collapses in Christchurch CBD in the 22 February 2011 Aftershock and provides guidance on the assessment of stairs in existing multi-storey buildings.

Published on 30 September 2011

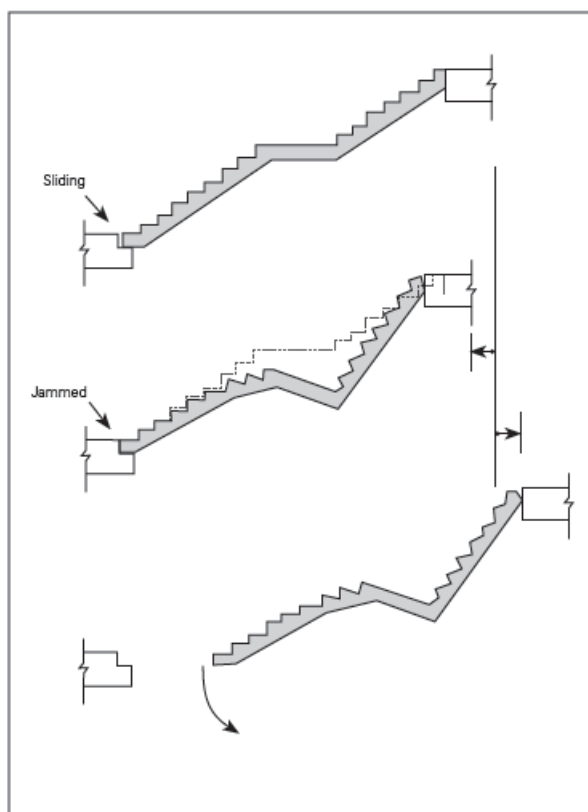
- Calculate the inter-storey drifts as per Item 2 above.
- Check if the movement causes the sliding end of the stair to impact against the support (wall, beam or landing) - see Figure 1.

Figure 1: Inter-storey drift along the stair compresses the stair shortening it.

When earthquake reverses, the stair can now fall off the supporting ledge. [2].

- If the lateral movement of the stair closes the gap, causing impact on the support/landing:
  - Look to increase the gap.
  - Check implications of bracing action as the stair struts between floors, if gap should close:

- Using the inter-storey drifts from Item 2 above, construction tolerances, residual width of seating, spalling of the concrete ends of the stairs or the edges of the supporting ledge and other factors, determine what should be the width of the seating (contact area) between the sliding end of the stair and the support. If the available width of support is inadequate, install catch-frames or similar safety devices or engineer extensions of the ledge to ensure adequate width of support for the end of the stair.
