Slope stability

QUICK GUIDE

North Island severe weather events 2023 remediation and repair

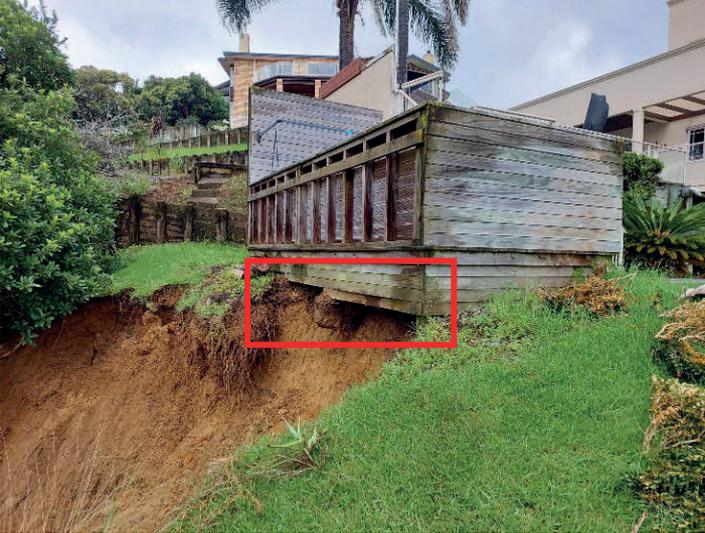
The landslide has exposed the concrete foundations. The supporting soil around and below the foundation has been lost. The loss of support is evidenced with sagging visible of the decking.

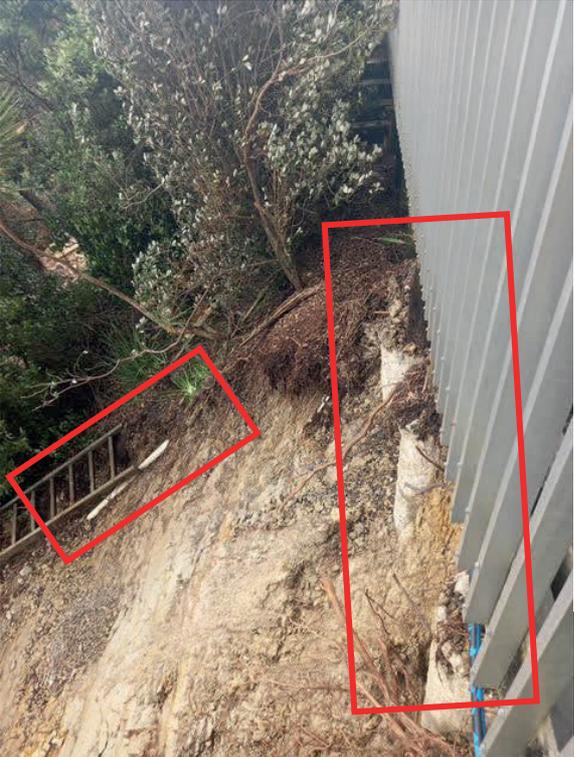
A shallow slip has exposed the foundations, as well as the once buried underground services. The soil around the front piles has been lost or reduced. The capacity of the deck to resist horizontal force may be compromised

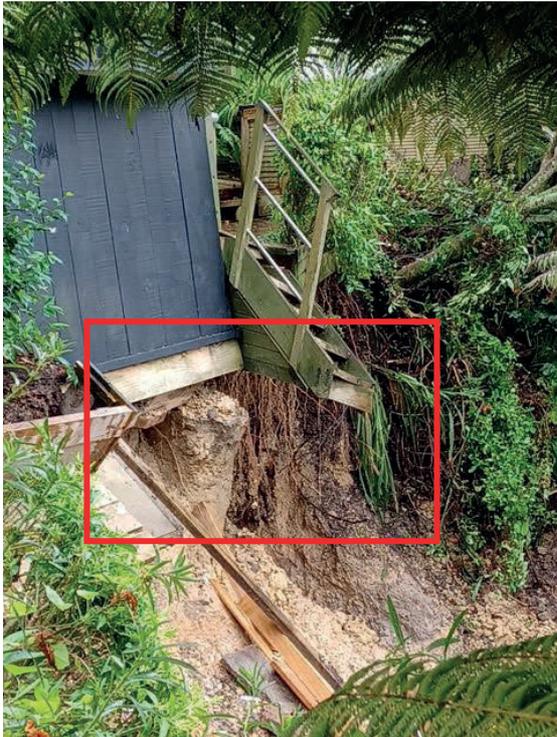
A slip has occurred. The foundations have been exposed and rotated which has compromised the building's structural integrity.

The red square highlights tilting of the foundation piles and nearby garden retaining wall, suggesting further movement may be imminent.

The tilted vegetation shows the direction of the slip.

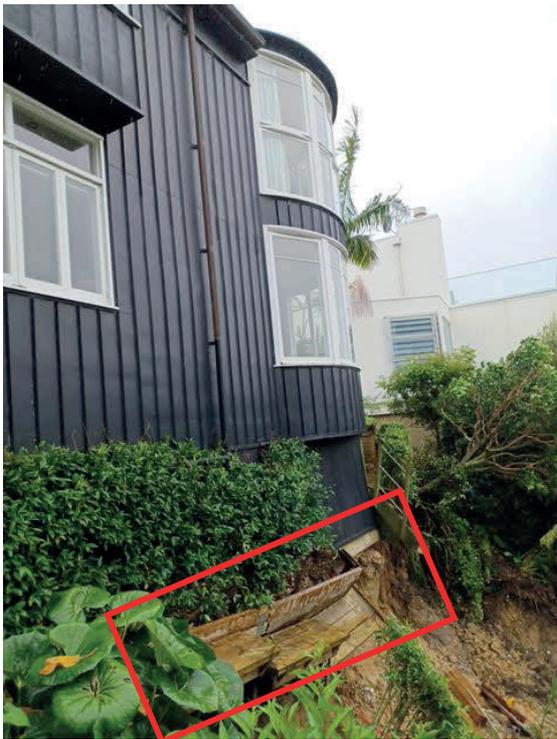
Photograph shows an alternative view to the photograph above, and better illustrates the extent of damage and the surrounding environment.

The timber retaining wall has broken, and no longer provides support to the building foundations. The damage to the retaining wall highlights the significant force and displacement taking place.

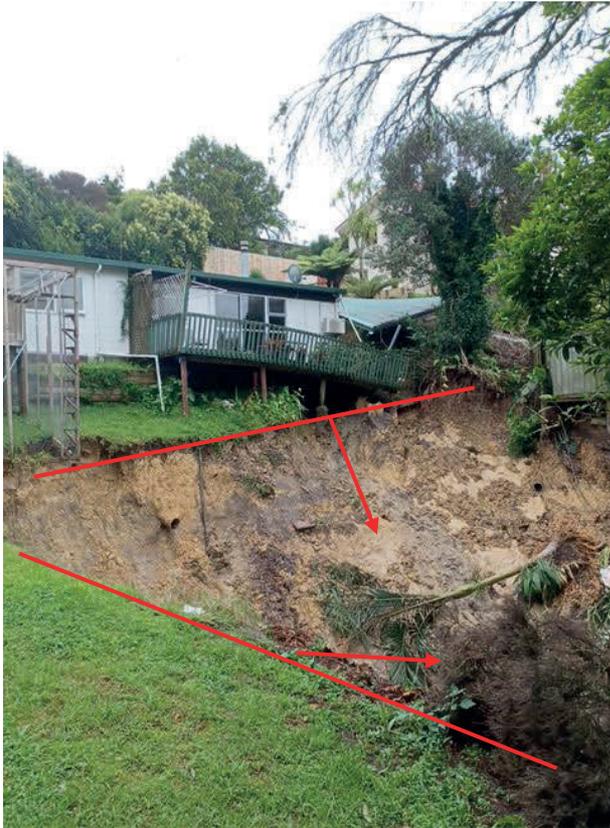
A landslide has occurred below a building and a carport. This photo shows an evacuation of soil, and damage to the buildings, including loss of vertical and lateral support to the corner deck piles. The carport structure has visibly slumped. Lateral support to the foundations needs to be considered.

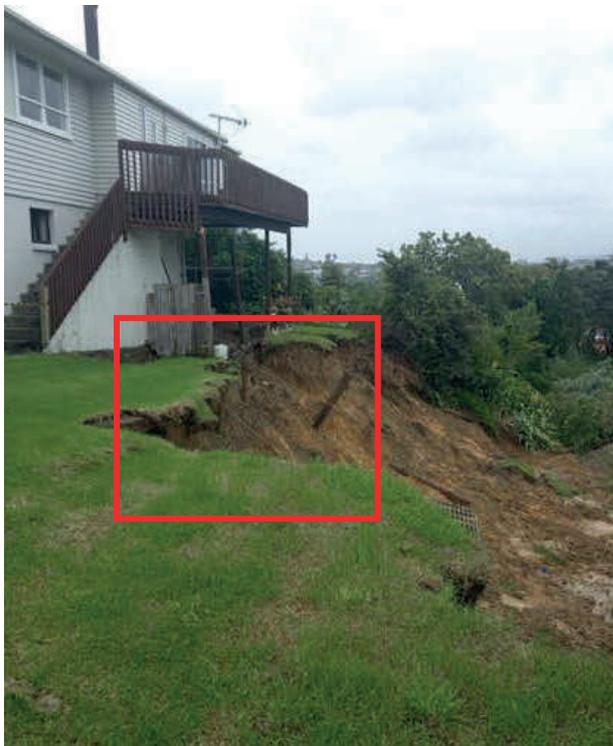
The photo shows the upper times decking has disconnected due to the land slip. Other piles also show signs of movement to varying degrees.

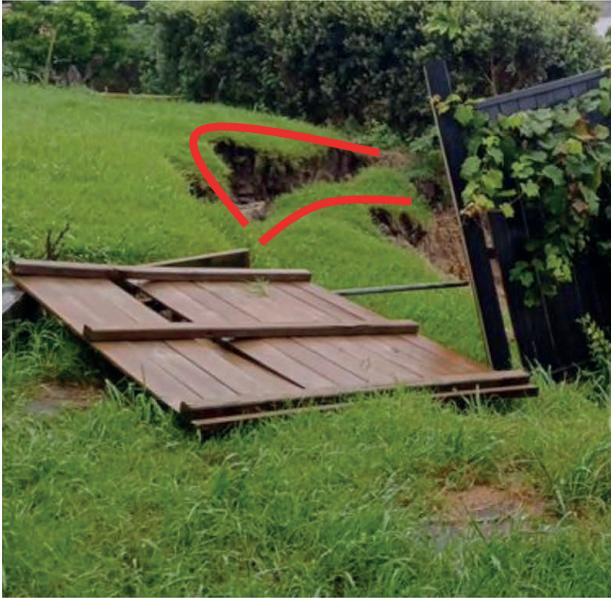
The photo shows the formation of a head scarp* and land slicing, indicating a slumping slope failure with potential for further slips. The base of the failure may show bulging of the land. The damage also reveals tilting and displacement of the fence.

*Main scarp / head scarp refers to a steep surface on the undisturbed ground around the periphery of the slide, caused by the movement of slide material away from undisturbed ground. The projection of the scarp surface under the displaced material becomes the surface of the rupture.

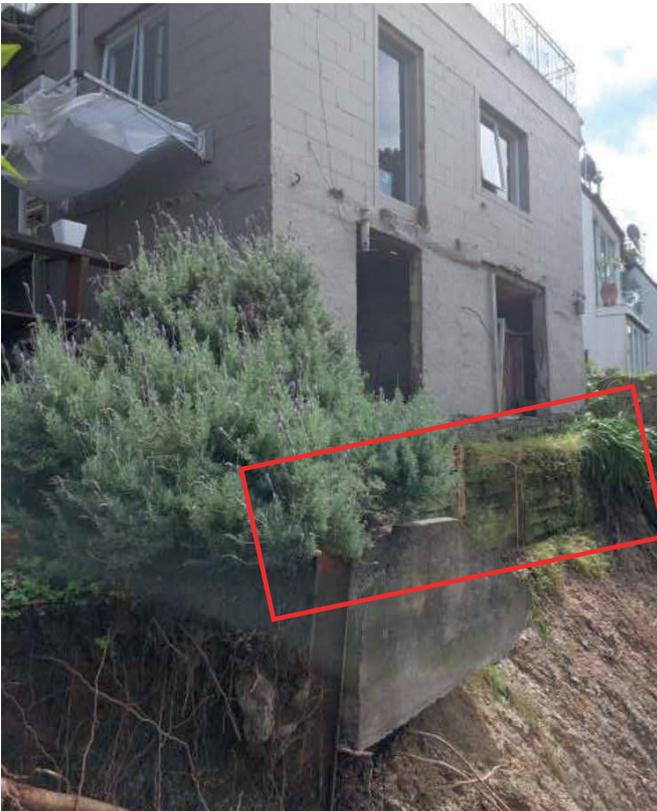
The photo shows a landslip below a building. Horizontal support to the retaining wall immediately below the building has been compromised. The foundation of the concrete wall has lost support and further failure is likely to occur soon.

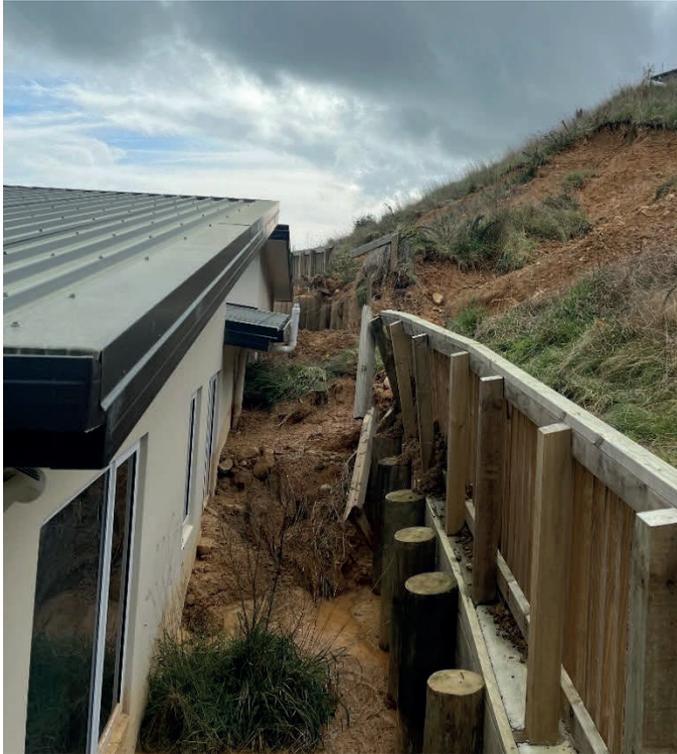
Slope debris has partially buried the building. The debris has loaded the external wall of the house.

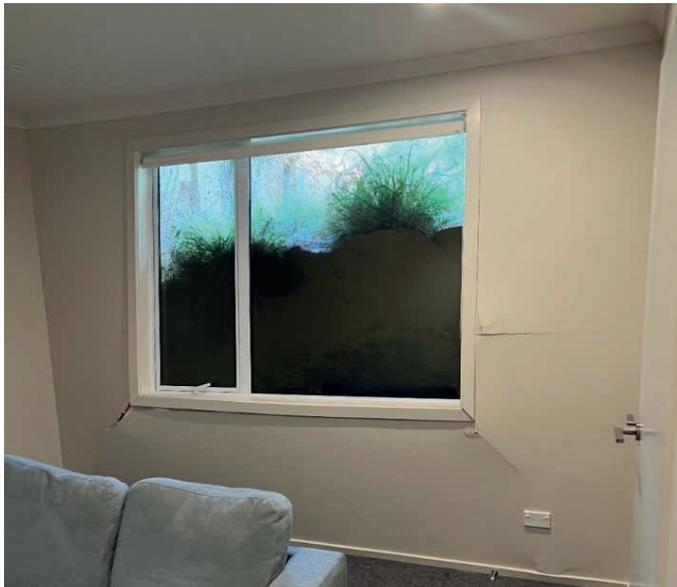
The strength of the external wall of the building has been significantly exceeded and has bulged inward. Internal linings have cracked and the horizontal strength of the building has been compromised.

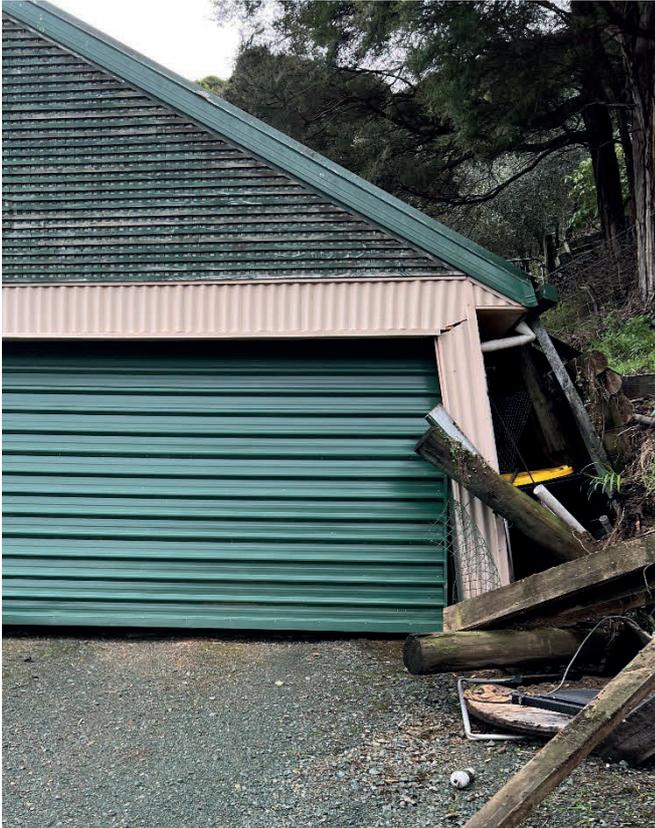
The building has been affected by failure of an adjacent retaining wall. The rotation indicates that the lateral strength of the building has been significantly exceeded.

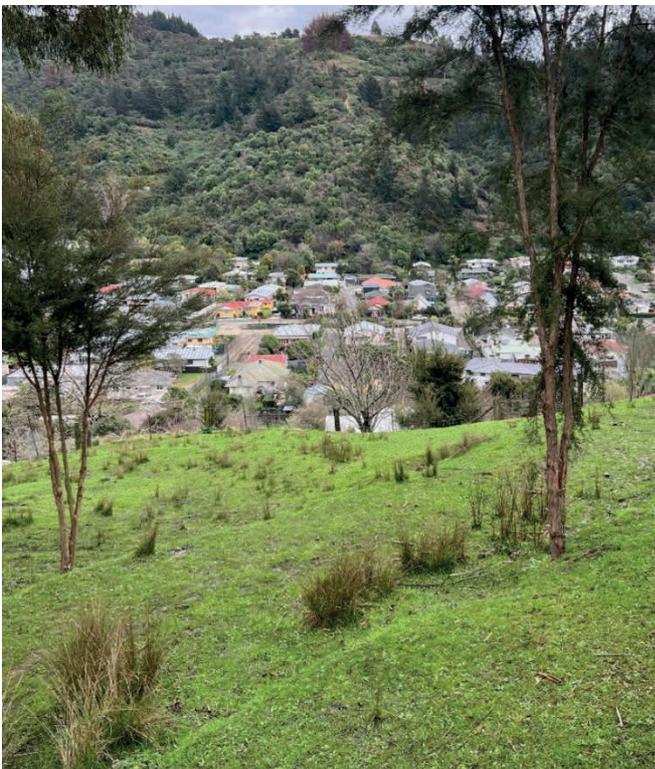
The photo shows a rippled or tiered surface, which suggests possible surface creep and the possibility of further movement. Buildings above and below this area of instability may be affected by this creep movement and should be inspected by a suitably experienced professional for damage.

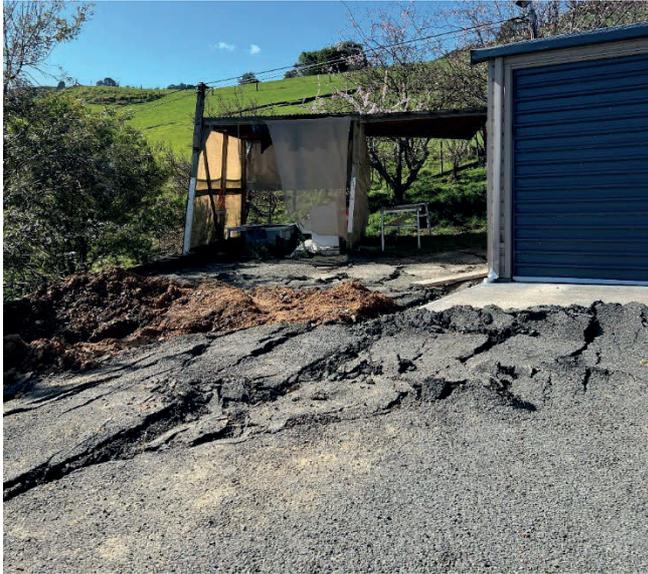
The photo shows a buckle in the asphalt surface at the bottom of a hill, indicating the potential for a slumping failure along the slope and the possibility of more slips in the future.

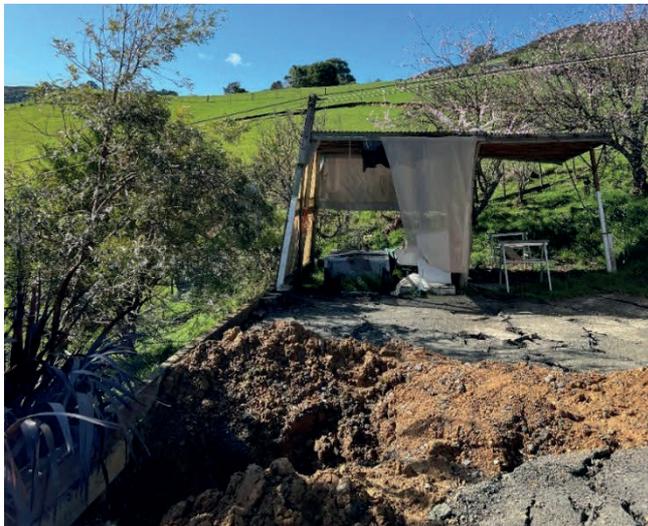
The photo provides a different view of a head scarp forming above the property. Combined with the buckling of surface asphalt seen in a previous photo, this suggests the instability may extend across the building platform.

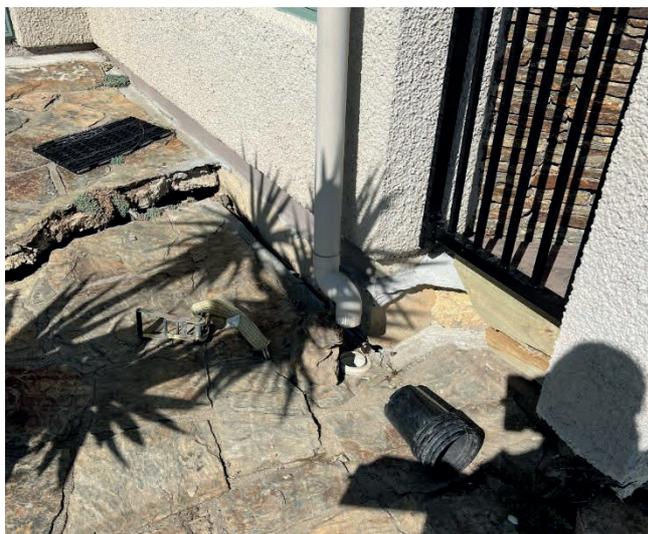
The photo shows a formed crack and an offset in the storm drainpipe. This indicates ground movement which may affect the building foundations and could be worsened by concentrated stormwater discharge into the displaced ground. Further movement may occur.
