Post-implementation review of the Hurunui/Kaikōura Earthquakes Recovery (Unreinforced Masonry Buildings) Order 2017 and Securing Fund

INDEPENDENT REVIEW REPORT

SEPTEMBER 2020

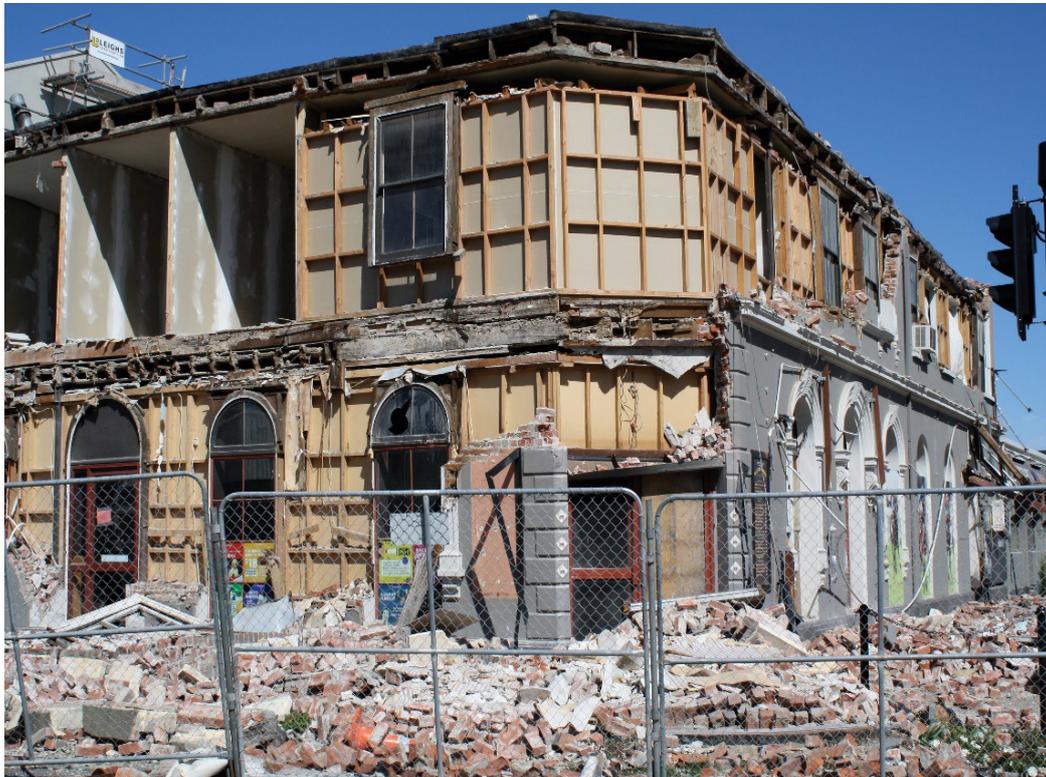
Figure 2: Collapse of the facade of a two-storey building in Christchurch, February 2011.

Falling debris from unreinforced masonry buildings caused the death of 39 of those 185 victims. A further 110 people were injured by falling masonry. Figure 2 shows the footpath covered in fallen masonry from the parapet and facade of a two-storey city building.

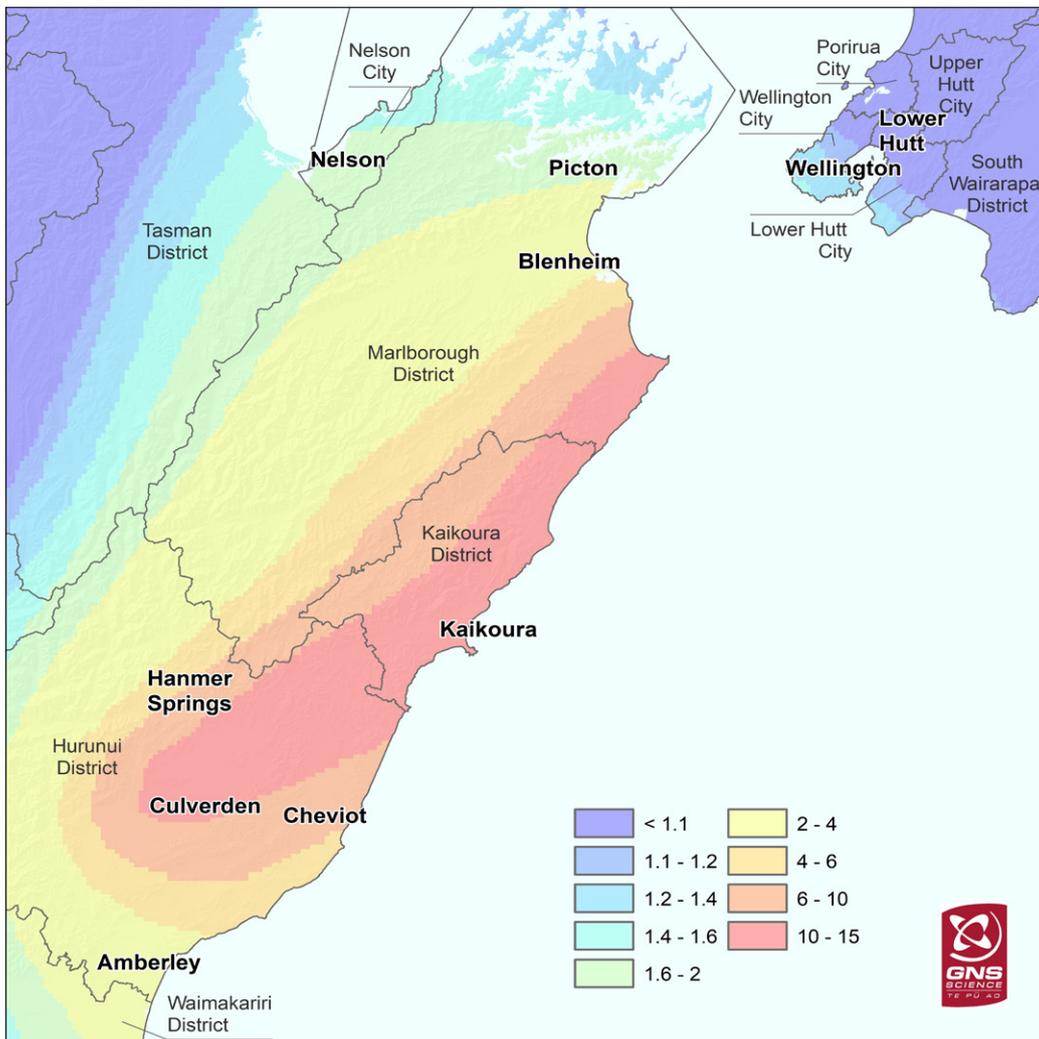
Figure 3: Relative probability of significant aftershocks in the upper east of the South Island to Lower Hutt City in the North Island for the period 5 September to 5 December 2017

The probability of a significant earthquake was two to four times the base rate (yellow) in the South Island towns of Amberley and Blenheim. The probability remained somewhat elevated (1.2-1.4 times base rate coloured blue and lavender) in the North Island city of Wellington, with Lower Hutt City (branded as Hutt City) pretty much back to its normal seismic risk level (violet). The red area centred on Kaikōura still had 10-15 times higher probability of an earthquake than would be the case before the Kaikōura earthquake.

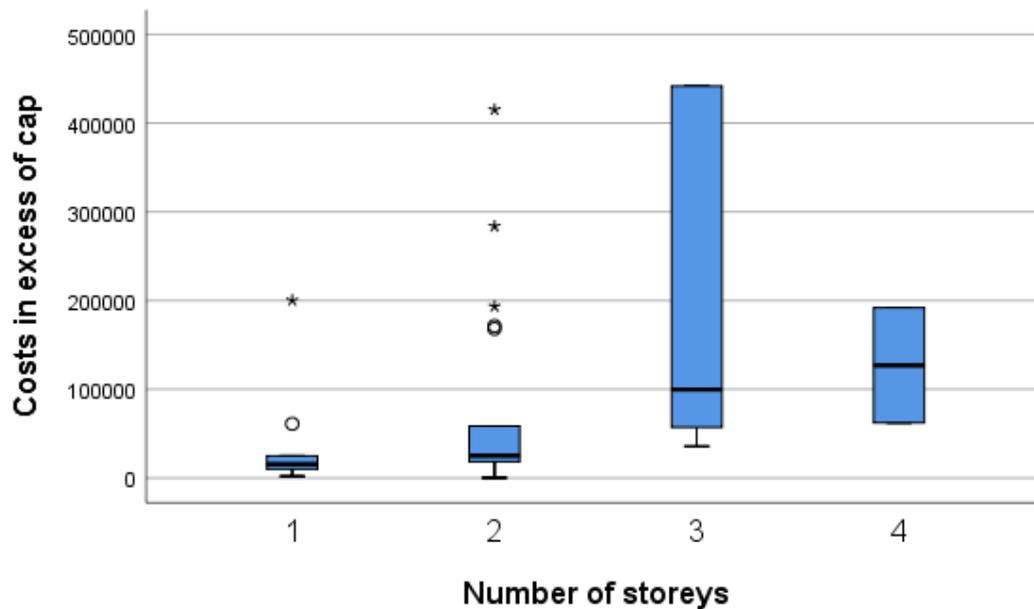
Figure 5: Distribution of costs for buildings that exceeded the capped amounts

Predictably, the cost per linear metre of securing was the lowest for one-storey buildings and where street frontages were shorter.

Detailed analysis of the cost of securing buildings in Wellington identified the average cost per linear metre of buildings found that the cost ranged from \$3,941 for one-storey buildings to \$6,839 for four-storey buildings. Costs ranged from \$3,104 for one-, to \$4,373 for two-storey buildings in Hutt City.

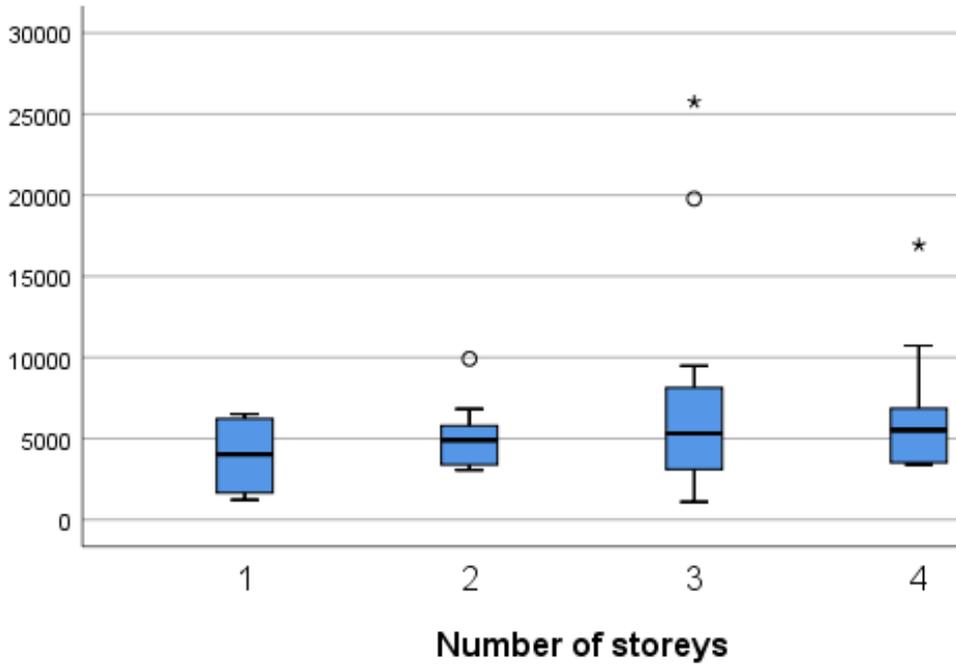
Figure 6: Total remedial cost per linear metre (engineering assessment and design) in Wellington City

For Wellington, the variation in remedial cost per linear meter for engineering assessment and design is shown in the box and whisker plots in Figure 5, and a key for interpreting box and whisker plots is shown in Figure 6.³⁶
