Determination 2015/052

Regarding the compliance of proposed building work at 70B Grand Vue Road, Kawaha Point, Rotorua, in respect of adjacent other property

Summary

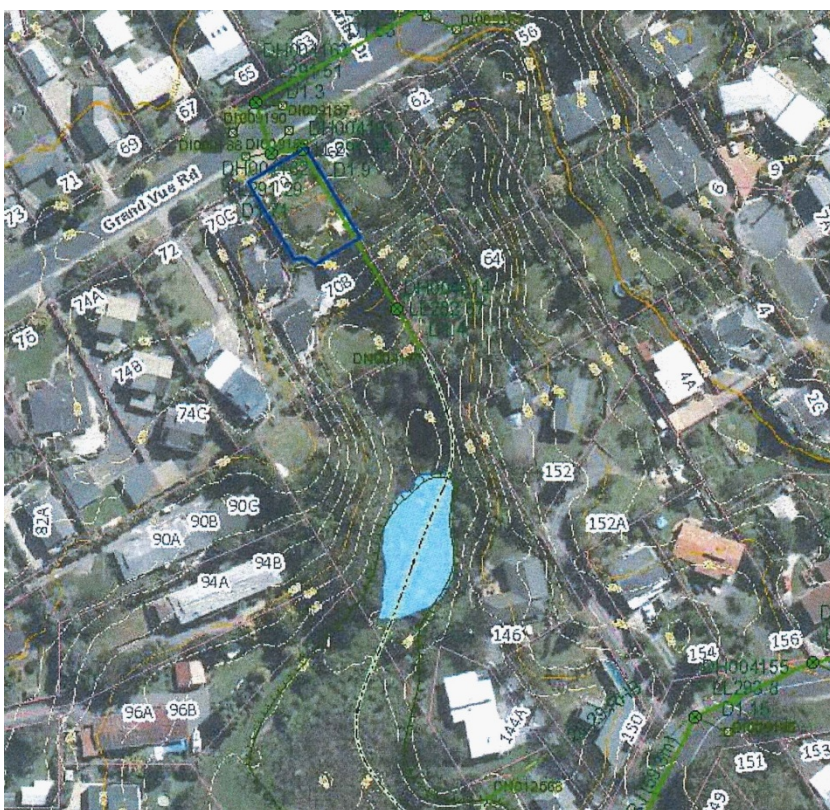
Figure 1: Sites and contours (from Rotorua District Council Geyserview)

2.3.1 The applicant's property lies to the east and southeast of the subject site:

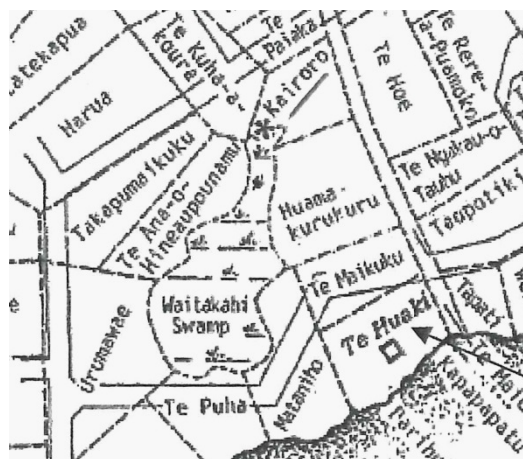
Figure 2: from *The founding years in Rotorua: A History of Eve, Stafford, D.M.*

2.3.2 The applicant provided excerpts from a publication that describes Kawaha's Māori Landmarks⁵. Figure 2 in that publication (reproduced in part adjacent) indicates the location of the Waitakahi Swamp and a fresh cold water spring known variously as the Kairoro Spring or Kahuroro spring:
