Determination 2017/075

Regarding the code-compliance of decks to a house at 9 Adamson Road, Taipa

This determination considers the compliance of a deck to wall junction with minimal or no gap. The determination discusses the weathertightness risk and whether the cladding is likely to be subject to solar-driven moisture from the deck, and the variation from the building consent.

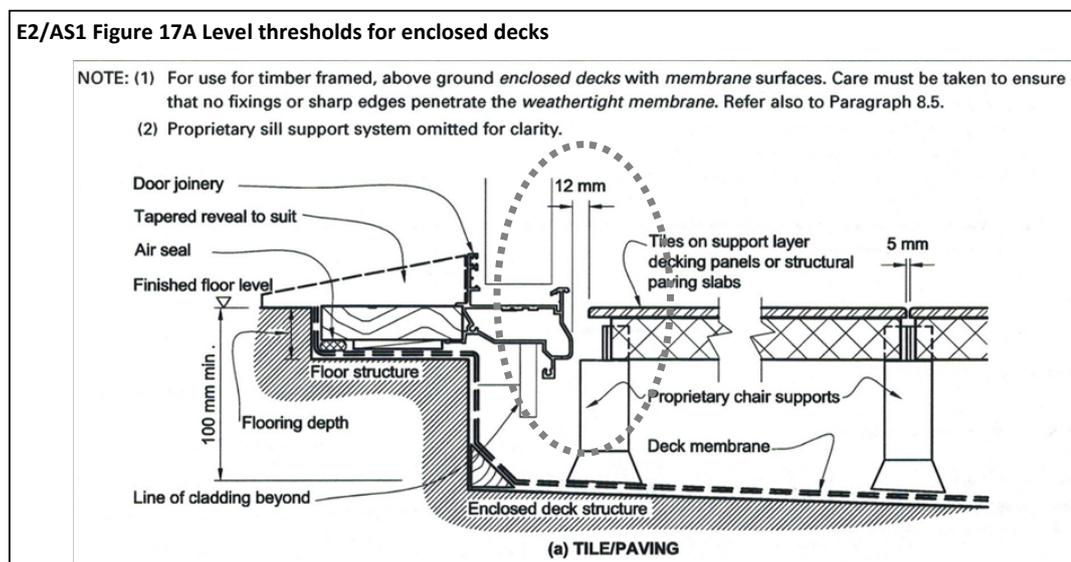
Figure 3: The relevant threshold detail from E2/AS1

Raised removable surfaces of tiles, pavers or timber shall be provided over the underlying weathertight enclosed deck surface for cleaning and maintenance, as shown in Figure 17A. A minimum gap of 12 mm shall be provided [emphasis added] against the wall or balustrade cladding.
