Determination 2010/030

The issue of a code compliance certificate for two relocated buildings at 91 Whangapoua Road, Coromandel

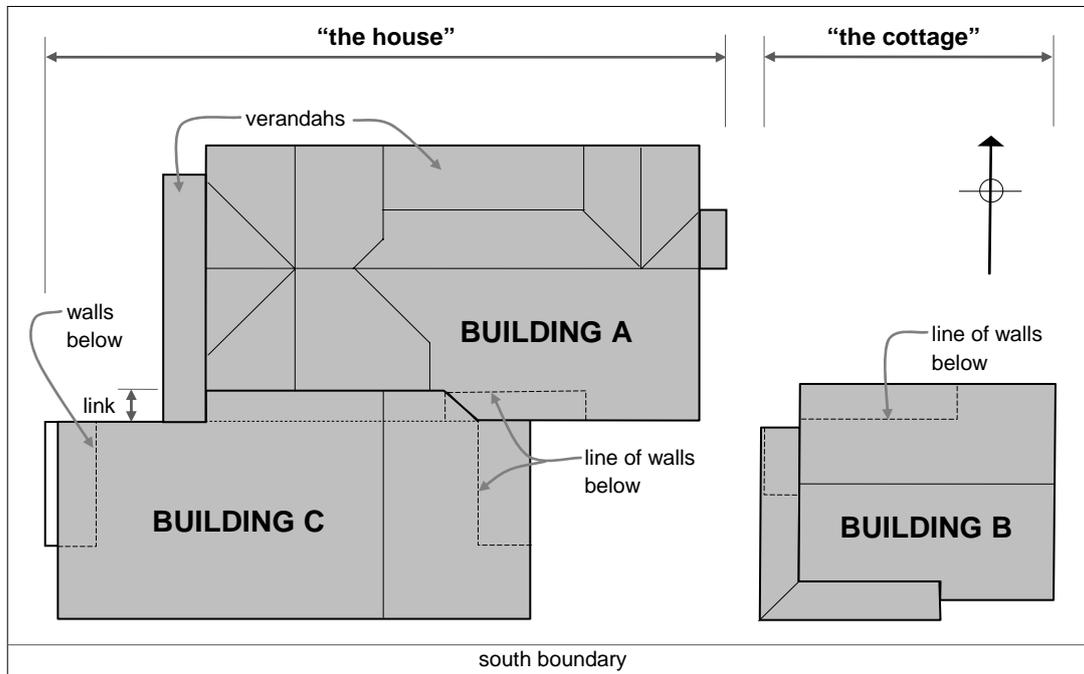
- 2.1 The building work consists of a large house and detached cottage, situated on a flat rural site that the expert considers to be in a medium wind zone in terms of NZS 3604³.
- 2.2 Construction is generally conventional light-timber framed; and is based on the use of three relocated buildings, hereafter described as “the house” and “the cottage” as shown in the following sketch:
