## Determination 2011/095

### Regarding the code-compliance of a channel drain around the foundation of a house and garage at 533 Waitoki Road, Wainui, Auckland

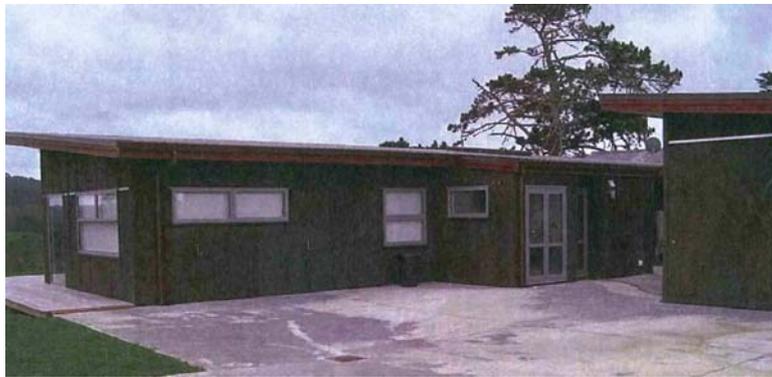
- 5.3 The expert further noted that the top of the concrete paving is generally around 70-100mm below the floor slab and noted that the plywood cladding extends 60-70mm below the cavity closure. The bottom of the channel drain was 120-140mm below the bottom edge of the plywood cladding.

- 5.4 The expert noted that the plywood cladding terminates ‘very close to the [grate of the channel drain] in places’ which raised the possibility of water hitting and bouncing up off the grill and hitting the bottom edge of the plywood cladding. The expert observed, in at least one instance, that the bottom edge of the plywood was not protected by a coating system. The expert was of the opinion that if the edge was not protected ‘water may soak into the plywood in sufficient quantities to cause premature deterioration of the cladding’, and that the effect of water ingress on the bottom plate should also be considered.

- 7.1 The authority should issue a notice to fix that requires the owner to bring the channel drain into compliance with the Building Code, identifying the item listed in paragraph 6.5.1. The notice to fix should not specify how those defects are to be fixed. The applicants should then produce a response to this in the form of a detailed proposal. Any outstanding items of disagreement can then be referred to the Chief Executive for a further binding determination.
- 7.2 Once the matters set out in paragraph 7.1 have been rectified to its satisfaction, the authority should grant the amendment to the building consent, and following that, the code compliance certificate in respect of the building consent as amended.
