Determination 2013/060

Regarding the refusal to issue a code compliance certificate for a 10-year-old house with a concrete tile roof at 209 Jowers Road, West Melton

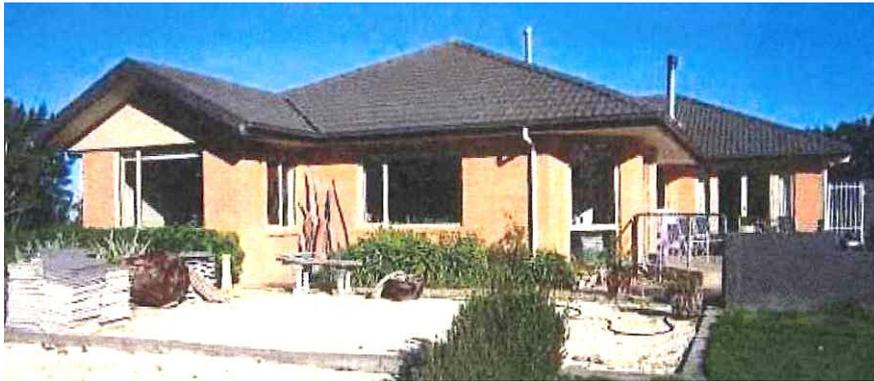
- 2.2 Construction is generally conventional light timber frame, with concrete foundations and floor slab, brick veneer wall cladding with textured fibre-cement to three gable ends, concrete tile roofing and aluminium windows. The relevant section of the roof plan is shown in Figure 1 above.
