Determination 2017/087¹

The refusal to issue a code compliance certificate for a 19-year-old house with EIFS wall cladding at 184 Adams Road, RD1, West Melton

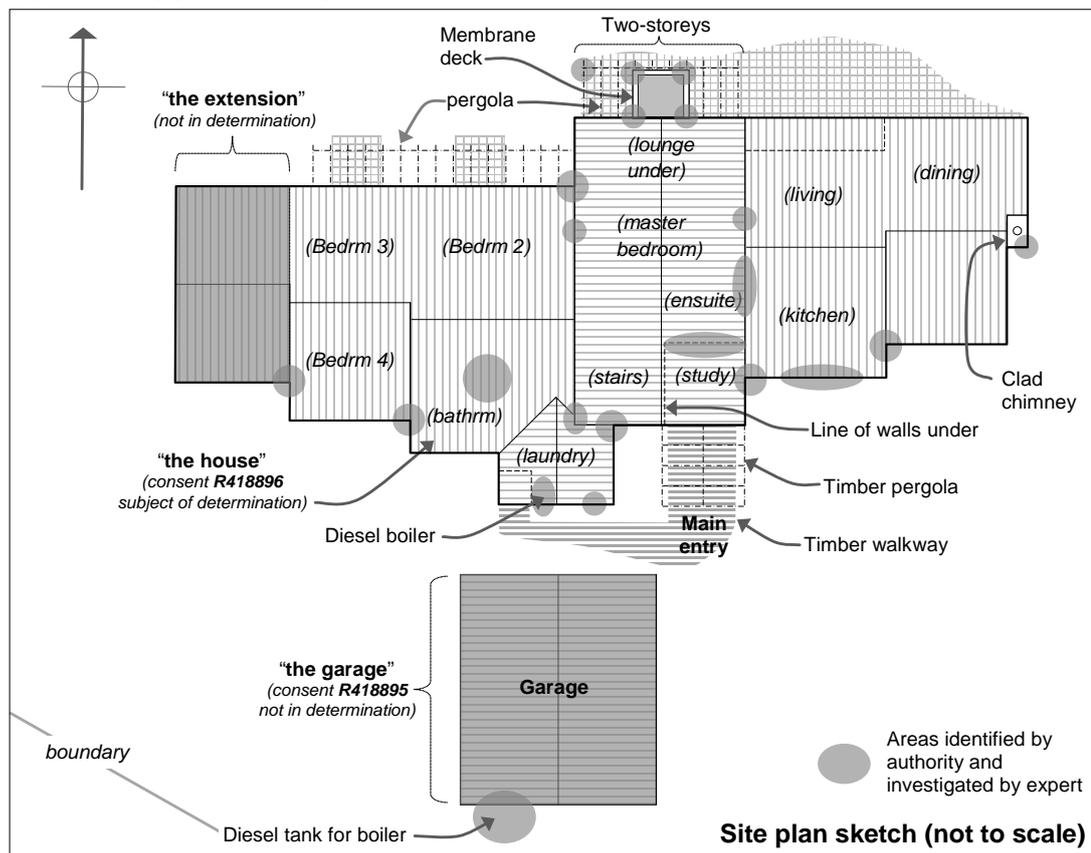
Figure 1: Approximate plan

5.4.1 The expert inspected the external building envelope of the house, taking into account the age of the building work and the risks applying to particular junctions and intersections (refer to Figure 1 for locations of significant observations).

6.4.1 The 460 litre fuel tank is located behind the detached garage (see Figure 1). The expert assessed the location of the tank against the requirements of AS 1691 Section 3. Oil Fuel Tanks¹³. Minimum separation distances required from adjacent construction are shown in Figure 2:
