Determination 2018/019

The code-compliance of the base of a wall to a large shed containing a dwelling at 122E Forestry Road, Waitoki, Auckland

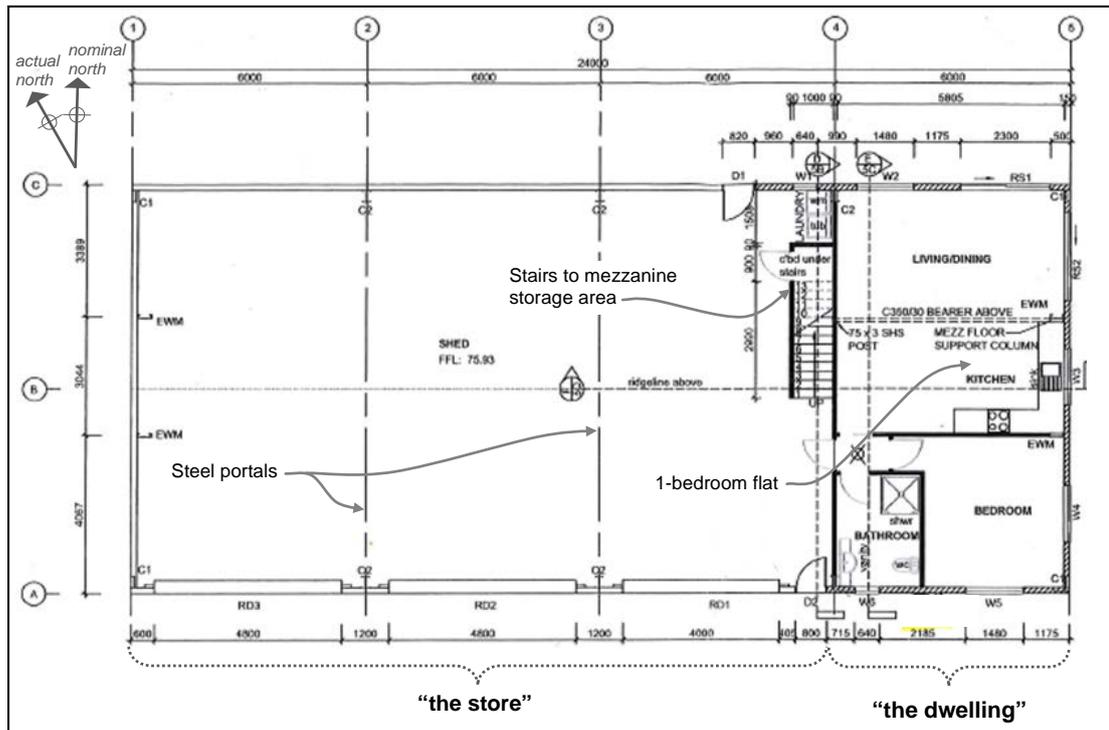
Figure 2: Floor plan of the shed as consented (not to scale)

- a 189m² store at the western end from Grid 1 to 4, with three 4.4m high industrial roller doors in the south wall (“the store”)
- a 63m² one-bedroom flat at the east lower level from Grid 4 to 5 (“the dwelling”)
- enclosed storage and a second bathroom on a mezzanine level above (“the mezzanine store”).

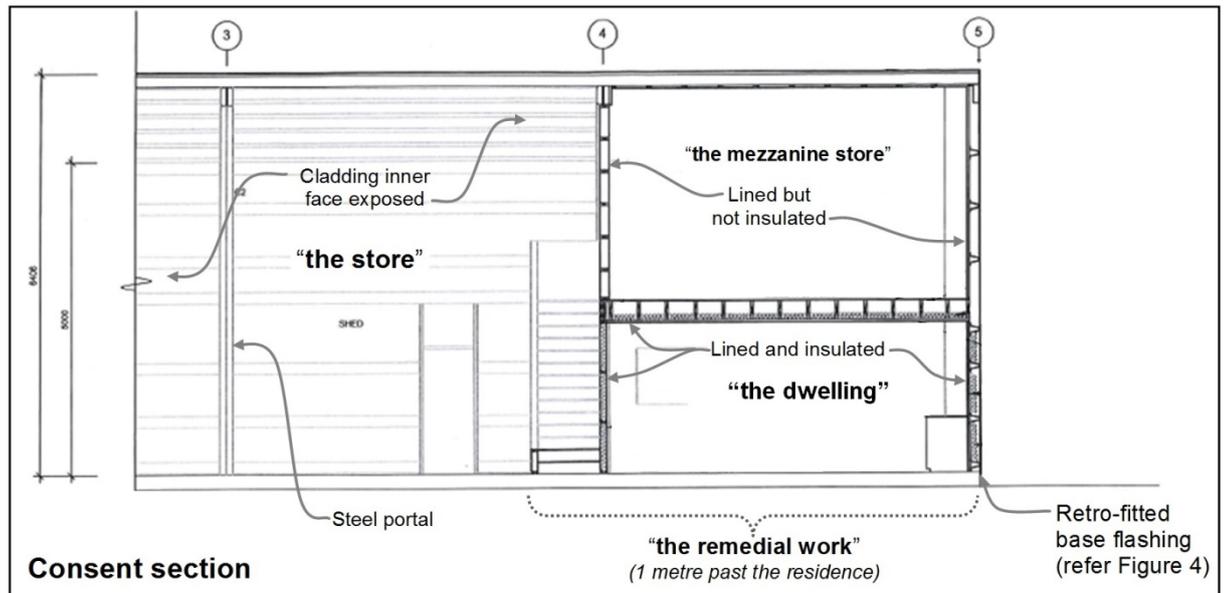
Figure 3: East/west section of the eastern end of the shed (not to scale)

- 2.1.5 All internal walls are timber-framed, and timber strapping is fixed to the external walls to the dwelling and mezzanine store to receive internal linings. All walls to the dwelling are lined and insulated, including the ceiling; the mezzanine store is lined but not insulated (refer Figure 3). Short sections of wall in the store between the dwelling and the two adjacent personnel doors on the North and South elevations are lined. The remainder of the building is unlined.

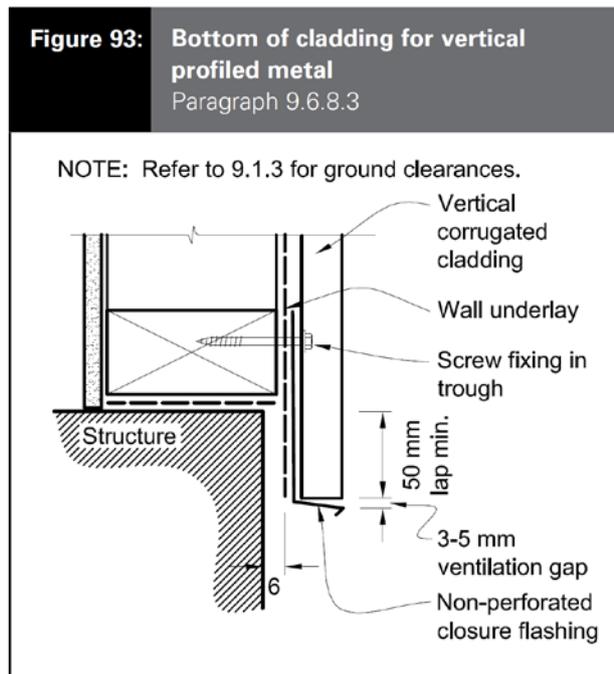
A.4 Figure 93 from the Acceptable Solution for Clause E2, E2/AS1:

4.2.3 I consider the detail referred to by the parties contained in E2/AS1 (Figure 93) has a limited application to this situation (refer Appendix A.4). Figure 93 only addresses the likelihood of capillary action drawing water up between the concrete slab and the rear of the cladding to the bottom plate. The bottom plate and closure flashing in Figure 93 is, in effect, providing a sealed air path above the top of the slab.
