Determination 2018/034

The refusal of a code compliance certificate for an addition at 42 Harley Close, Hauraki, Auckland

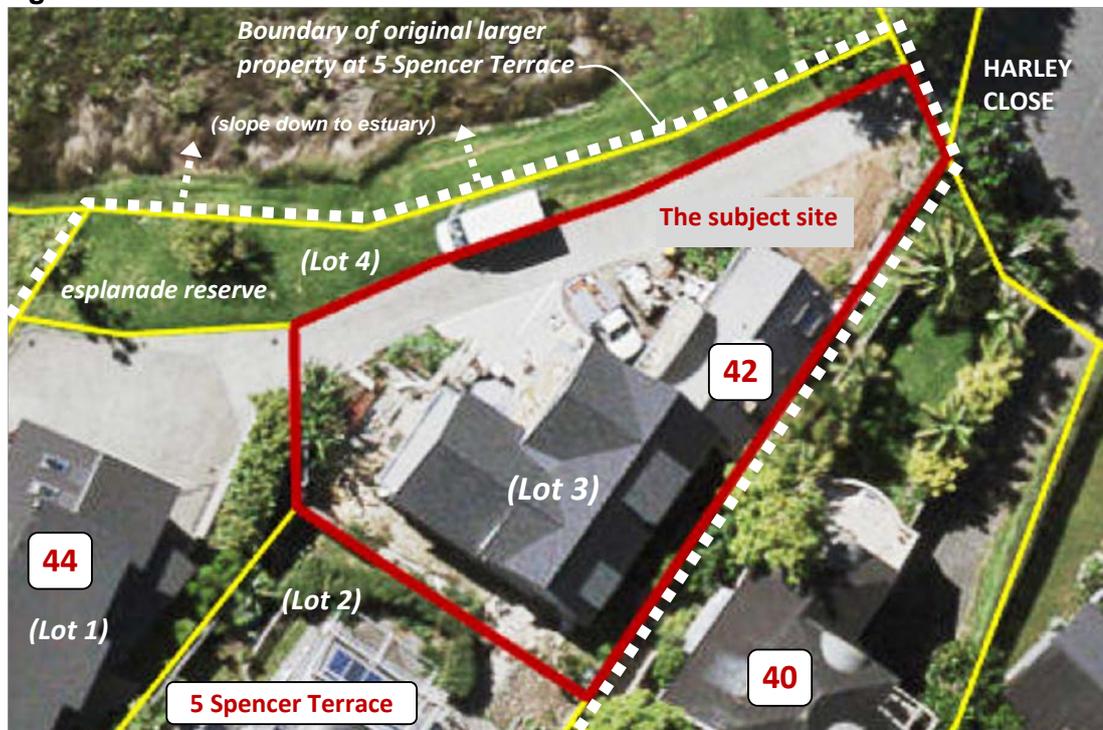
Figure 2: The subdivision

- 2.1 The building is situated on a triangular-shaped site in a medium wind zone⁴ for the purposes of NZS 3604⁵. The site slopes down towards the adjacent estuary to the northwest, with Harley Close to the northeast as shown in Figure 2:

2.2.2 In 2009 the property was subdivided into four lots as shown in Figure 2 and new certificates of title were issued on 18 March 2010. The applicant purchased the studio building on 31 March 2010, and then prepared a proposal for the house addition which received resource consent in April 2014.
