## Determination 2019/013

# Regarding the refusal to issue a code compliance certificate for the relocation of and 18-year-old alterations to a house at 9 High Street, Waddington

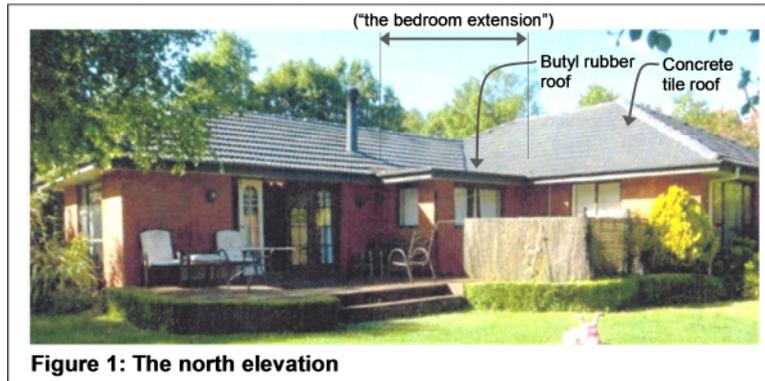
Figure 1: The north elevation

1.5.2 As the authority has limited its concerns to the matter outlined in paragraph 2.6.1 and 2.6.2, this determination is limited to the membrane roof constructed as part of building work carried out under Building Consent (No. BC990766) dated 8 November 1999. I have not considered other elements of the alterations or the original house which are remote from the bedroom extension roof as shown in Figure 1.
