Determination 2020/002

Regarding the consented alterations to the walls and roof of a house and its compliance with Building Code Clause B1 at 25 Sturrocks Road, Redwood, Christchurch

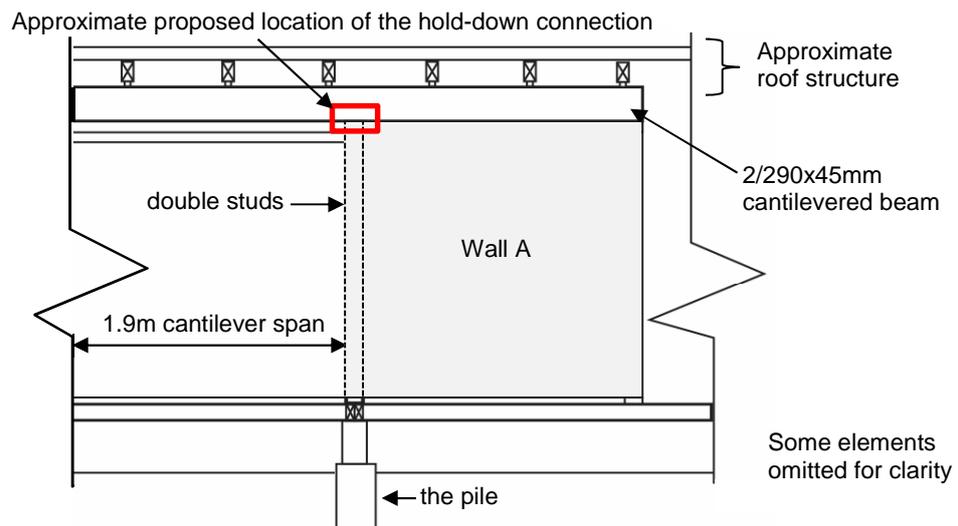
Figure 3: Sketch of section A of the as-built construction (not to scale)

- The two cantilevered beams are not nailed together in a manner that satisfies the requirements of NZS 3604²⁰.
- The hold down connection at the south end of the cantilevered beam is adequate. However, the hold down connection at the midpoint of the cantilevered beam (refer Figure 3) cannot be confirmed as compliant. It is not clear whether the connection continues through the timber blocking into the wall framing below, which is necessary to resist uplift loads.
- After measuring the ceiling slope the second experts calculated the theoretical deflection of the cantilevered beam to be 2.7mm. NZS 1170.0²¹ suggests an appropriate deflection limit for a cantilevered beam as 7.6mm, so the calculated deflection is within the suggested limits.

- The calculations provided by the engineer have identified that a hold-down connection is not required to the cantilever beam as there is no net uplift at the base of the beam where it is supported by Wall A (refer Figure 3 – proposed location of hold-down connection) . I agree with this view reached by the engineer and second experts, and consider in this aspect the cantilevered beam complies with Clause B1.
