## Determination 2020/007

### Regarding the compliance of sub-floor fixings to the foundations of a house at 43B Armagh Terrace, Marton

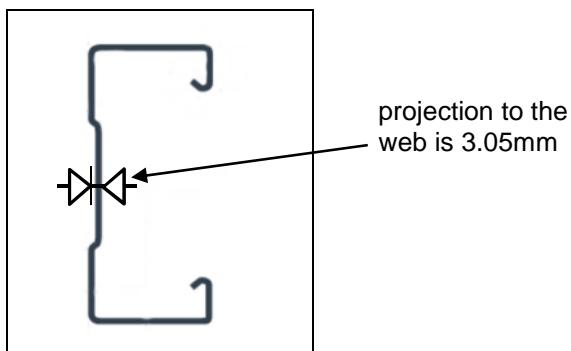
**Figure 1: Profile of the consented bearers**

- 2.1 The building consent for the house was issued on 22 August 2018; the consent was in respect of building work described in a national multiple-use approval<sup>6</sup>.
- 2.2 The house has a simple rectangular floor plan, with floors, walls, and roof formed using 150mm thick structurally insulated panels (“SIPs”) which consist of colour-coated metal bonded to both faces of an expanded polystyrene foam (“EPS”) core. The roof is a 15° pitch gable roof.
- 2.3 The floors are supported on H5<sup>7</sup> treated timber piles and the installed bearers, which are formed from continuously rolled high-tensile galvanised steel.
- 2.4 The consented bearers were continuously rolled high-tensile galvanised steel bearers, which are 150mm high, 65mm wide and have a base metal thickness (BMT) of 1.45mm. The profile of the consented bearers is shown in Figure 1.

- 2.8 The inwards projection of the installed section is 6.55mm, compared to 3.05mm for the section described in the building consent.
