Determination 2022/019

Regarding the authority's refusal to issue a code compliance certificate for the stucco monolithic plaster cladding on an extension to an existing dwelling

468A Wright Road, Aongatete, Katikati, Bay of Plenty

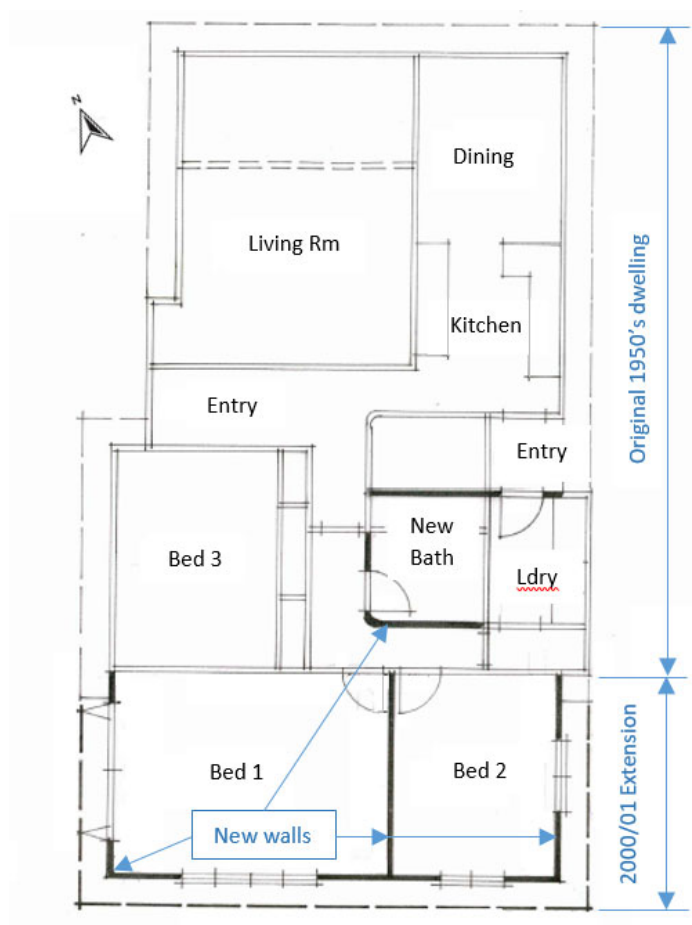
Figure 2: Floor plan (not to scale).

- 2.1. The original dwelling is a single storey timber framed building with an external stucco monolithic plaster cladding (see figure 1).
- 2.2. The building work in this case relates to the construction of an 8.5m wide x 4m long extension to the south end of the existing dwelling (see figure 2). The building work consists of constructing timber piles, subfloor framing, and light timber wall framing, with particleboard flooring, and solid monolithic stucco cladding directly fixed over the external wall framing. Timber-framed windows have been installed, and the roof eaves are approximately 600mm wide.
- 2.3. The building consent plans stated the external cladding was to be “solid plaster on mesh on 10mm [thick proprietary cement boarding] to match existing stucco”.

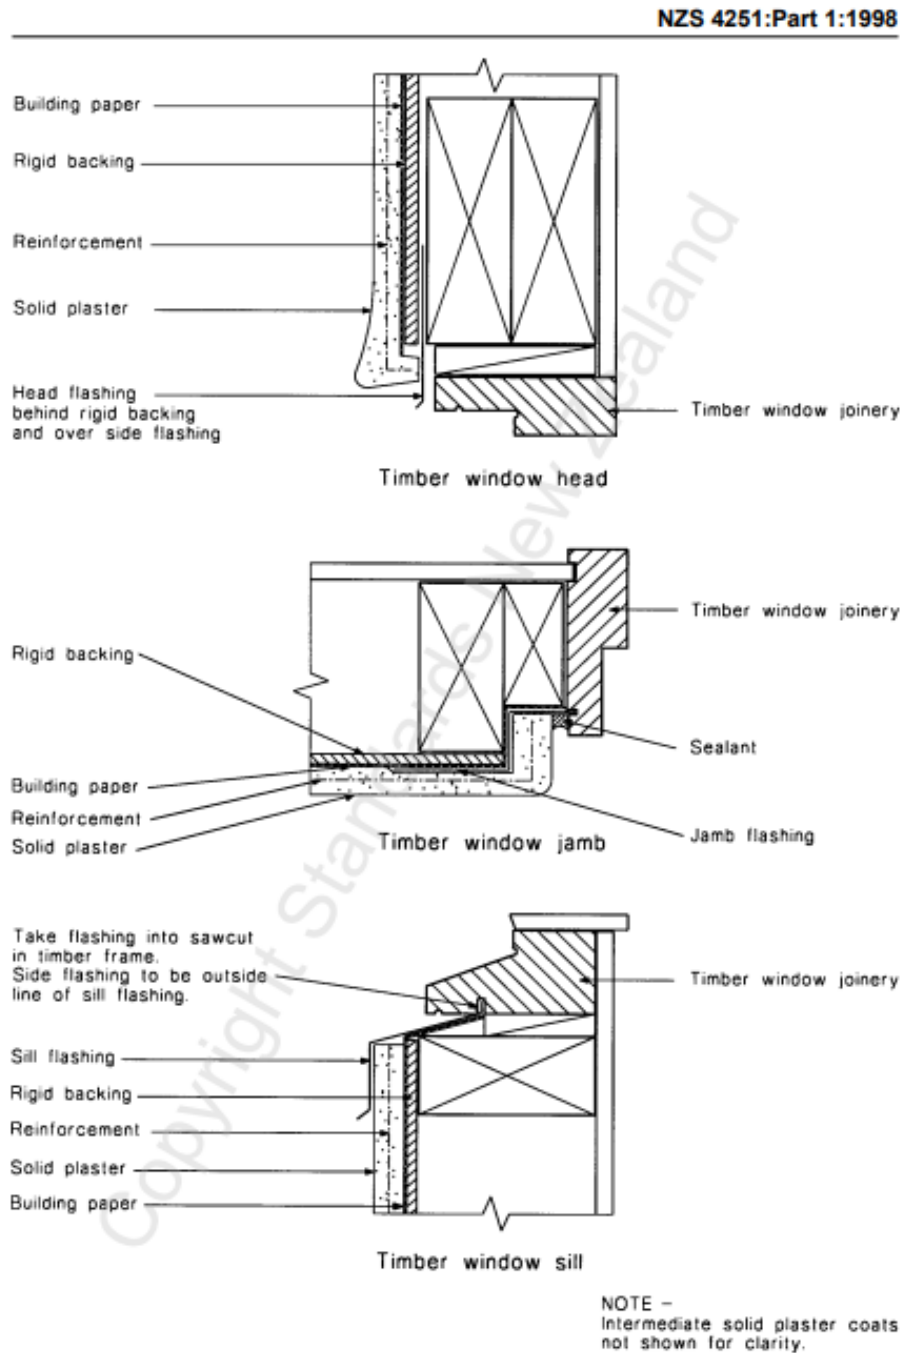
Figure 1(b) – Flashing for timber window frames

5.6. The expert noted that NZS 4251.1:1998 figure 1(b) provided head, jamb and sill flashings details (see Appendix B)²⁰, but no flashing details were included in NZS 4251:1974.

²⁰ NZS 4251.1:1998 is a superseded standard (superseded by NZS 4251.1:2007), but it was current in October 2000 when building consent 64033 was granted. Figure 1(b) has been reproduced in Appendix B for context only, noting that the original building consent plans did not indicate how the windows were to be installed.
