# Determination 2025/049

## The compliance of a replacement cladding system on a dwelling with clauses B2 and E2 of the Building Code

16A Marellen Drive, Red Beach, Auckland<sup>1</sup>

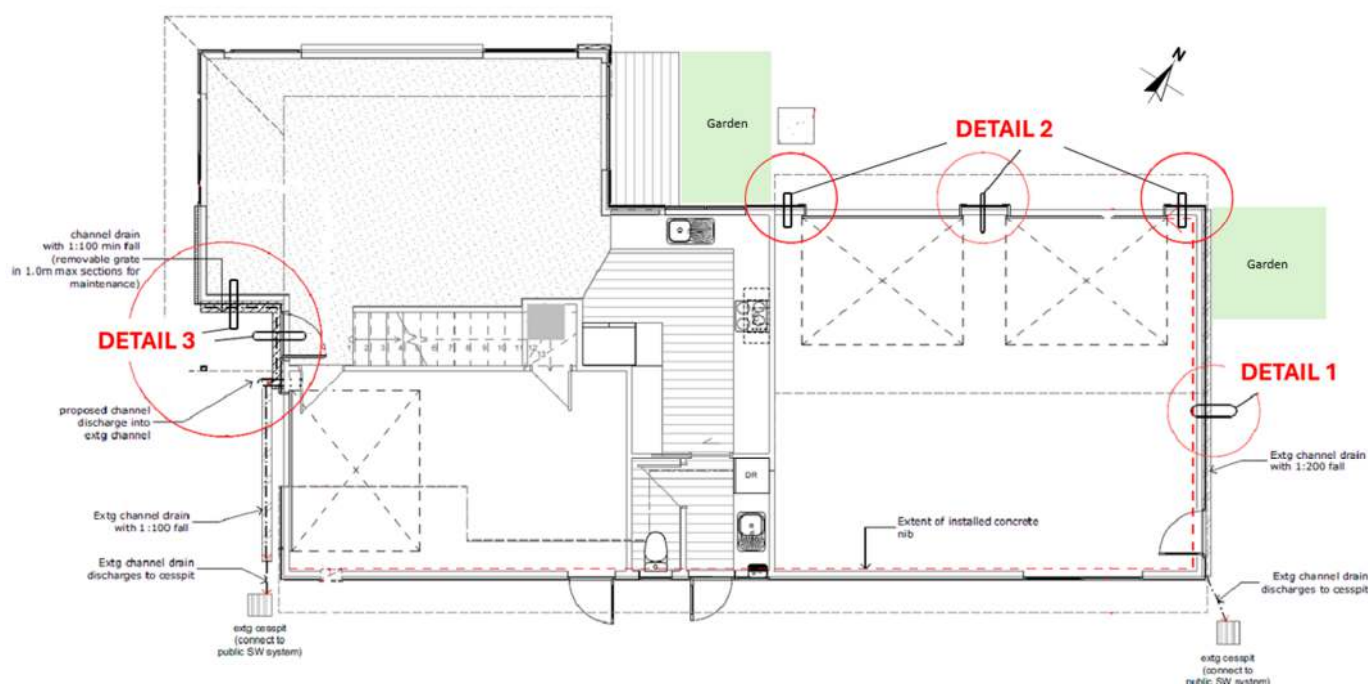
Plan 1: Floor plan with locations of details (not to scale)

- 2.3. This determination is concerned with three details, with the issue in dispute being the termination of the cladding relative to the finished ground and channel drains below. Details 1 and 2 have been constructed on two elevations of the rear garage. Detail 3 is proposed for the external walls adjacent to the front entrance, above a channel drain that is proposed to be replaced. See Plan 1.
