# Determination 2025/051

**Compliance of an altered timber retaining wall with Clause B1 *Structure* and an associated surface water management system with Clause E1 *Surface water* for protection of other property**

**50A, 52 and 52A Jackson Terrace, Ranui, Porirua**

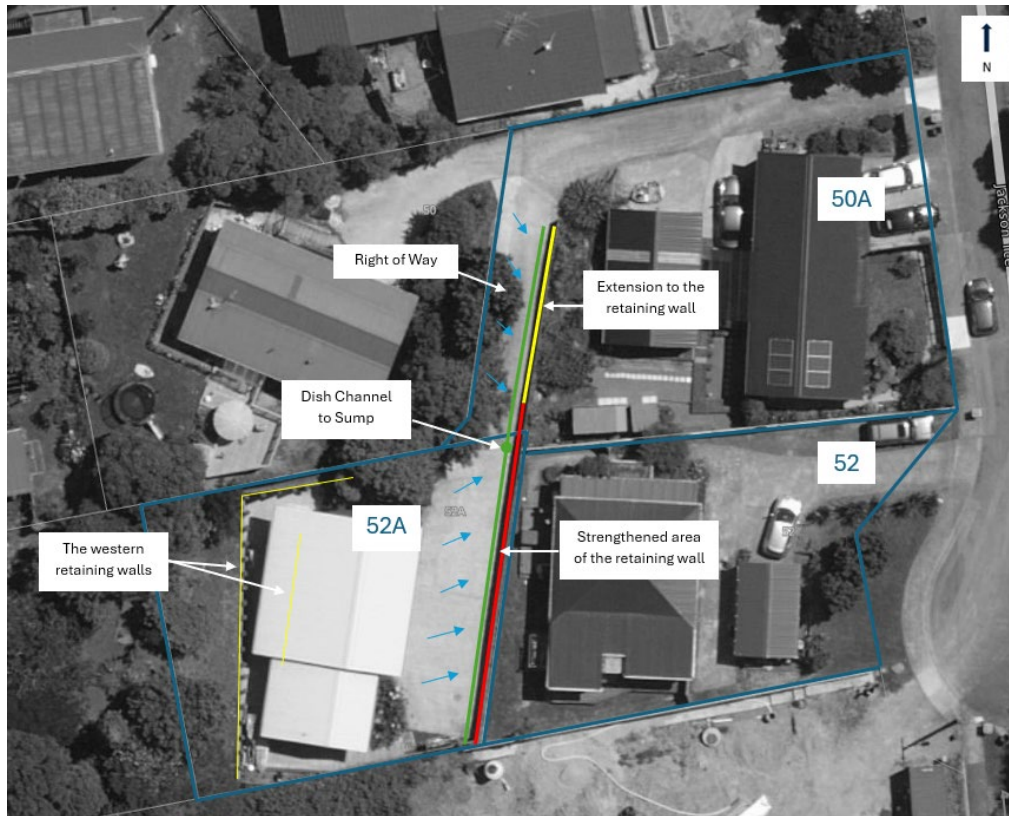
**Figure 2: Site Plan of 50A, 52, and 52A Jackson Terrace, including the locations of the building work (not to scale)**

- 2.1. In 2009, a subdivision was completed to create four new allotments being 50, 50A, 52 and 52A Jackson Terrace. The subdivision created a right of way easement ("ROW") over 50A Jackson Terrace to allow for access to the existing dwelling at 50 Jackson Terrace and the vacant allotment at 52A Jackson Terrace. Over the allotments, the land falls from west to east, with the properties 50A and 52 in the east being relatively flat land compared to the slope on 52A (figure 2).
