# Determination 2026/004<sup>1</sup>

**An authority's decision to issue two notices to fix for building work carried out without consent, a change of use and non-compliance with the Building Code**

**11 Laurence St, Manly, Auckland**

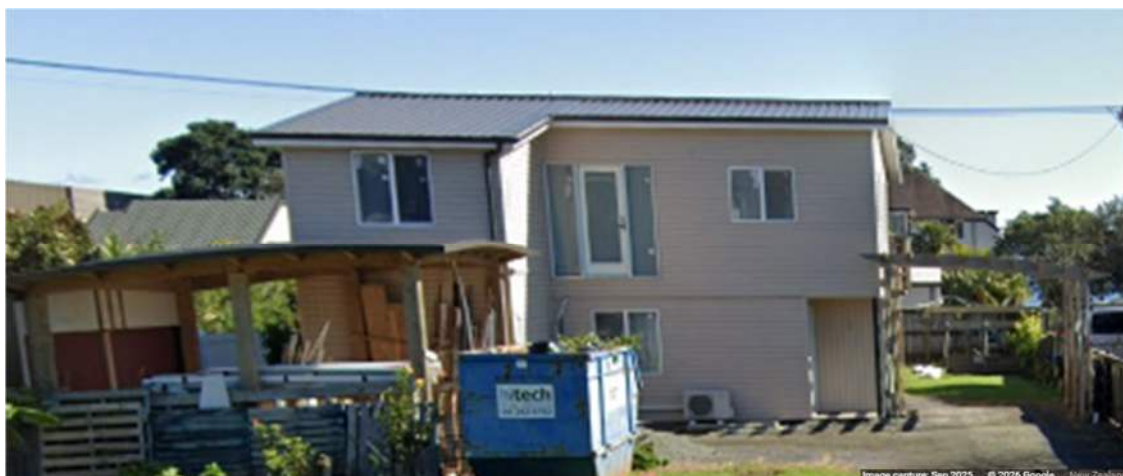
**Figure 1: The main building, the carport (left front) and pergola (right).**

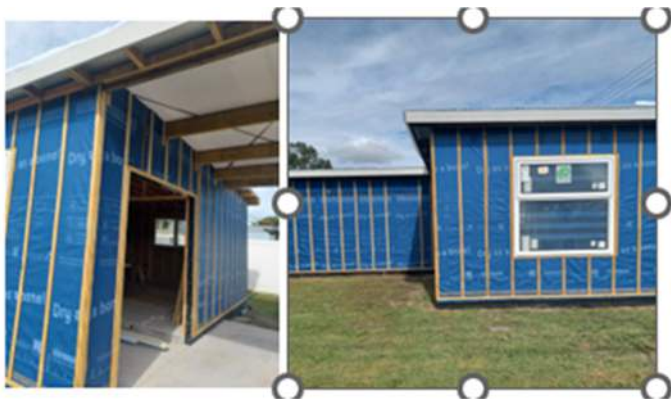
**Figure 2: The smaller building.**<sup>4</sup>

- This item relates to the smaller building at the property (see Figure 2), which the owners consider is a rebuild and extension of the former shed.<sup>16</sup> They state the construction has a total floor area of 29.6m<sup>2</sup>, plus a 'porch' and 'patio' within Schedule 1.
- The as-built plan notes this building is 2.5m high, and its south elevation is 200mm from the first-floor deck attached to the north side of the main building.
- The smaller building is constructed of three 'parts'. The southern end is 17.1m<sup>2</sup>, the middle is 22.04m<sup>2</sup> – this area has walls and a roof and an opening leading onto the northern part (see Figure 2, left). The northern end is 8m<sup>2</sup> and open on three sides.
- In total, the building is approximately 47.14m<sup>2</sup>.

- Clause 24 – it appears the owner is relying on this clause in relation to the northern end of the concrete slab (see Figure 2, left). However, the concrete slab is one continuous building element, and I consider it would be artificial to consider only a portion of the
