# Determination 2026/017

**The issuing of a certificate of acceptance for work completed on a new shower room, and whether the building work complied with the building code.**

**110a Lynwood Rd, New Lynn, Auckland**

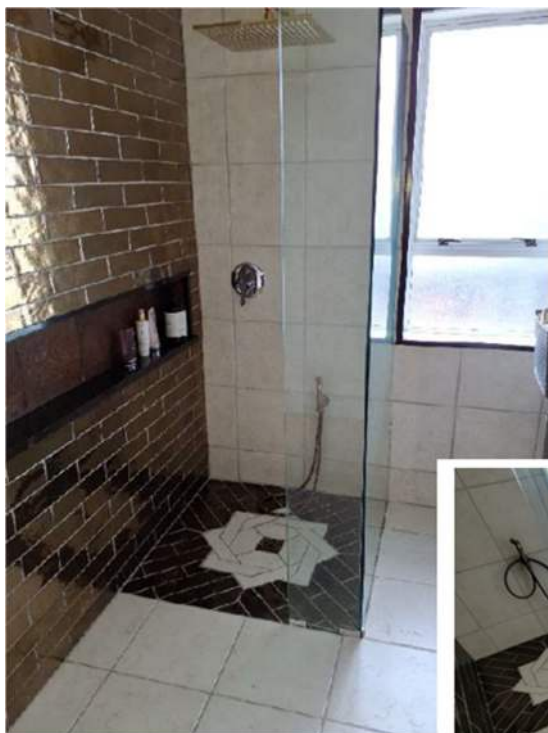
**Figure 1: The shower room**

- 1.3. This determination arises from the authority’s decision to issue the certificate of acceptance (COA04522498) (“the COA”) for alterations to an existing dwelling to create a new shower room where a previous bathroom existed (refer to figure 1). The current owners believe the building work does not comply with the Building Code and the COA should not have been issued.
