Department of
Building and Housing
Te Tari Kaupapa Whare

Weathertightness:

Guide to the Diagnosis of Leaky Buildings

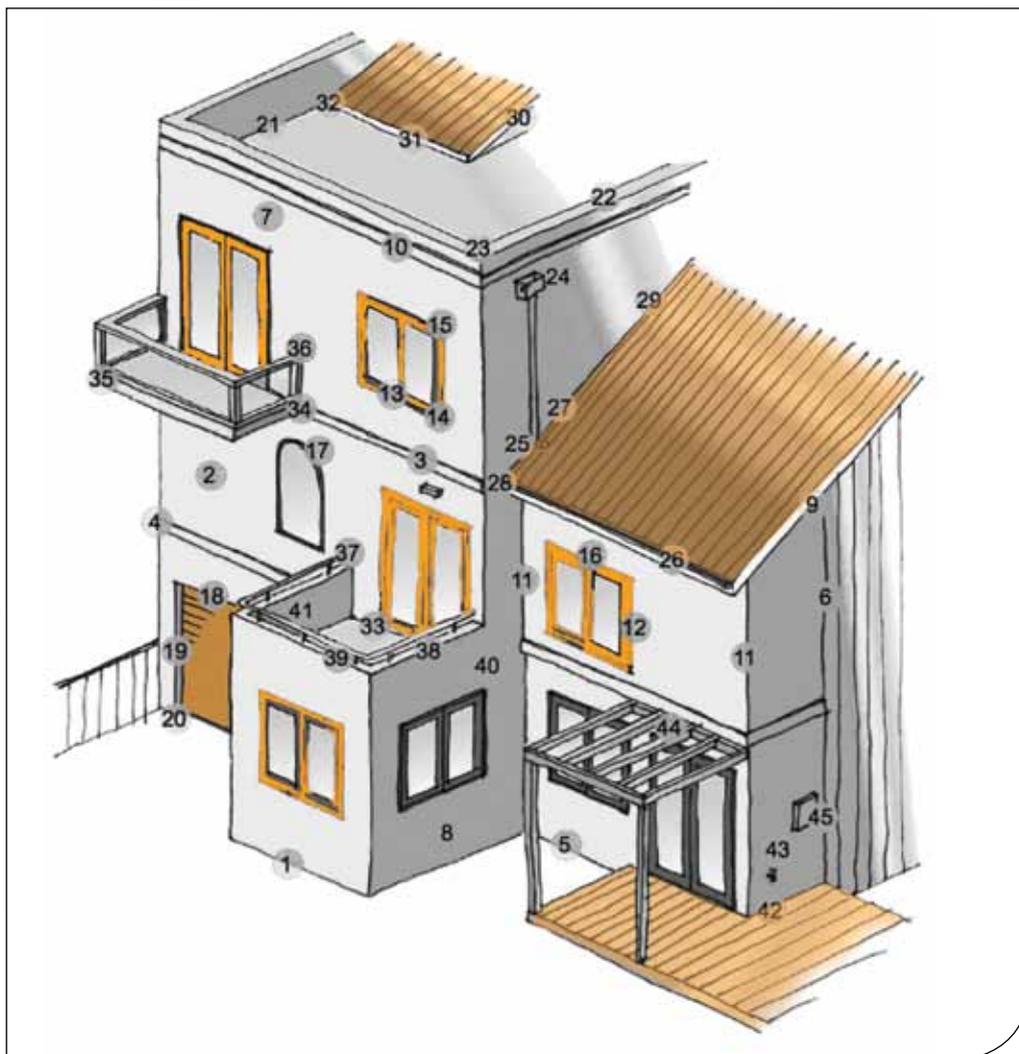
Figure 2: Common areas of weathertightness risk

Common areas of weathertightness risk features in a building are illustrated in **Figure 2** and described in **Table 1**. This is not an exhaustive summary. For example, retaining walls (tanking problems, poor drainage) or columns (inadequate top flashings or bottom clearances) may also be problematic.

After a general assessment of the building, any high-risk design features can be investigated in greater detail. Areas such as head flashing projections, cladding base details and clearances, apron flashings with kickouts and sealing of penetrations can indicate both the quality of workmanship and how well the designers and builders have understood detailing for weathertightness.

Description	Potential deficiencies
Cladding – general		
1	Base clearances	Inadequate cladding clearance (to ground, paving or decks) and fall away from building perimeter Insufficient floor height above ground, paving or decks
2	Body of cladding	Cracking
	Vertical control joints	Lack of or poor control joints
3	Horizontal and inter-storey control joints	No control joints, lack of flashings at joints Poor overlaps, flashing traps moisture
4	Horizontal joints – corners	Gaps, poor seals, no soakers
5	Cladding base	No anti-capillary offset/poor overlap No plaster drip edge Inadequate ground clearance
6	Inter-cladding junctions	No back-flashing, scribes etc
7	Sheet joints	Joints cracking/pouting, nails popping Joints lining up with window jambs
8	Material quality	Sub-standard solid plaster, reinforcing placement incorrect Unsuitable weatherboard profiles for the conditions
		Waterproof paint coating/sealer defects, lack of maintenance

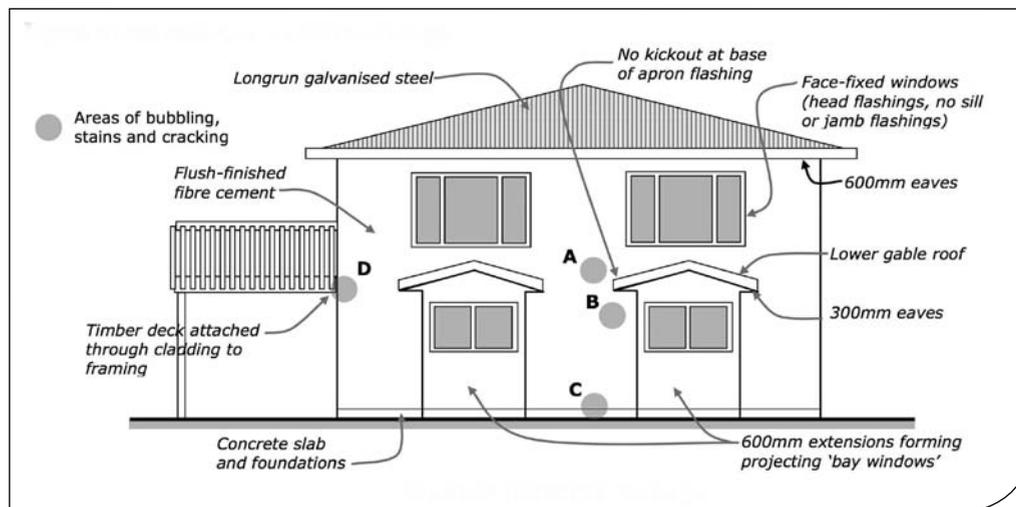
Figure 3: Elevation with visible moisture damage

This appendix provides an example of how a diagnostic investigation might proceed. It sets out an approach to examining one elevation, as illustrated in Figure 3, of a notional two-storey, stand-alone, timber-framed building. The sample uses the steps described in this document, and concludes with the defect analysis and summary outline of a recommended remediation for the subject elevation.

- flush-finished, texture-coated fibre-cement wall cladding system with no visible inter-storey joint, with stains and cracks apparent
- windows face-fixed with metal head flashings but no sill or jamb flashings
- complex roof-to-wall intersections above the two bay windows
- apron flashings above the bay windows without any kickouts – sealant was used at the bottom of the flashings to prevent water entry, but appears to have failed at location A
- 600 mm eaves at upper roof level and 300 mm eaves to the bay windows
- timber slat deck, on adjacent elevation, fixed directly through the cladding with coach screws at first floor level.

The cladding is showing signs of damage due to moisture ingress as follows:

- location A – cracking of cladding and paint bubbling at inter-storey level above bay window roof
- location B – cracking of cladding and paint bubbling below missing kickout flashing
- location C – nail popping and discolouration at bottom plate level directly below other defects – cladding is installed hard up against the foundation restricting drainage at bottom of sheet
- location D – cracking of paint and bubbling of paint at inter-storey level – adjacent to where the deck is fixed.

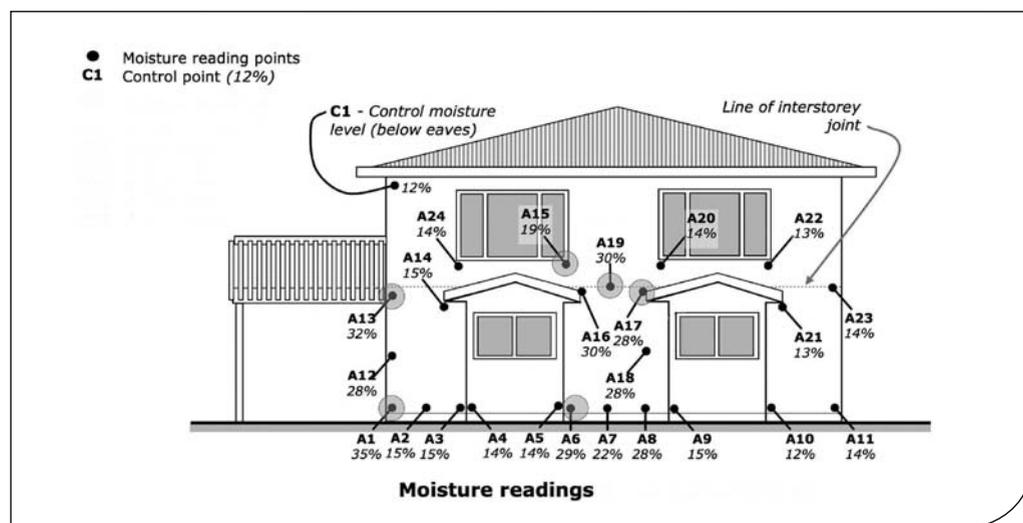
Figure 4: Moisture readings

Invasive electrical resistance moisture meter readings were taken in the framing timber in each of the locations shown in Figure 4 at three progressive depths, starting close to the exterior surface with the last reading in the approximate centre of the studs.

Dyed water was then injected under the bay window apron flashing (at A16) with dye traces subsequently found in location C at A6 (refer to Figure 4). Photographs of the results were recorded as evidence.

Additional information was gained from the actual drilling for invasive moisture readings. The hardness of the timber could be estimated by the resistance of the drill compared with the control point. Similarly, the moistness, smell and nature (appearance and level of decay) of the drillings themselves gave clues to support the meter readings.

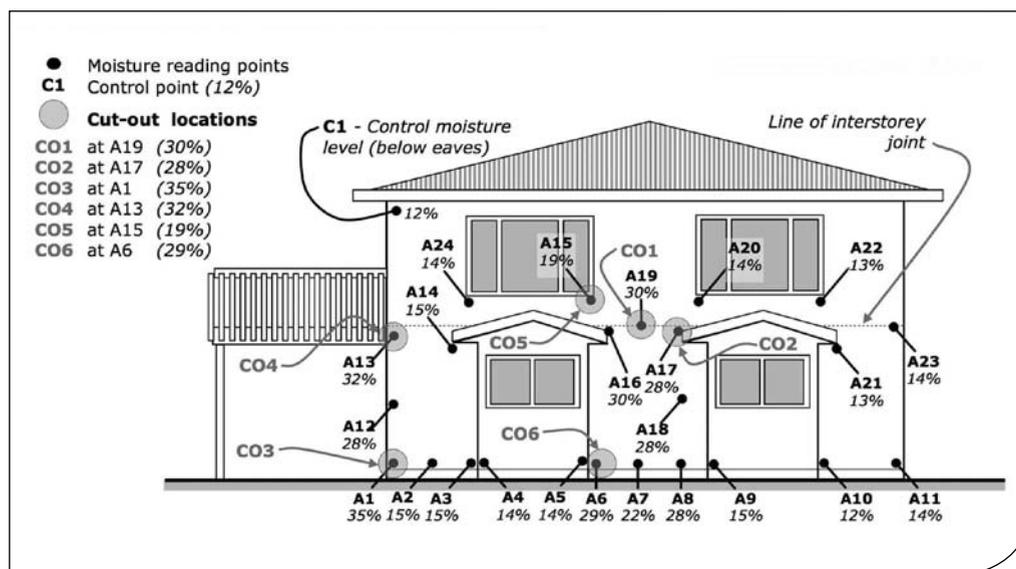
Figure 5: Cut-out locations

Cut-outs were taken at areas with different construction features and high moisture readings (more than 3–4 percent above the emc) to confirm the indicative results from the previous non-invasive and invasive testing. In this example, cut-outs were made at the locations shown in Figure 5.

In this example, as shown in Figure 5, the locations for cut-outs were selected as follows.

- **CO1** – to expose the inter-storey joint detail (refer to location A) and confirm decay.
- **CO2** – to confirm whether the apron flashing (location B) directed water into the wall rather than away from it, because there is no kickout on the actual flashing. The dye test had already indicated a moisture path from A16 to A6. There was no need to take cut-outs at A14, A16 or A21, as it was assumed that construction details would be similar.

The evidence and analyses have been carefully weighed up in order to reach some firm conclusions. The recommendations set out below for the extent of cladding and timber framing replacement (with reference to Figure 5) consider both current and potential damage.

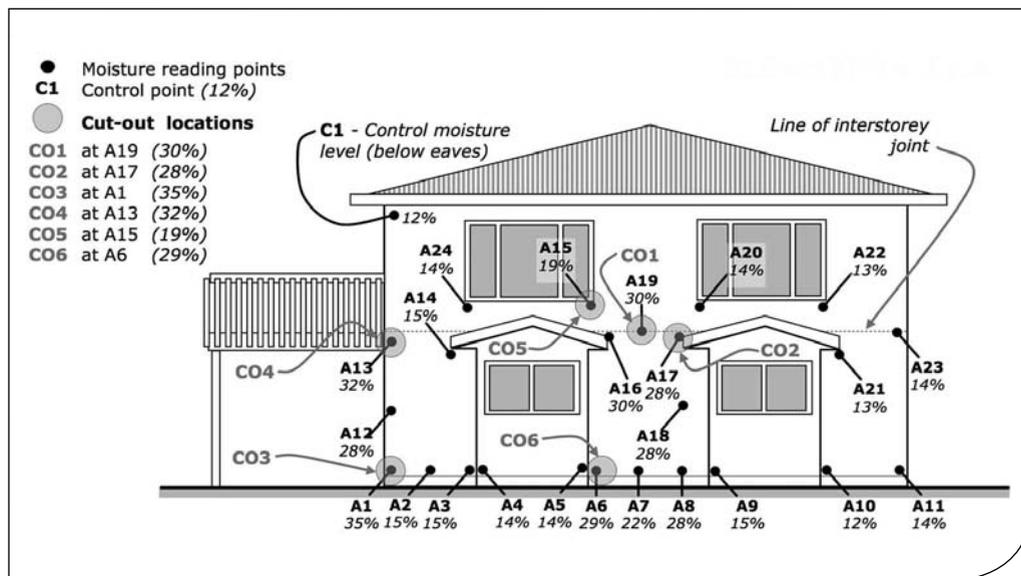
Figure 6: Location of moisture readings

From the investigation described already, together with the laboratory test results, a scenario of the moisture penetration and subsequent damage has been developed. Refer to Figure 6.

Although the moisture content is slightly above the 18 percent threshold (confirmed by taking further moisture content readings after the cut-out was made), only minor visible signs of moisture ingress and mould were found. The laboratory analysis reported the timber framing sample showed incipient decay that will probably continue without at least some in situ preservative treatment to avoid further decay.
