Department of
Building and Housing
Te Tari Kaupapa Whare

DEALING WITH TIMBER IN LEAKY BUILDINGS

A GUIDE FOR BUILDERS AND BUILDING
PROFESSIONALS

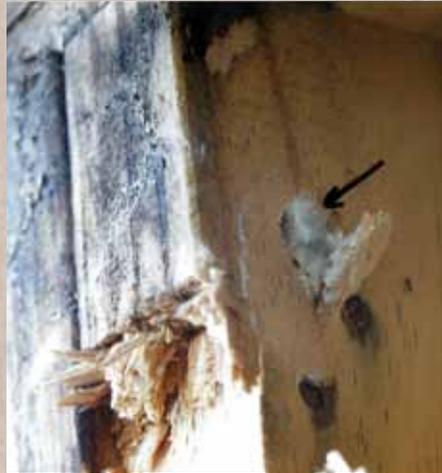
1. Brown rot in apparently sound timber

Brown rots eventually cause wood to turn dark brown, and crack along and across the grain, creating a pattern of cubes (Photos 1 – 3). Brown rots are usually hard to spot in the early stages and can rapidly cause serious decay and strength loss, even when the timber is not particularly wet. Brown rots are less common in timber that has been treated with boron, but common in untreated radiata pine.

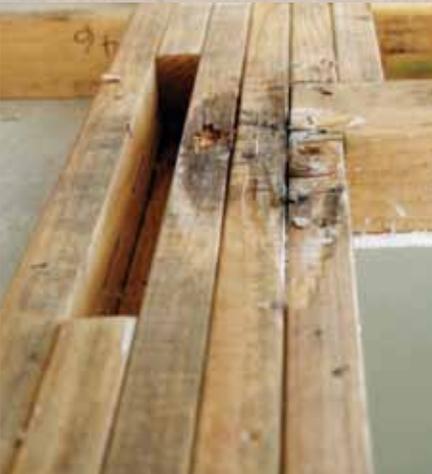
2. Start of brown rot from leak off the end of a head flashing

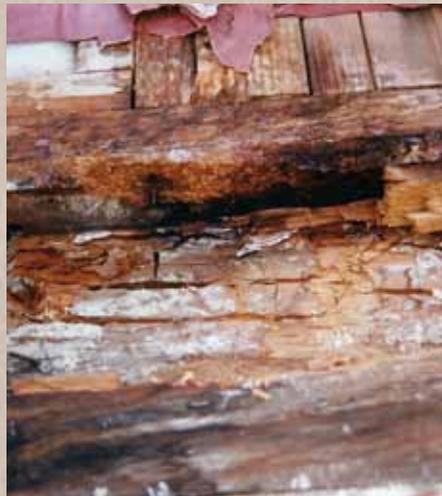
3. Advanced brown rot

Decayed timber needs to be removed and replaced with H1.2 (or higher) treated framing. Where the timber shows obvious signs of failure (as in photos 3 and 4, for example) there is typically no need to test the decayed portions before removal. Testing should focus on identifying where the timber is sound. The general recommendation is to cut out any timber at least one metre beyond the last visual signs of fungal decay on any individual piece of timber (see Figures 1 and 2).

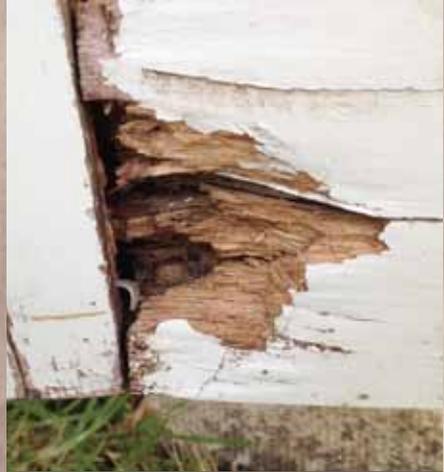
4. White rot in timber joinery

White rots at well-advanced stages cause the timber to become lighter in colour and fibrous in texture without cross-checking along and across the grain (Photo 4). White rots are less common in radiata pine than brown rots.

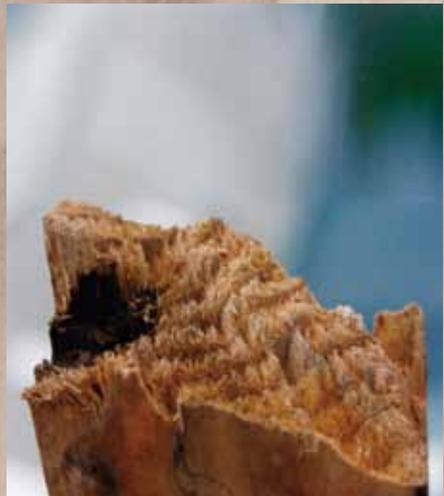
5. Fracture surface of timber with soft rot

Soft rot is more common in boron-treated timber that has been wet for a prolonged period. It is difficult to spot as there is often little outward sign of decay. Sometimes the timber may become a dirty grey-brown colour, but not always (Photo 5). When a sample at least the size of a matchstick is broken off, the surface at the break can sometimes look like a broken carrot.

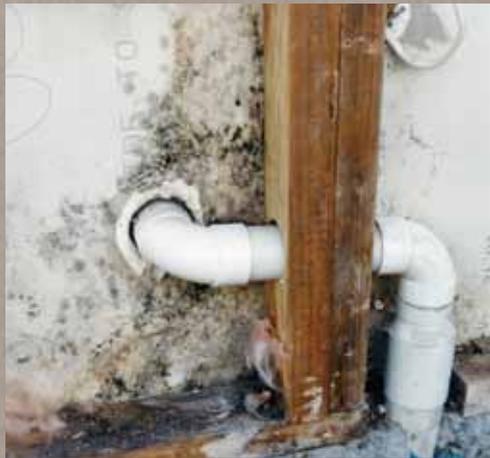
6. Mould on plasterboard lining around a leak

Because all moulds tend to look the same to non-specialists (Photo 6), moulds found on site can only be identified under a microscope by qualified laboratory specialists with experience in identifying fungi.
