Determination 2008/33

Determination regarding a code compliance certificate for 8-year-old additions to a house at 225 Adams Road, RD1, Christchurch

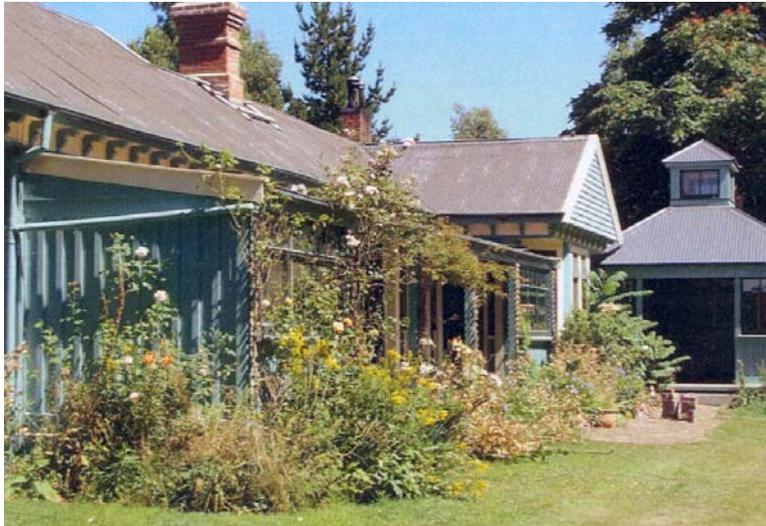
The original lean-to kitchen has been demolished and replaced with an addition that fills in the southwest corner. The addition is roofed with an extension of the existing south gable and has a concrete perimeter foundation wall, timber piles and particle board flooring, with timber weatherboard cladding, re-used double-hung windows, and timber facings and eaves brackets to match the original house.
