Determination 2009/58

Determination regarding the refusal to issue a code compliance certificate for four blocks of semi-detached townhouses at 42A Park Avenue, Papatoetoe

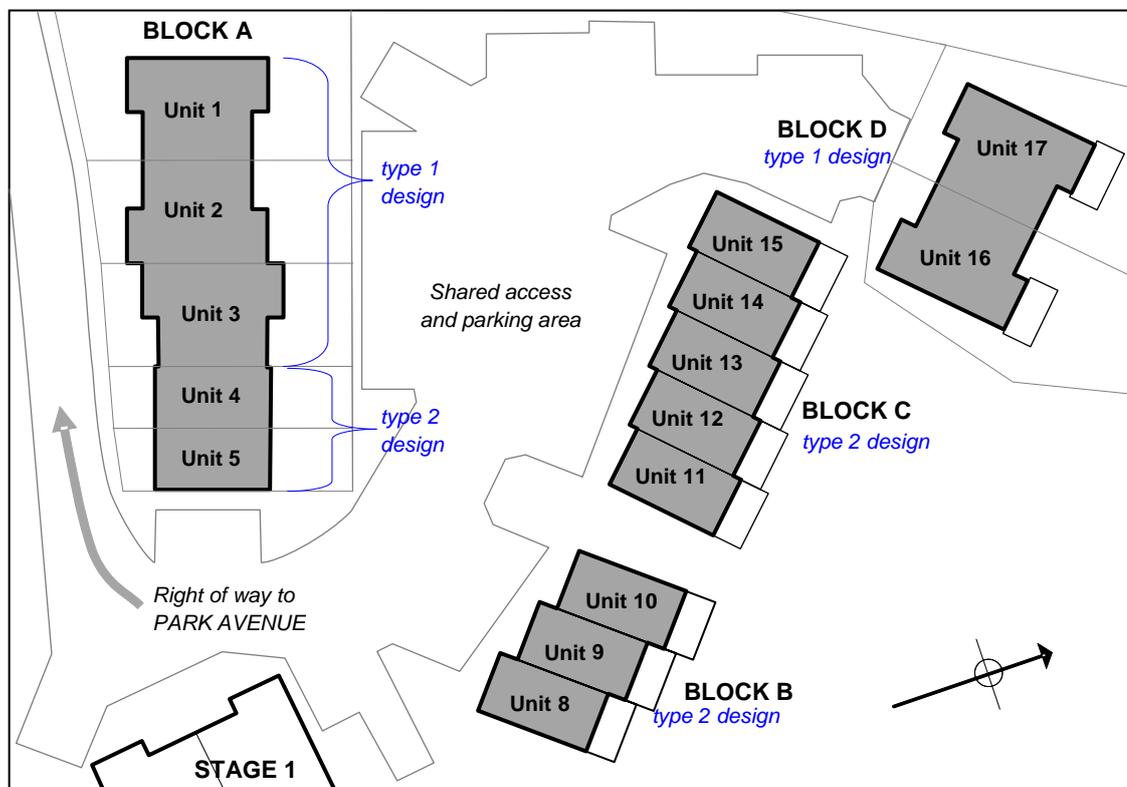
Figure 1: Site plan

- 2.1 The building work is situated on a sloping site in a low wind zone in terms of NZS 3604⁴, and consists of 15 units in 4 free-standing blocks (“the blocks”) as shown in the following site plan:
